DOVERSPIKE NO. 1 DAM

NDI I.D. PA-01131

PHASE I INSPECTION REPORT  
NATIONAL DAM INSPECTION PROGRAM

DEPARTMENT OF THE ARMY  
BALTIMORE DISTRICT, CORPS OF ENGINEERS  
BALTIMORE, MARYLAND 21203

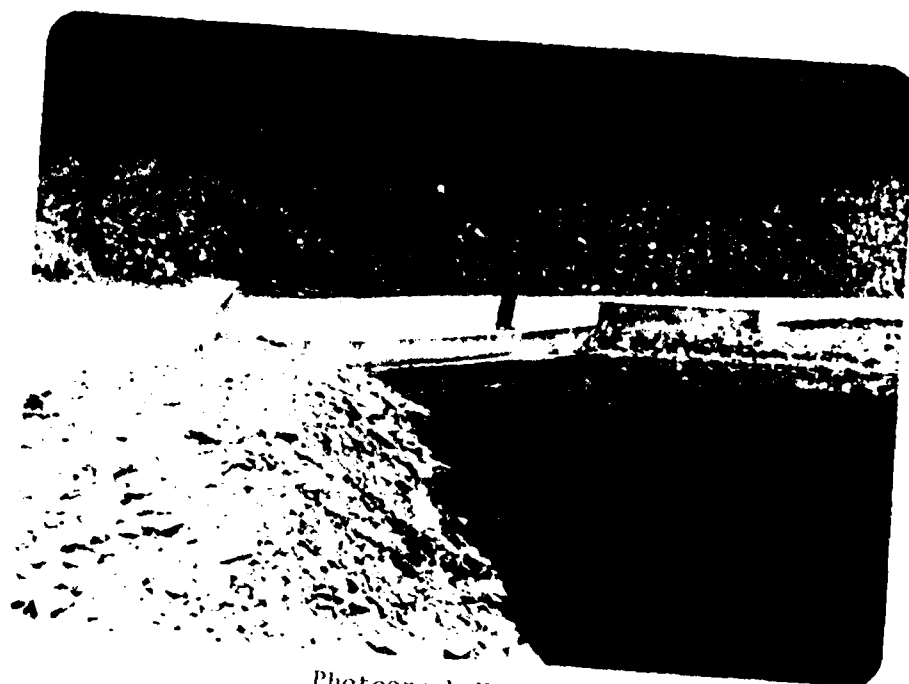
Photograph No. 3  
Emergency spillway approach channel.

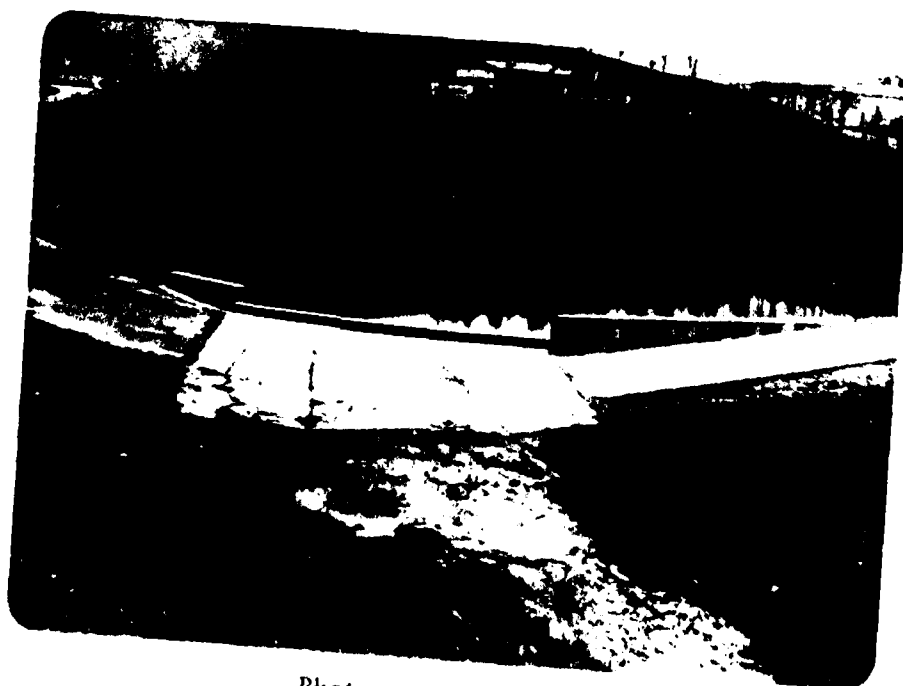
Photograph No. 4  
Emergency spillway overflow structure  
and discharge channel.

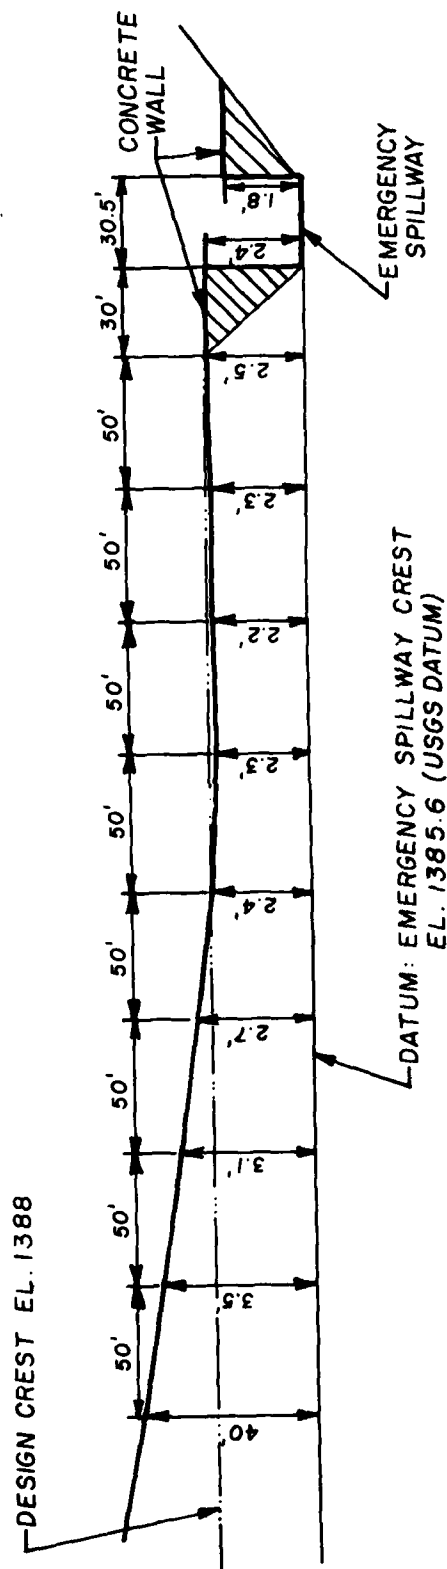
# DAM CREST PROFILE (LOOKING DOWNSTREAM)

The crest of the dam was surveyed relative to the emergency spillway crest elevation and it was found to be generally at or above the design crest elevation. The dam crest profile is illustrated in Plate 5. The downstream slope was surveyed and found to be reasonably within the design slope of 3H to 1V.
