6) National Dam Inspection Program,
LAKE PINECREST DAM

PHASE I INSPECTION REPORT,
~~NATIONAL DAM INSPECTION PROGRAM~~

L. ROBERT KIMBALL & ASSOCIATES
CONSULTING ENGINEERS & ARCHITECTS
EBENSBURG, PENNSYLVANIA
15931

SEPTEMBER, 1980

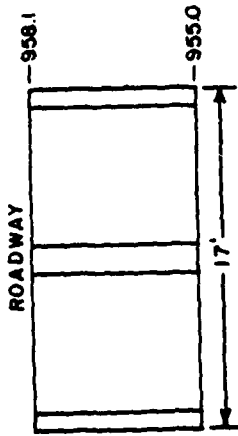
SPILLWAY SECTION

c. Appurtenant Structures. The concrete spillway is in a deteriorating condition. Several cracks were observed in the chute walls and erosion at the outlet of the chute is beginning to undercut the section.

3.2 Evaluation. The embankment appeared to be in fair condition. No seepage was noted on the downstream slope. The concrete chute spillway is in a deteriorating condition and several cracks were noted on the spillway wingwalls. Discharges through the chute are eroding the outlet and are beginning to undercut the end section.

1. The concrete spillway should be repaired.
2. Erosion protection should be provided at the spillway outlet. Additional riprap should be placed beyond the spillway outlet to protect the downstream toe adjacent to the spillway discharge outlet.
