PENNSYLVANIA  
NDI No. PA 00908  
PENN DER No. 63-78

# REFUSE SETTLING BASIN

UNITED STATES STEEL CORPORATION  
RAW MATERIALS DIVISION

PHASE I INSPECTION REPORT  
NATIONAL DAM INSPECTION PROGRAM

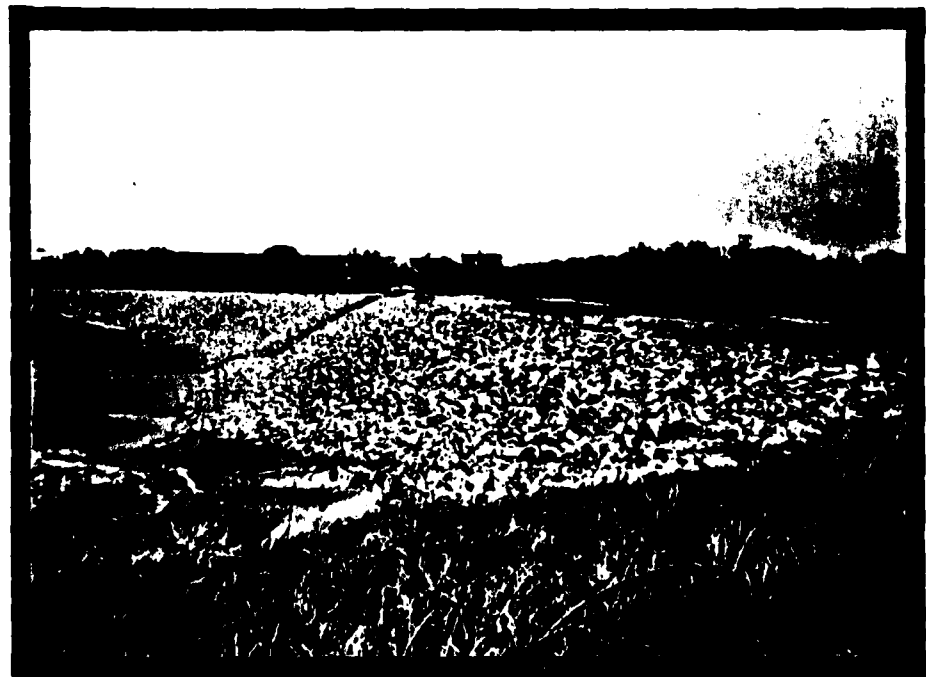
(2) Upstream Slope: The upstream slope of the embankment had a uniform covering of sandstone riprap. The riprap materials ranged in size from 2 inches to 20 inches and were uniformly placed across the slope. No erosional gullies or scarps were observed. The upstream slope ranged from 1.8H:1V to 2H:1V with a 27 foot wide bench at about mid-height. The groin area between the riprap and the unsubmerged portion of the slope was in good condition along the entire upstream toe.

Photo 2 Embankment A - Upstream Slope. Dark strip at center of embankment is slurry discharge stream.

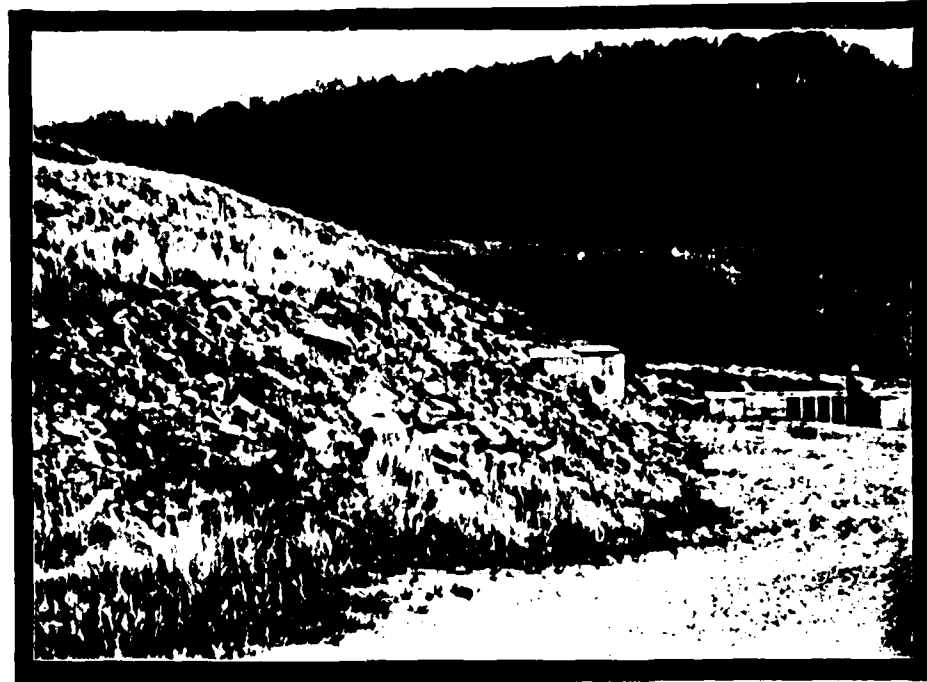
On the left, the abutment drops into a valley which is generally swampy and contains considerable water related vegetation. Also, some softness in the toe area was observed immediately below the slump of the rockfill toe area described earlier.

The swampy areas were generally soft and contained standing water, but no moving water was observed.

Photo 3 Embankment A - Downstream Toe Area showing principal spillway outlet structure. Note swampy conditions beyond embankment toe.

- a. Review and evaluation of monitoring instrument data.
- b. Investigation of the swampy conditions at and below the toe of the embankment.
- c. Stability calculations, if necessary.

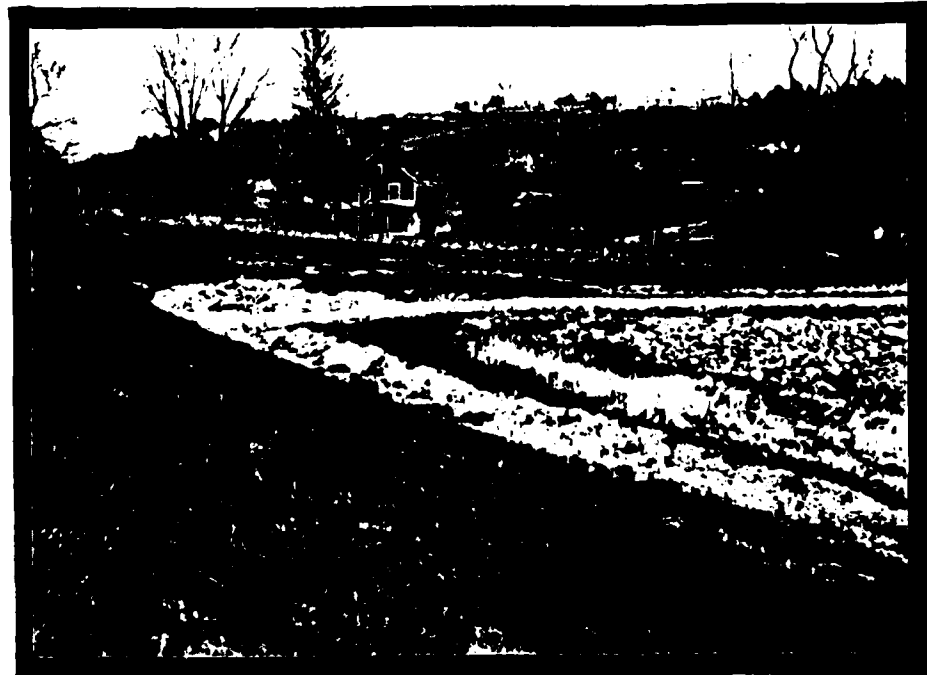
(2) Left: The left abutment consists generally of a flat area beyond the embankment containing the riprap lined emergency spillway. The area was covered with a uniform stand of dense grass and was observed to be in good condition. No instability and no seepage were observed anywhere on the left abutment.

Photo 4 Emergency Spillway Channel on left abutment of Embankment A.

- c. Mow dense vegetation on the upstream and downstream slopes.
- d. Carefully inspect upstream and downstream slopes and backfill all animal burrows and eroded areas.
- e. Clean road drain catch basins and regrade the surface as necessary to promote proper drainage in the left groin.
- f. Repair the eroded areas below the road drain outlet structure and provide an adequate erosion resistant drainage channel.
- g. Repair the eroded area below the Pond Drain 2 outlet and provide an adequate erosion resistant channel.
- h. Replace the eroded backfill behind the emergency spillway chute's right wall and modify surface drainage patterns to assure the integrity of the replaced backfill.
- i. Clean vegetal growth and debris from the emergency spillway chute.

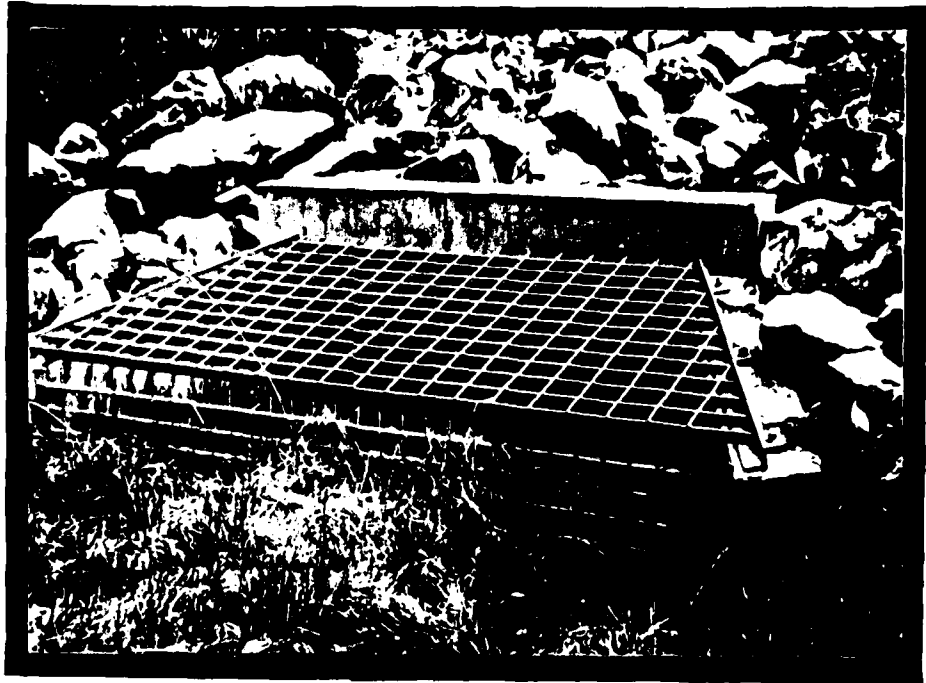
Photo 7 Underflow Pipes Inlet at downstream  
(up-valley) toe of Embankment B.

- a. Repair minor sloughing and minor erosion and backfill animal burrows observed on and adjacent to Embankment A.
- b. Repair minor erosion observed adjacent to the underflow pipes inlet structure.

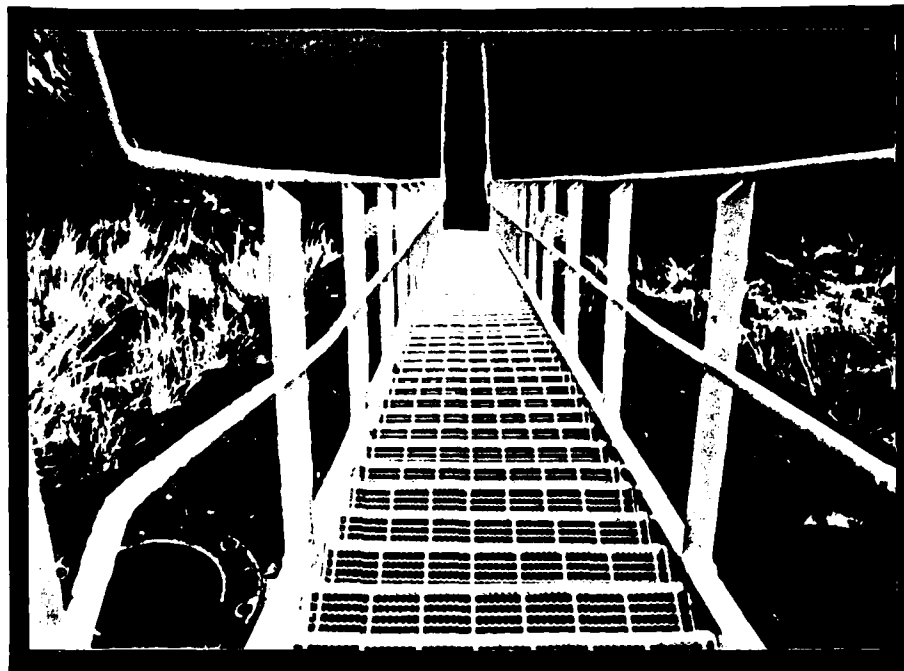
Photo 9 Principal Spillway Intake Ports and access stairway.

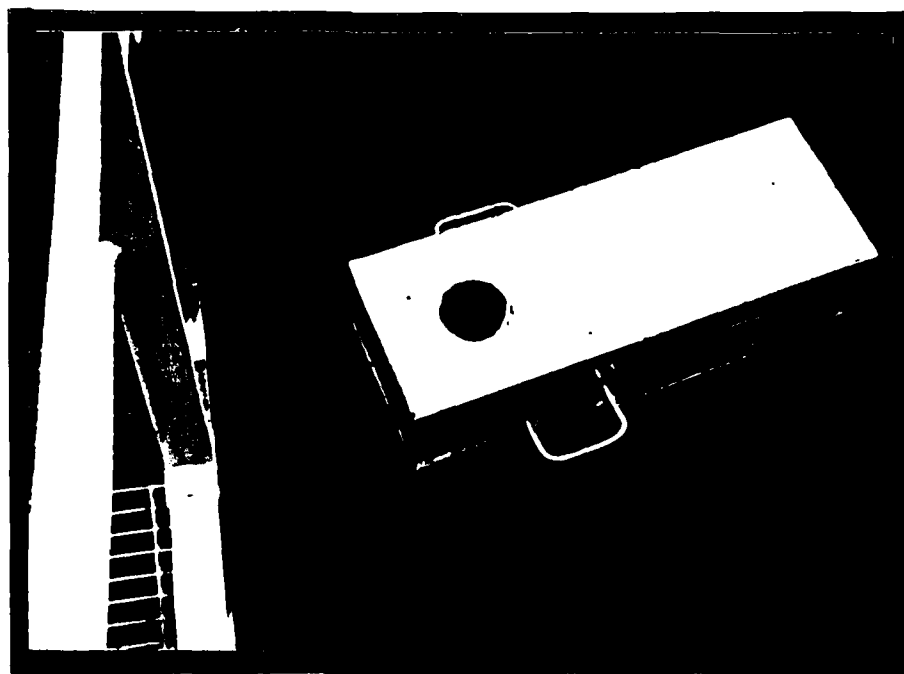
Photo 10 Principal Spillway Intake Port with flow control box.

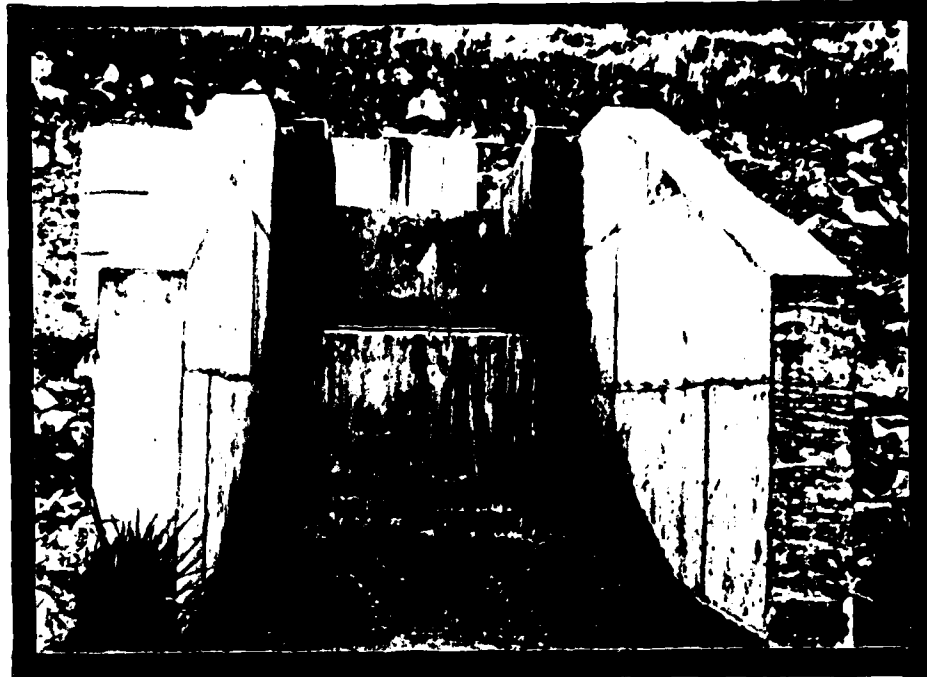
Photo 11 Principal Spillway Outlet Structure showing overflow weir from below.

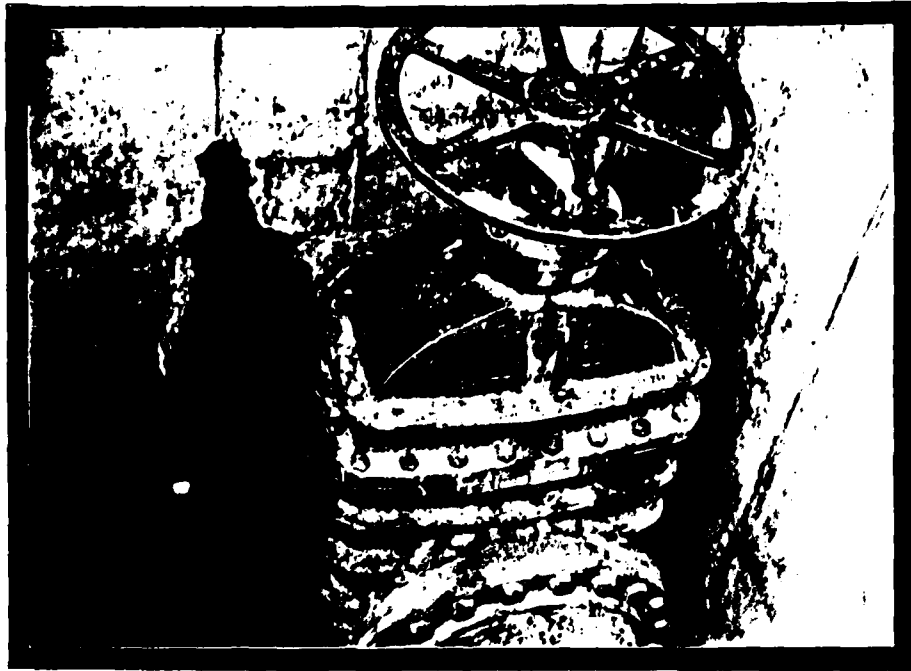
Photo 13 Principal Spillway Outlet Structure showing gate valve control which is immediately upstream of the overflow weir shown on Photo 11.
