② National Dam Inspection Program
UNIVERSITY OF MARYLAND
BALTIMORE COUNTY

DAM (NDI-ID Number MD34)

PHASE I INSPECTION REPORT

AUGUST 1980

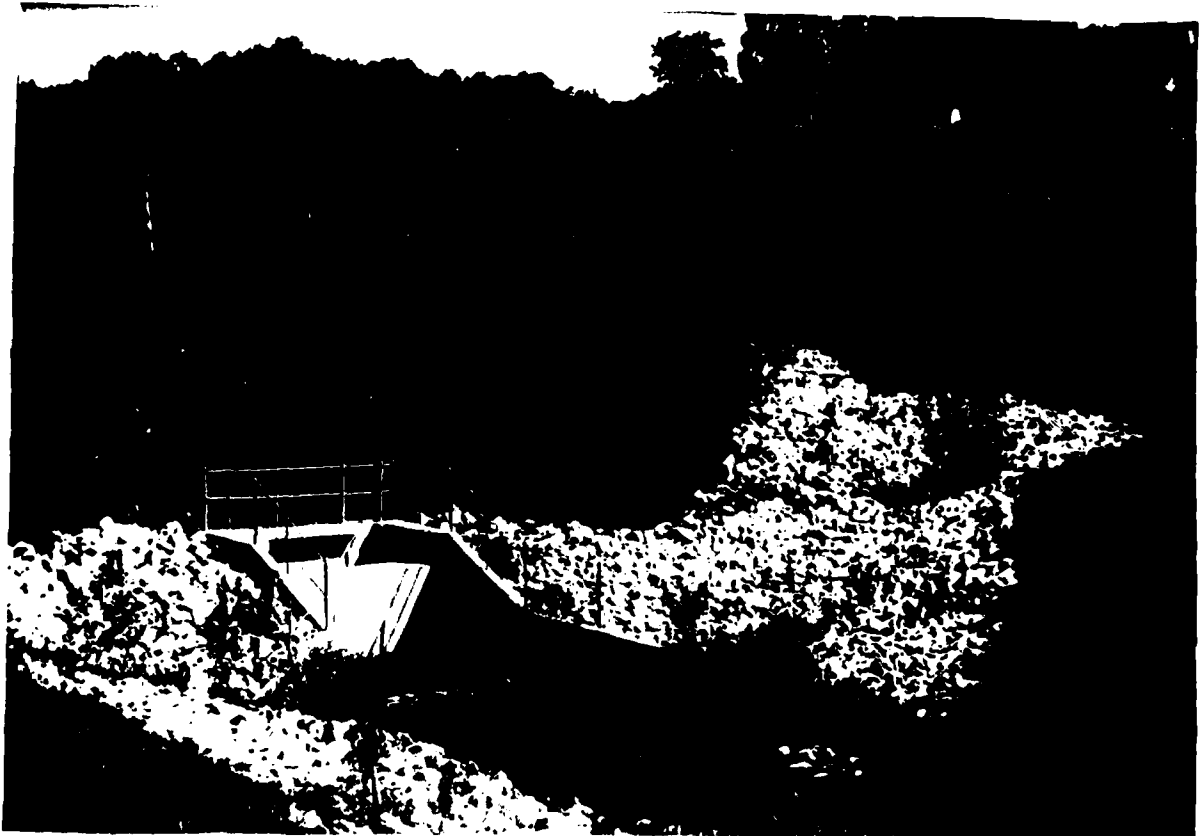
Overview of Dam

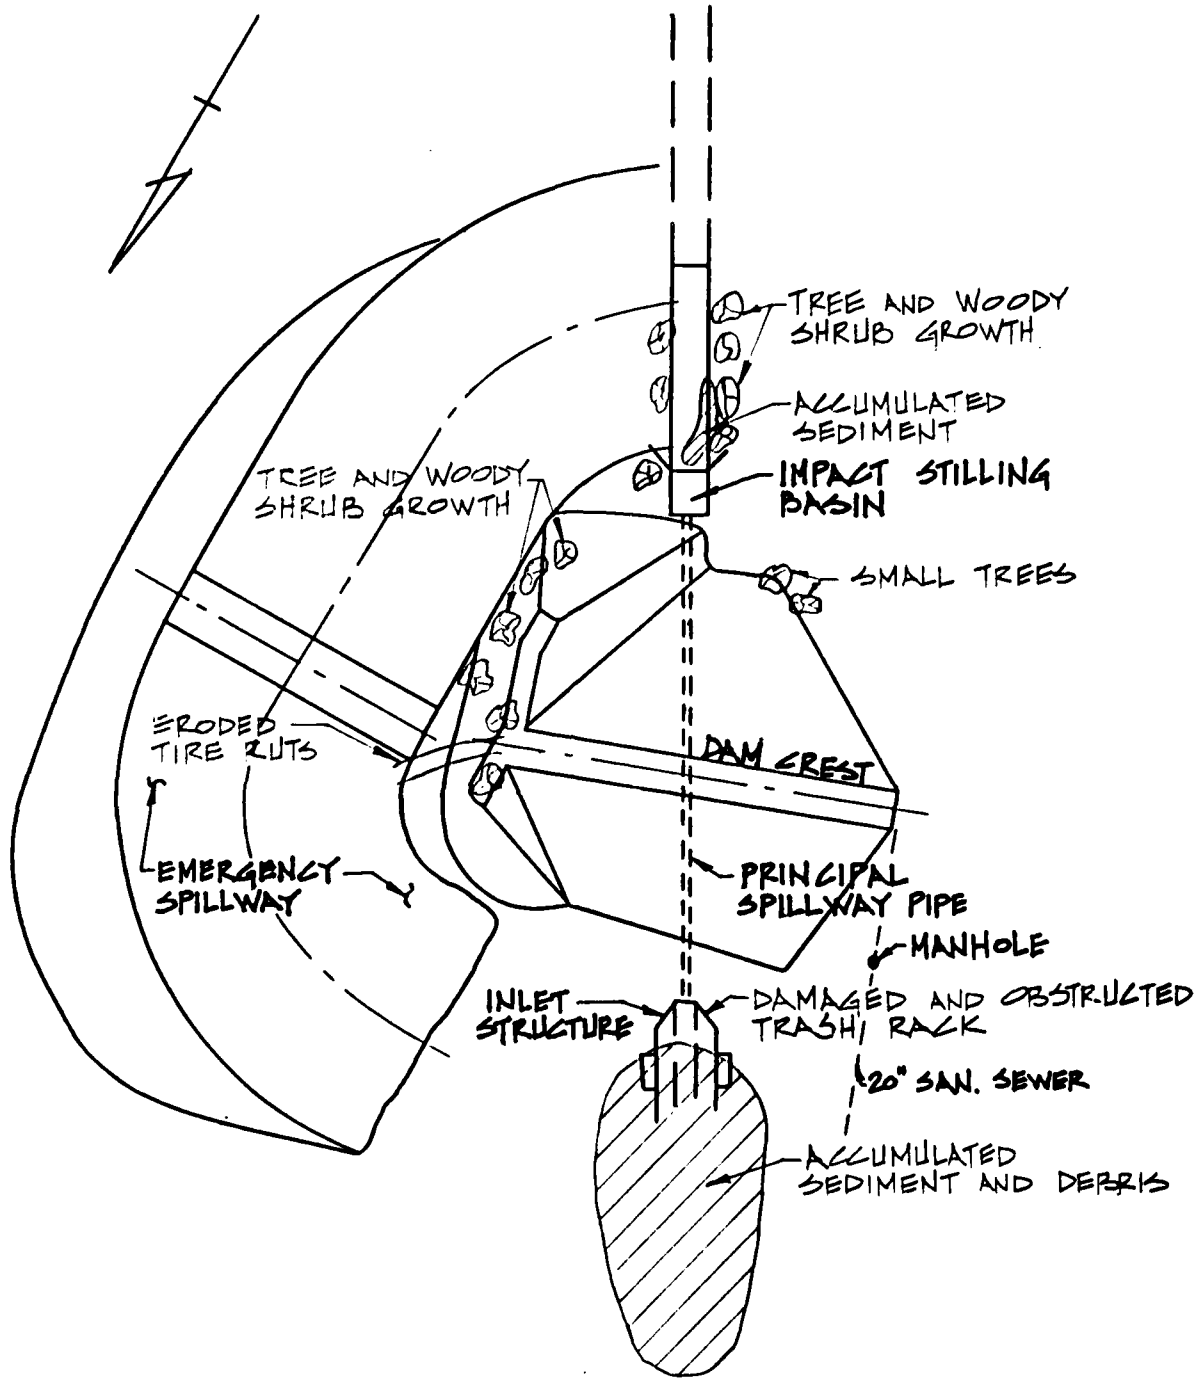
DATE: AUG. 8, 1980		NATIONAL DAM INSPECTION PROGRAM	U. M. B. C. DAM FIELD SKETCH
SCALE: NONE			
DR: JLM	CK: TED	ACKENHEIL & ASSOCIATES CONSULTING ENGINEERS BALTIMORE, MD.	
DWG. NO. A-10

B. EMBANKMENT: Embankment slopes had field measured inclinations approximating 3H:1V and a crest width of 20 ft. Embankment crest and slopes had a dense grass covering and appeared stable. Trees and woody shrubs were located along the embankment-spillway abutment, extending from dam centerline to the impact stilling basin. Eroded tire ruts were observed along the dam crest, bottom of the spillway channel, and embankment-spillway abutment (see field sketch).
