Name Of Dam: CRAB ORCHARD CREEK

Inventory Number: VA. 02102

## PHASE I INSPECTION REPORT NATIONAL DAM SAFETY PROGRAM

JULY 1980

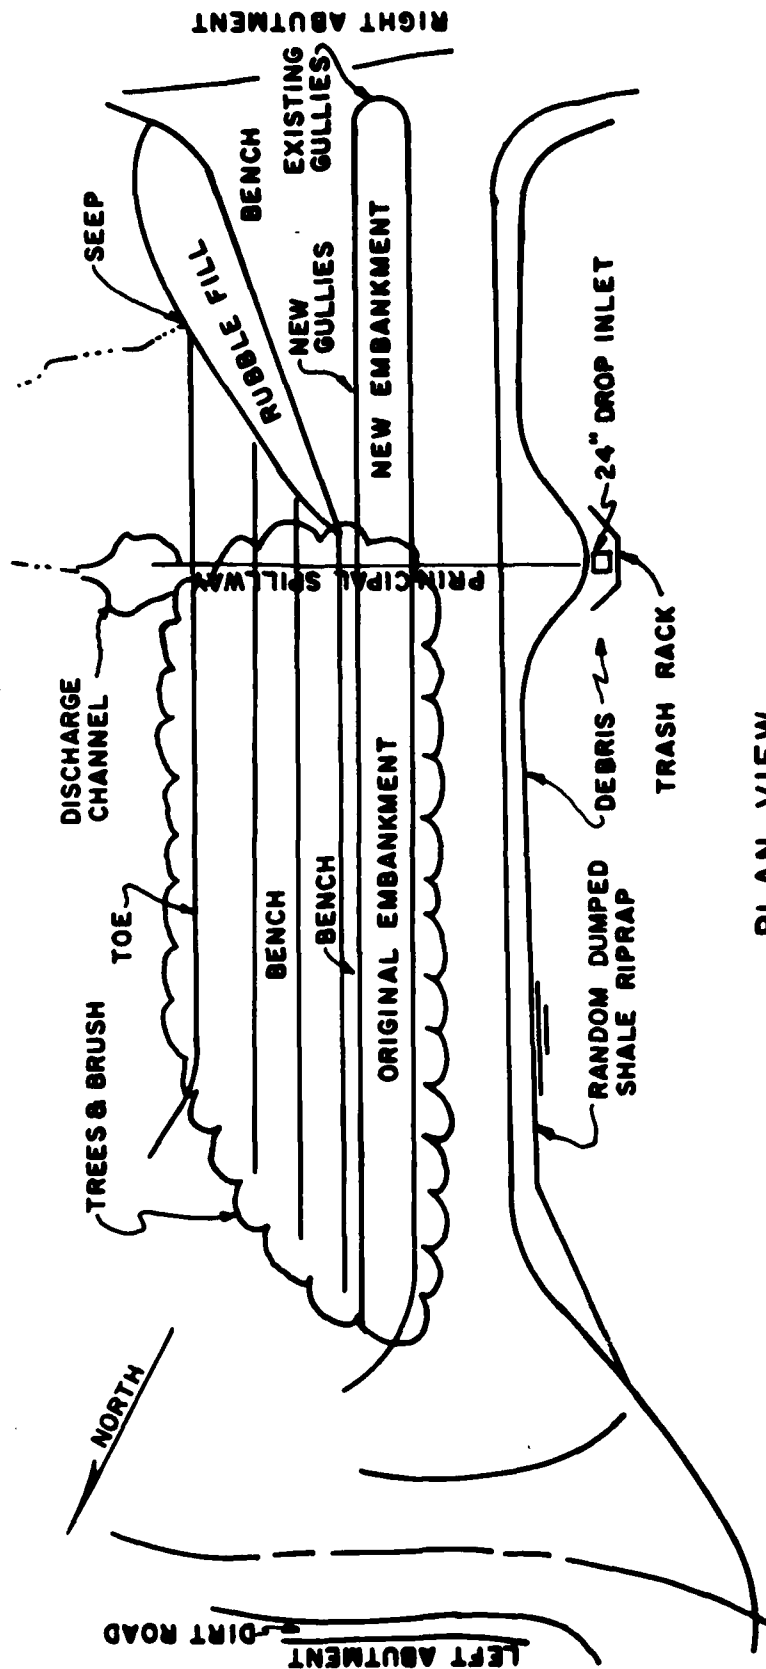
PLAN VIEW

There is one seep located at the base of the dam at the right abutment as shown on Plate II. The origin was not found because of vegetation and boulders inhibiting the inspection in the area. The owner representative said he had checked the spring monthly for the past two years and had noted no changes. Flow is clear. No estimate of the quantity was made. The source and age are unknown.

d. Maintain regular inspection of the seep on the right downstream abutment. Should flow suddenly increase and/or become turbid without explanation contact a geotechnical engineering consultant for further evaluation.

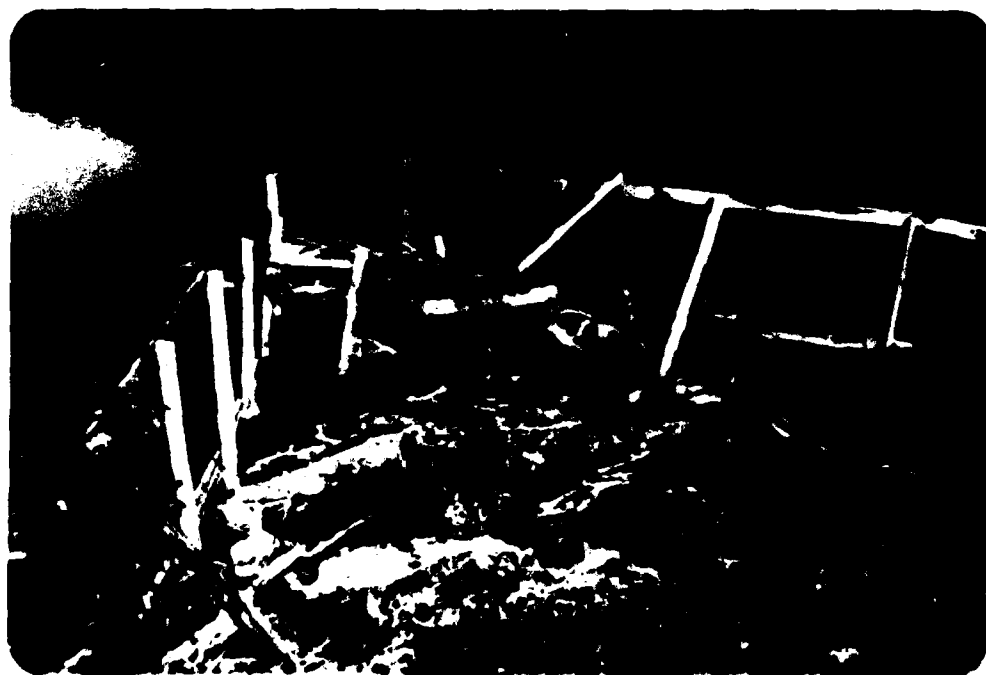
PHOTO #4 PRINCIPAL SPILLWAY  
INTAKE STRUCTURE

prevent large debris from entering the pipe (Photo 4). A wire cage is placed over the intake to prevent finer debris from entering the intake pipe. Debris is located around three sides of the wire cage allowing clear flow through only one side. The 24-inch concrete discharge pipe is submerged in the stilling basin (Photo 5). Wooden piles are located about 75 feet upstream of the principal spillway intake. The owner's representative indicates that an emergency gate located beneath the piles is no longer useful. No outlet pipe was observed during the inspection.

e. Remove the debris from around the fence and cage protecting the intake structure, and along the upstream slope.
