Name Of Dam: **TIMBER LAKE DAM**
Location: **CAMPBELL COUNTY, VIRGINIA**
Inventory Number: **VA. NO. 03102**

PHASE I INSPECTION REPORT

NATIONAL DAM SAFETY PROGRAM

JULY 1980

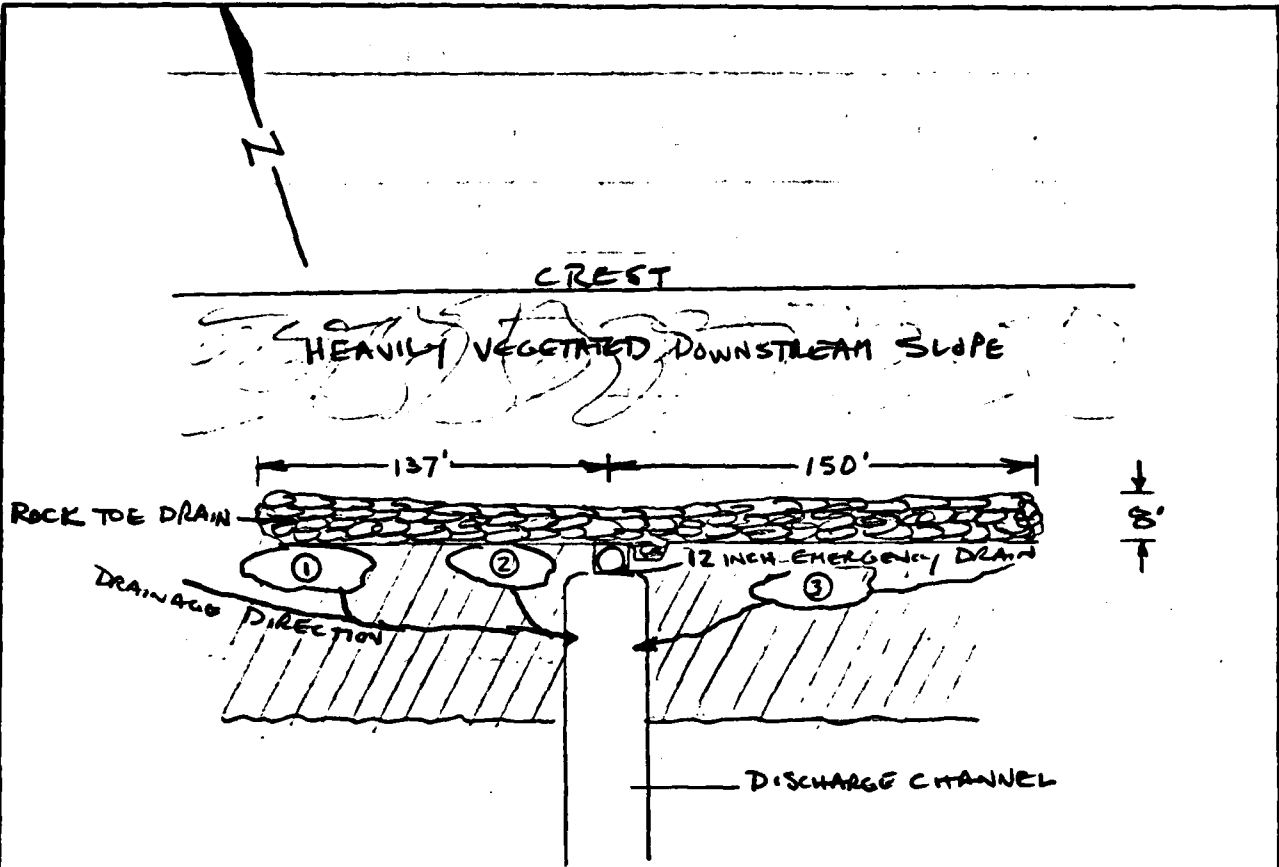
SHEET NO. 1 OF 2
 JOB NO. V80107

6.2.2 Subdrainage and Seepage: A benched 8 ft high toe drain extends approximately 185 ft along the downstream slope (see Sheet 1, Appendix III). The rock toe drain appears to be functioning properly, as no saturated zones or seeps were noted on the downstream embankment above the toe. However, a saturated zone extends to approximately 50 ft beyond the lowest point of the toe drain. This may represent seepage through the foundation, or merely seepage through the rock since no outlet drains were provided.

Scattered seepage areas were located below the toe drain, along the downstream slope. The seepage was iron-stained and was seeping at a rate of no more than 1 gpm. The ground surfs below the toe drain was generally saturated to a point 50 ft below the drain. It would appear that the toe drain is functioning properly. A small spring was observed along the right side of the drain outfall channel, 10 ft from the end of the pipe. Flow was estimated at 5 gpm. See accompanying field sketch, Sheet 1.

- ① WET AREA
- ② SEEPAGE AT LESS THAN 1 GPM; IRON STAINING; 40' x 30'
- ③ SEEPAGE AT LESS THAN 1 GPM; IRON STAINING
- //// SATURATED GROUND; GENERALLY EXTENDS 50 FT BELOW TOE OF DRAIN; CONSIDERABLY MORE MOISTURE ON RIGHT SIDE OF OUTLET PIPE.

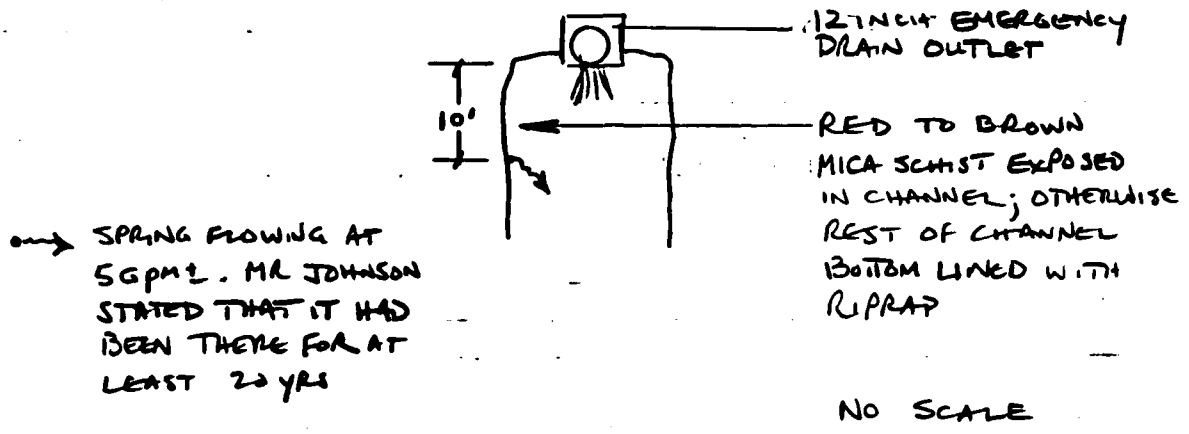
SPRING LOCATION

was also observed along the right side of the drain outfall channel, 10 ft from the end of the pipe. Flow was estimated at 5 gpm (see Sheet 2, Appendix III).
