LAKE WATAWGA DAM

NDI ID NO. PA-00098  
DER ID NO. 64-38

PHASE I INSPECTION REPORT  
NATIONAL DAM INSPECTION PROGRAM

JULY 1980

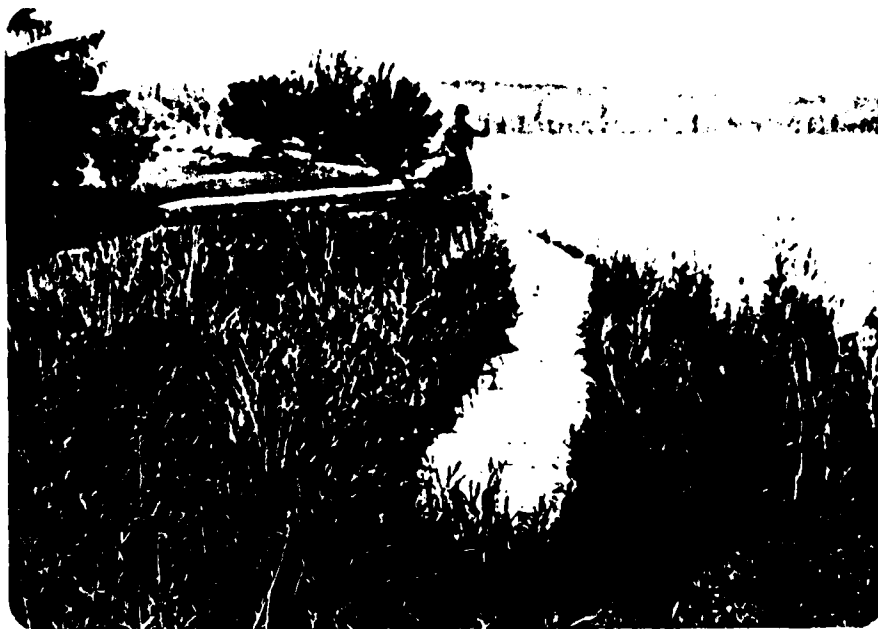
A. Top of Dam.

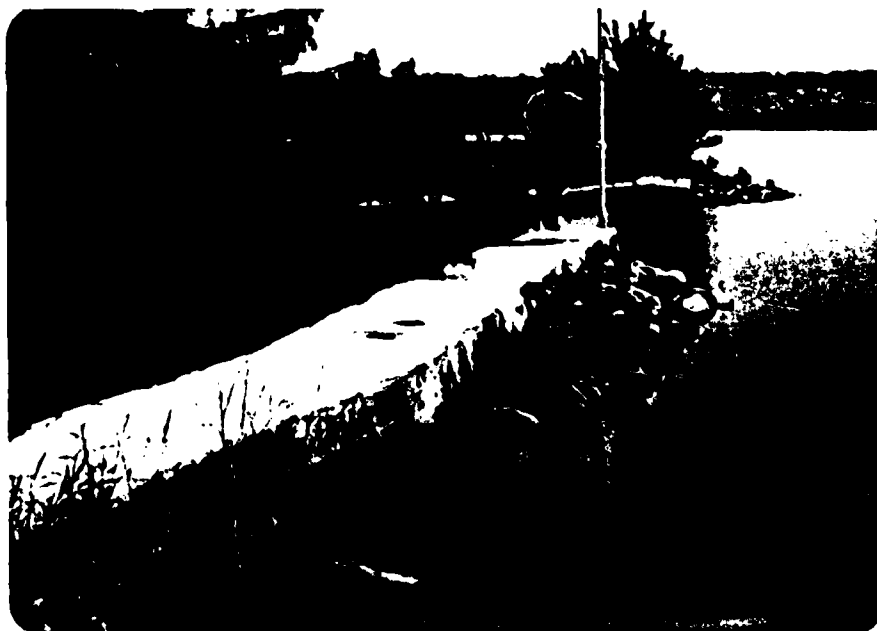
| VISUAL EXAMINATION OF | OBSERVATIONS | REMARKS OR RECOMMENDATIONS |
|---|---|---|
| COREWALL - LEFT<br>OF SPILLWAY | Only small portion visible;<br>6 fine cracks extend<br>across top; areas of<br>local deterioration on<br>upstream face. | Upstream and downstream<br>fills cover most of<br>corewall. |

B. Corewall at Left Side of Dam.

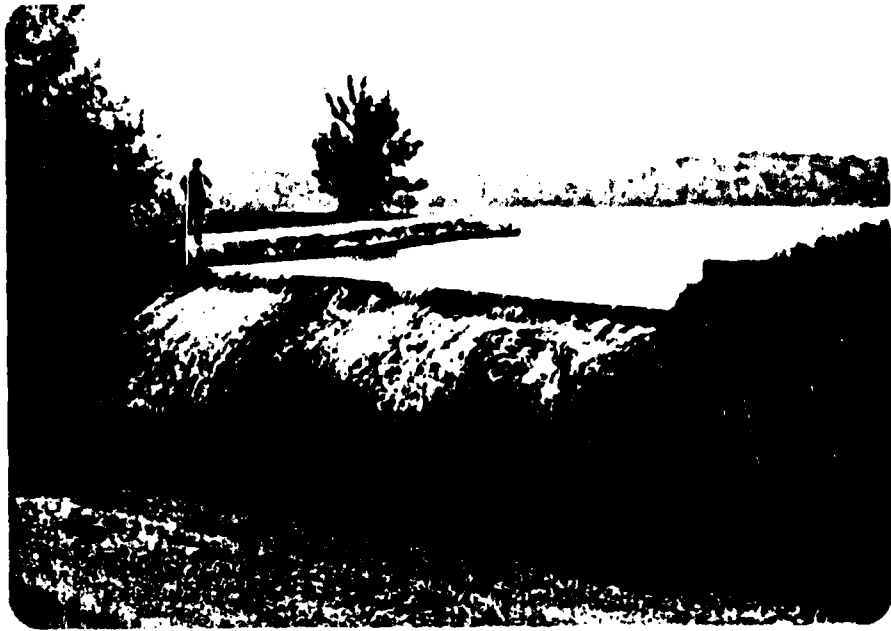
c. Appurtenant Structures. The corewall section that acts as the spillway weir is in good condition. The concrete apron slab is cracked at several locations (Photographs F, G, and H). Differential vertical movement has occurred at some cracks, up to a maximum of 3/4 inch. At the downstream left corner of the concrete apron, a triangular piece of the slab is missing (Photograph I) and substantial amounts of water were flowing into the resulting void. Examination of the apron slab at its downstream end indicates a probable concrete thickness of about 4 inches. The sidewalls at the apron have some small cracks and minor deterioration where they meet the apron. The downstream stone masonry face of the spillway is in fair condition. No mortar is apparent between the stones. The spaces between the stones can be probed to an average depth of 6 inches. Stones were missing from the structure at two locations. At one location, the resulting void was probed to a depth of 2 feet. At the other location, near the top of the structure, the resulting void was probed to a depth of 4 feet (Photograph J). Any seepage or leakage that might exist at the toe of the spillway was obscured by the flow over the spillway on the day of the inspection. Downstream from the spillway, the right wingwall is overgrown with trees and brush and is partially collapsed.

G. Spillway.
