DELAWARE RIVER BASIN  
LAUREL RUN, CARBON COUNTY  
PENNSYLVANIA  
NDS ID PA. 00616  
DER ID 13-97

# PLACID LAKE DAM

PHASE I INSPECTION REPORT  
NATIONAL DAM INSPECTION PROGRAM

**PHASE I INSPECTION REPORT  
NATIONAL DAM INSPECTION PROGRAM**

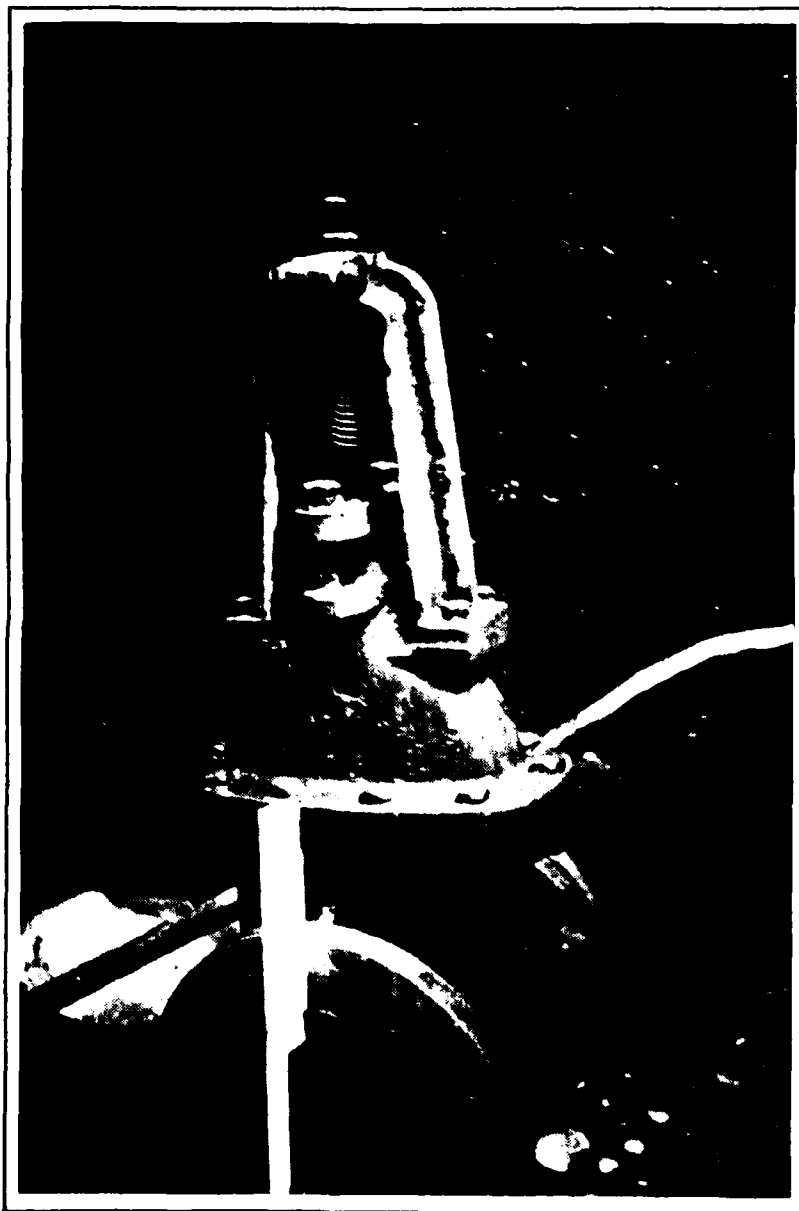
PHOTOGRAPH NO. 2

2. Spillway. A concrete box drop inlet is shown on Photograph 1. The interior of the drop spillway appears to be in good condition, with no evidence of cracking, staining or deterioration of the concrete. As shown on Photograph 1, a flashboard structure is supported on bricks above the lip of the concrete structure. Four plastic pipes on the opposite side of the flashboard structure were installed to discharge cool water from below the reservoir surface. A six inch gate valve is on the drop inlet floor on the upstream side. The valve assembly is rusted and the handle is not affixed to the valve.

POND DRAIN GATE VALVE ON  
BASE OF RISER.

- (5) Erosion of the upstream face should be halted and the damaged embankment repaired.
- (6) The inlet sluice gate and the reservoir drain gate valve should be lubricated and exercised on a regular basis to insure their operational status.
