**Name of Dam:** Lake Anne Dam

**Location:** Fairfax County, State of Virginia

**(Inventory Number: VA 05909)**

**PHASE I INSPECTION REPORT.**

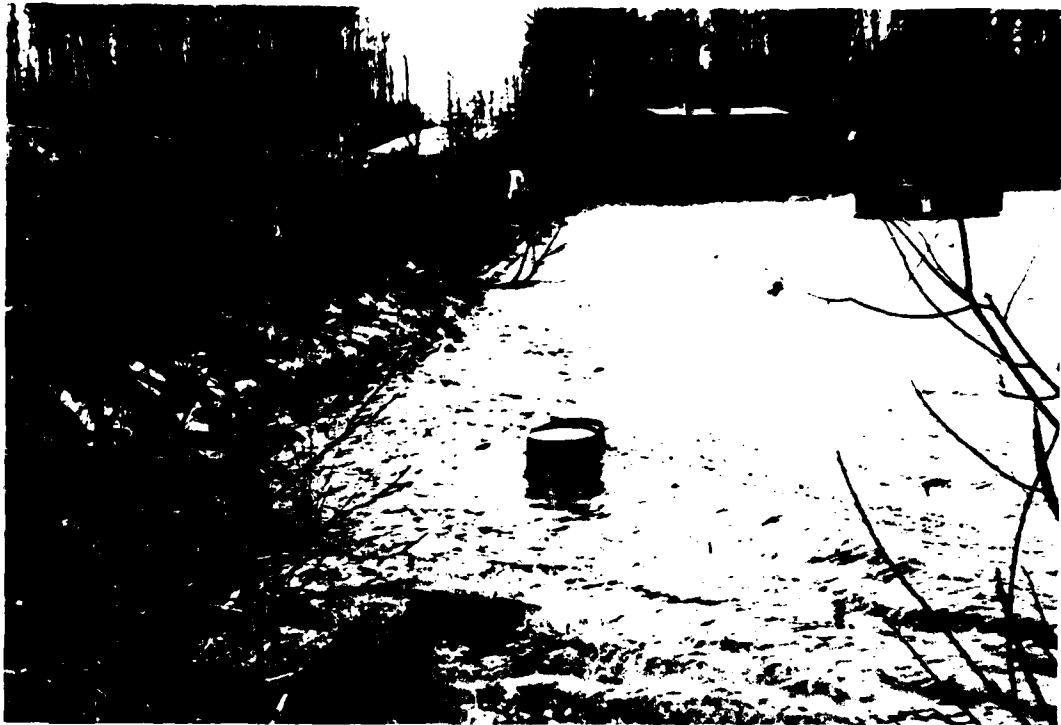
**PHOTO 1. Upstream Slope from Left Abutment**

| VISUAL EXAMINATION OF | OBSERVATIONS | REMARKS OR RECOMMENDATIONS |
|---|---|---|
| RIPRAP FAILURES | There is riprap on the upstream slope between elevations 322 and 327 ft. M.S.L. No riprap failures have occurred, but the stone is partially covered by soil in places and deficient in thickness in a few places. There is grouted riprap, which appears to be in satisfactory condition, in the lower portions of the contacts between the abutments and upstream embankment. | The riprap on the upstream slope should be extended a few ft. higher to provide protection at higher reservoir levels. |

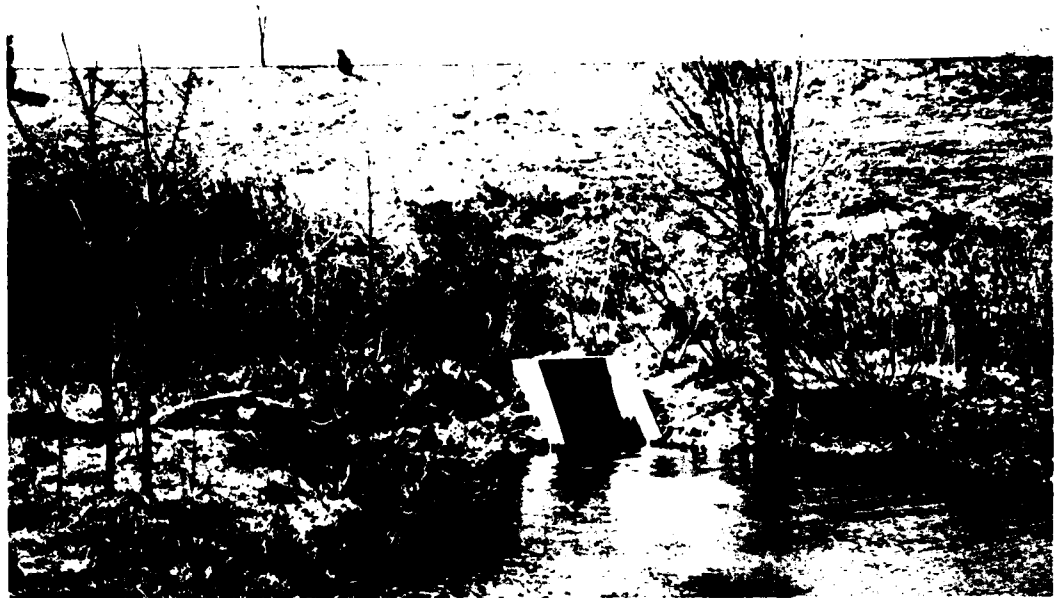
**PHOTO 5. Spillway Outlet Structure and Downstream Slope**

| VISUAL EXAMINATION OF | OBSERVATIONS | REMARKS OR RECOMMENDATIONS |
|---|---|---|
| OUTLET STRUCTURE | The concrete top of the conduit terminates at the outlet. In the next nine ft. at which point the concrete ends, the side walls gradually become lower. The concrete appears to be in good condition, with no evidence of cracking or spalling. | |
