| REPORT DOCUMENTATION PAGE | | READ INSTRUCTIONS<br>BEFORE COMPLETING FORM |
|---|---|---|
| 4. TITLE (and Subtitle)<br>Phase I Inspection Report<br>National Dam Safety Program<br>Lake Arrowhead Dam<br>Stafford County, State of Virginia | | 5. TYPE OF REPORT & PERIOD COVERED<br>Final |

NAME OF DAM: LAKE ARROWHEAD DAM

PHASE I INSPECTION REPORT  
NATIONAL DAM SAFETY PROGRAM

Name of Dam: Lake Arrowhead Dam  
State: Virginia  
County: Stafford  
USGS 7.5 Minute Quadrangles: Storck, VA and Somerville, VA  
Stream: Unnamed Tributary to Aquia Creek  
Date of Inspection: 17 April 1980

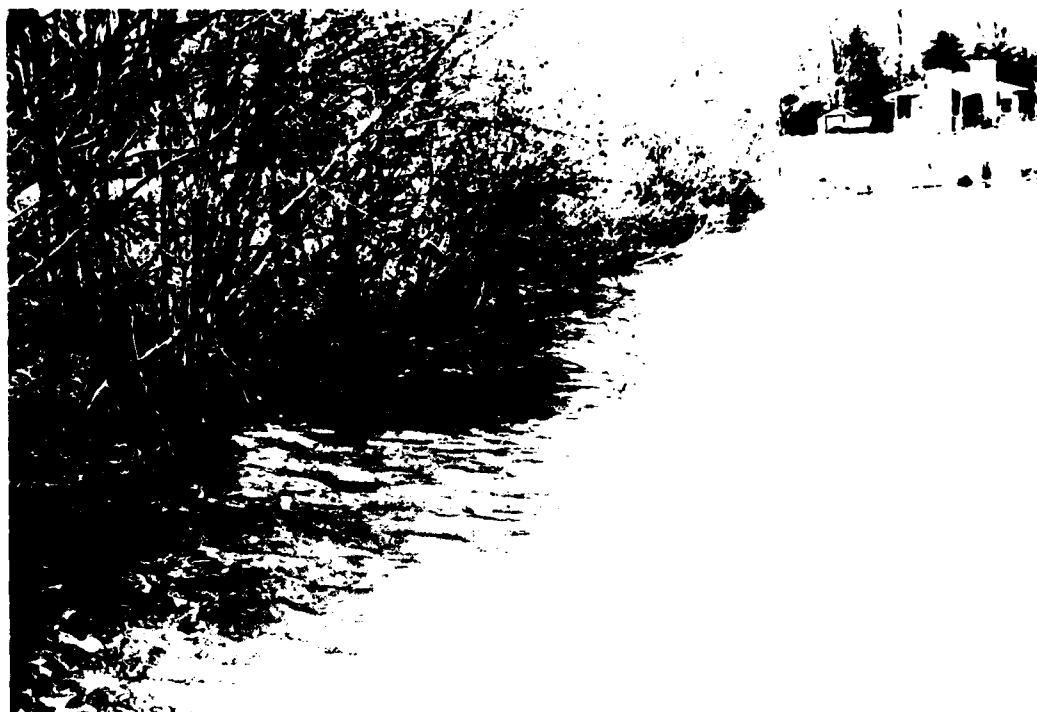
3.1.2 Dam: The embankment was found to be in generally fair condition with no surface cracks or sloughs. The surface of the downstream slope is fairly uneven. Minor erosion has occurred on the upstream slope along the waterline and in an area where a fire hydrant with a line into the lake has been installed. The upstream slope is covered with brush and small trees; the downstream slope is covered with brush and small-to-medium size trees.

**PHOTO 1. Upstream Slope (Emergency spillway approach channel at far right)**

approach channel should be reconstructed and better defined. The erosion on the upstream embankment slope should be repaired and riprap should be installed near the waterline. A good grass cover should be established over the entire embankment and in the emergency spillway approach channel. The tree stumps, logs, and other debris in the emergency spillway discharge channel should be removed. The entire discharge channel should be widened, regraded, and provided with erosion protection. Grouted riprap may be necessary. A trash rack should be installed on the principal spillway riser. The driftwood in the pool below the principal spillway outlet structure should be removed, as should the vegetation overhanging the pool. A staff gage should be installed to monitor reservoir levels above normal pool.

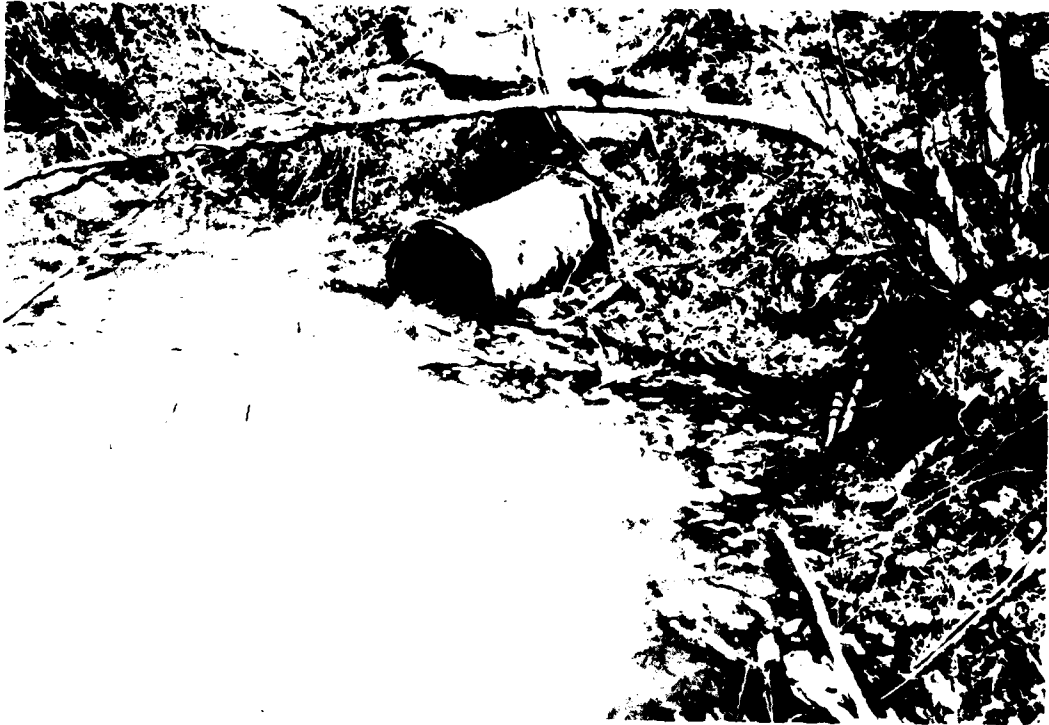
3.1.3 Appurtenant Structures: The 12 inch corrugated metal pipe principal spillway riser and outlet structure appear to be in satisfactory condition. There is no trash rack on the riser. The outlet structure discharges into a small pool at the upper end of Little Lake Arrowhead. There is no riprap in the pool, which is partially overhung by brush and small trees. During the visual inspection it was observed that sediment and small pieces of driftwood have collected in the pool.

**PHOTO 3. Principal Spillway Outlet**

| VISUAL EXAMINATION OF | OBSERVATIONS | REMARKS OR RECOMMENDATIONS |
|---|---|---|
| OUTLET STRUCTURE | The outlet structure is a 12 in. diameter C.M.P. which protrudes from the downstream embankment at the toe with no visible supporting structure except some rock around the mouth of the outlet. The outlet appears to be in satisfactory condition. | |

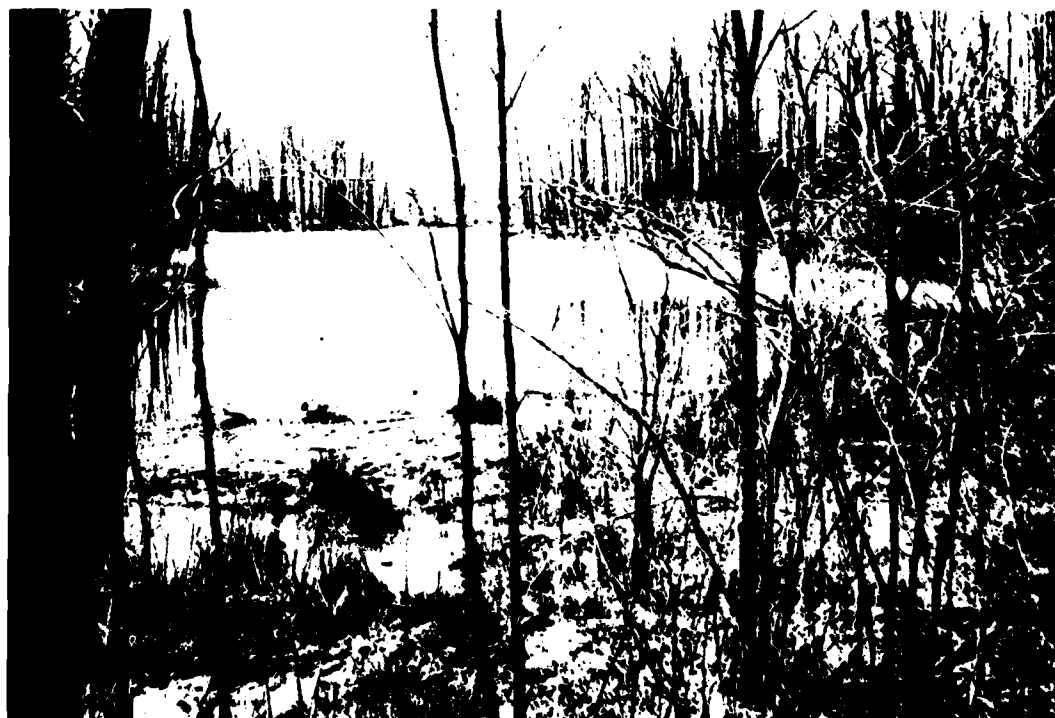
**PHOTO 6. Downstream Area (Little Lake Arrowhead)**
