TOTEM DAM

(NDI I.D. No. PA-00042,

PHASE I INSPECTION REPORT,

GAI CONSULTANTS, INC.

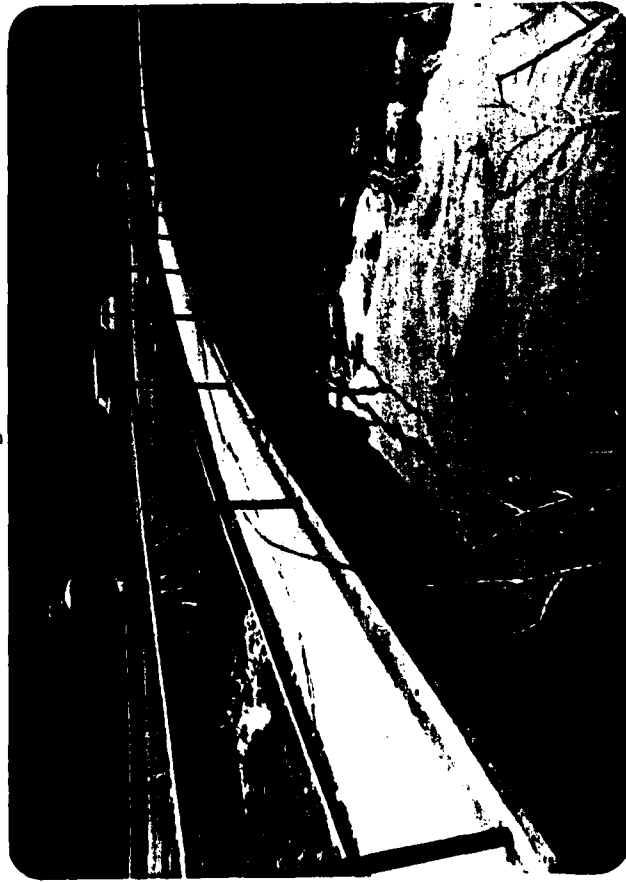
7

owner who acquired the facility in 1966. Consequently, its operability is questionable. The gate control along the upstream embankment face appears securely mounted; however, some surficial corrosion was observed (see Photograph 7). Minor leakage was observed at the discharge end of the conduit, but, was not measurable (see Photograph 8). The apparent plan of the outlet conduit does not conform to the design drawings.

| ITEM | OBSERVATIONS/REMARKS/RECOMMENDATIONS | NDI# PA - 00042 |
|---|---|---|
| GATE(S) AND OPERA-<br>TIONAL EQUIPMENT | Gate mounted on upstream embankment face about 12 feet from the left abutment. Never operated by present owner. Corrosion observed. | |

d. Check the present operability of the outlet conduit control valve and initiate repairs, if necessary. In addition, the conduit should be operated on at least an annual basis and preventive maintenance performed concurrently.
