1. REPORT NUMBER VA 18101		2. GOVT ACCESSION NO. AD-A091537		3. RECIPIENT'S CATALOG NUMBER 537	
4. TITLE (and Subtitle) Phase I Inspection Report National Dam Safety Program Sunken Meadow Dam Surrey County, Commonwealth of Virginia			5. TYPE OF REPORT & PERIOD COVERED Final

Name of Dam: Sunken Meadow Dam (Inventory Number VA 18101)

PHASE I INSPECTION REPORT

Name of Dam: Sunken Meadow Dam
State: Commonwealth of Virginia
County: Surrey
USGS 7.5 Minute Quadrangle: Claremont, VA
Stream: Sunken Meadow Creek
Date of Inspection: 10 July 1980

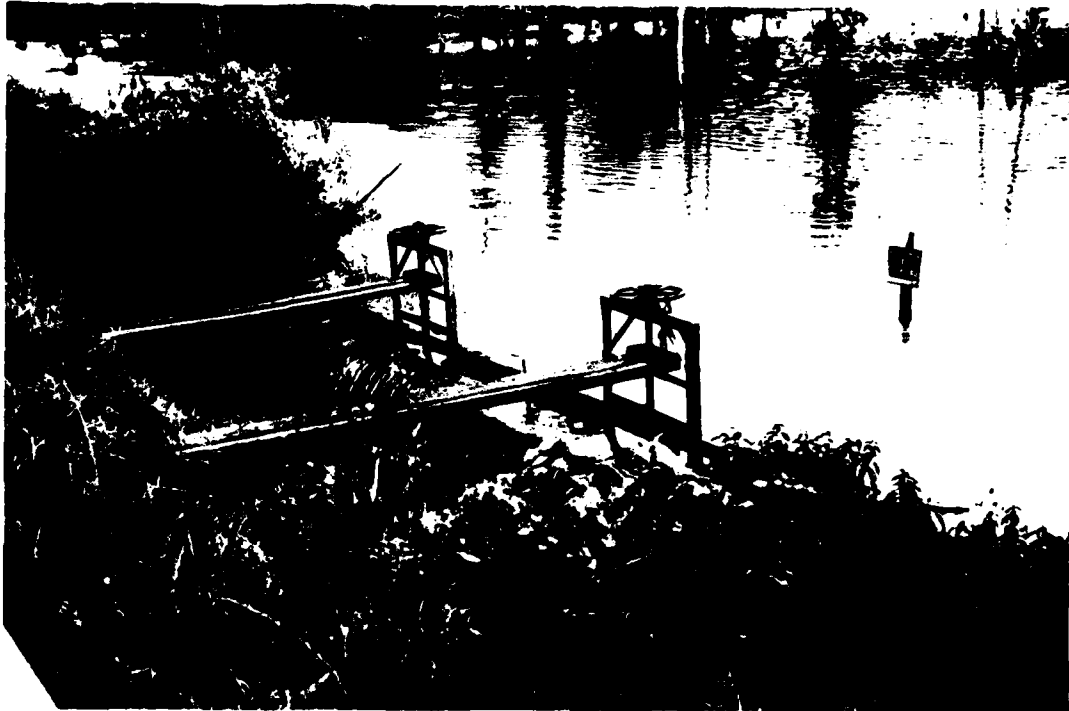
There are two 36 inch diameter slide gates in the concrete weir. Controls for the gates are located directly above the gates, on platforms above the weir, and are reached by means of catwalks extending from the upstream headwall of the culvert. According to the owner of the reservoir, the gates need to be lubricated.

PHOTO 1. Spillway Weir and Controls for Emergency Gates

The gates should be lubricated as necessary and kept in an operable condition.

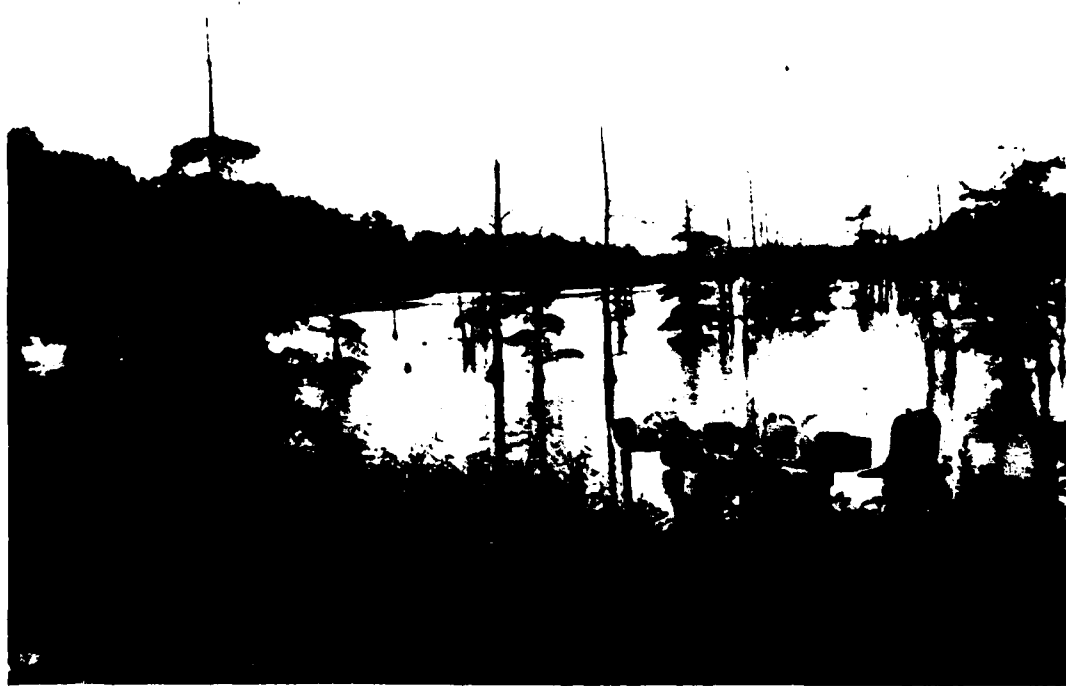
3.1.4 Reservoir Area: The reservoir slopes range from gentle to moderate and are heavily wooded. The slopes appear to be in good condition, with no evidence of erosion. The original dam at this location was built before the Civil War, and the total amount of sedimentation is not known. The extent of sedimentation was not directly observed. However, sedimentation is not expected to be occurring at a significant rate because all of the watershed is heavily wooded. The reservoir appears to be fairly shallow. There are scattered trees within the reservoir, both dead and living, near the dam.

PHOTO 4. Reservoir from Crest of Dam
