4. TITLE (and Subtitle) Phase I Inspection Report National Dam Safety Program Broaddus Dam Caroline County, Commonwealth of Virginia		5. TYPE OF REPORT & PERIOD COVERED Final

NAME OF DAM: BROADDUS DAM

Name of Dam: Broaddus Dam
State: Commonwealth of Virginia
County: Caroline
USGS 7.5 Minute Quadrangle: Bowling Green, Virginia
Stream: Maracossic Creek
Date of Inspection: 8 July 1980

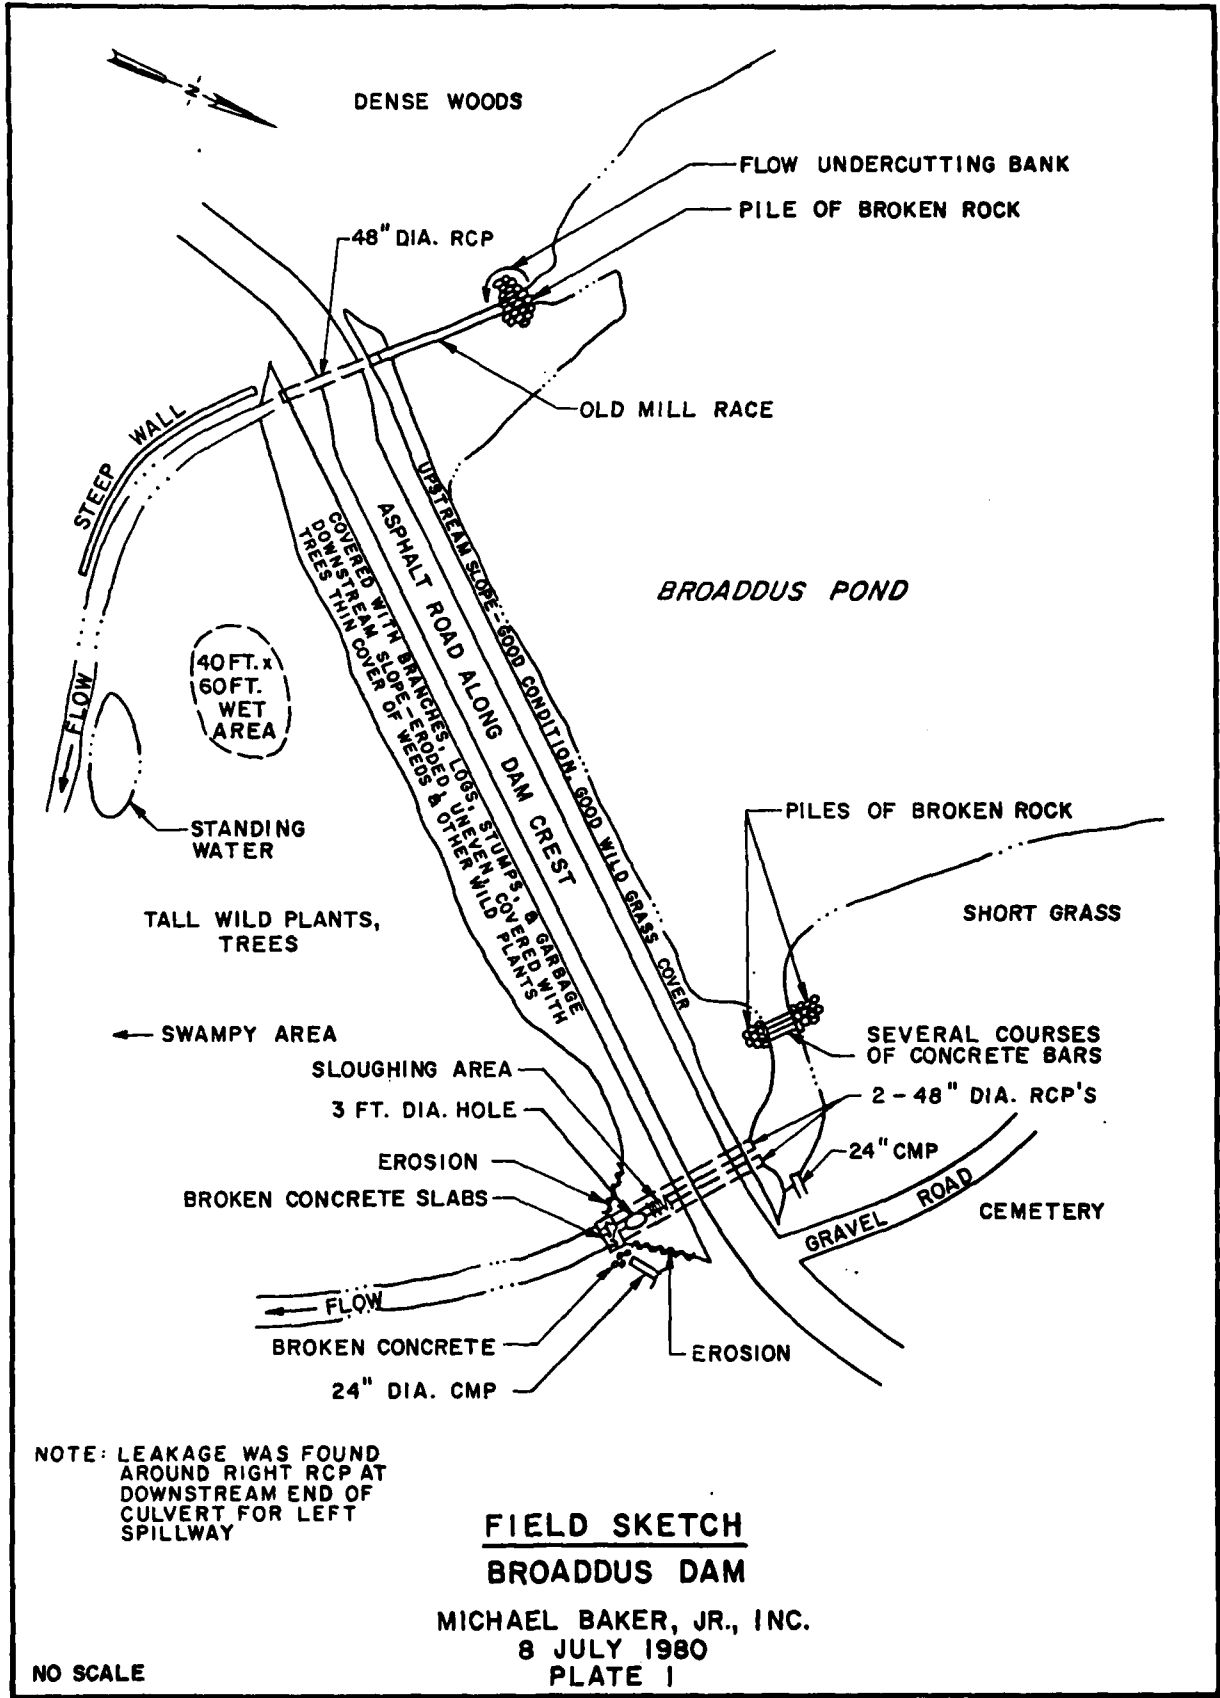
**FIELD SKETCH
BROADDUS DAM**

NOTE: LEAKAGE WAS FOUND AROUND RIGHT RCP AT DOWNSTREAM END OF CULVERT FOR LEFT SPILLWAY
