LAKE WHETSTONE  
NDI ID NO. MD-53

PHASE I INSPECTION REPORT

NATIONAL DAM INSPECTION PROGRAM

July 1980

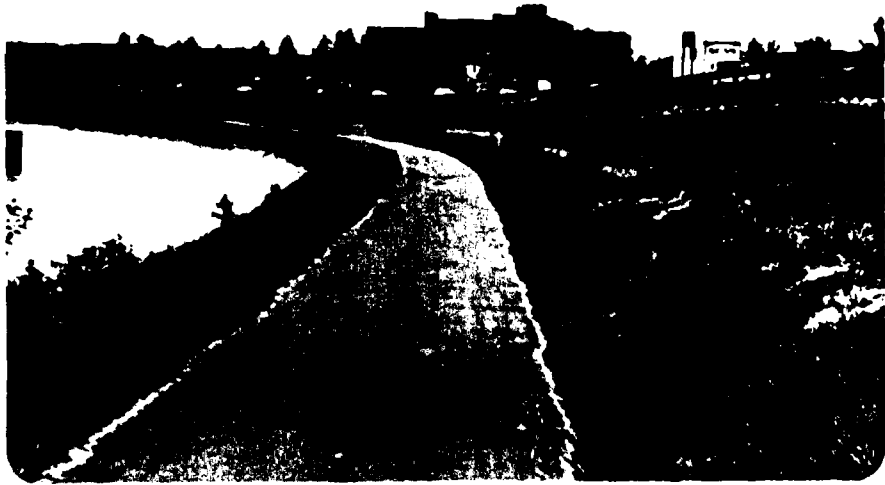
A. Upstream slope and walkway

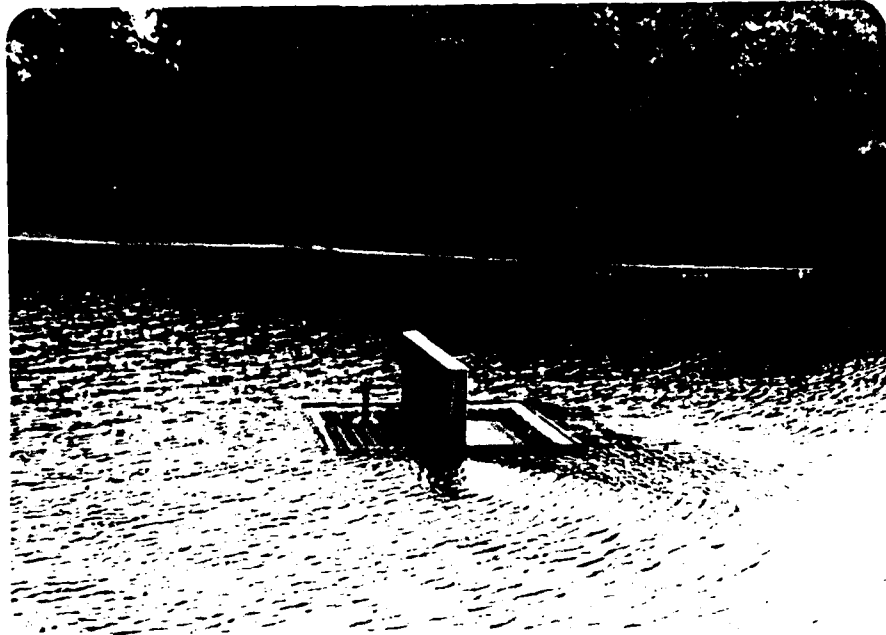
- (2) Appurtenant Structures. The drop inlet spillway and outlet works appear to have been constructed in accordance with record as-built drawings. During the visual inspection, some debris was observed on the grating at the drop inlet spillway. While the amount of debris present would not significantly affect the spillway capacity, continued accumulation of debris would eventually adversely affect the spillway's hydraulic capacity.

C. Drop inlet with trash grate

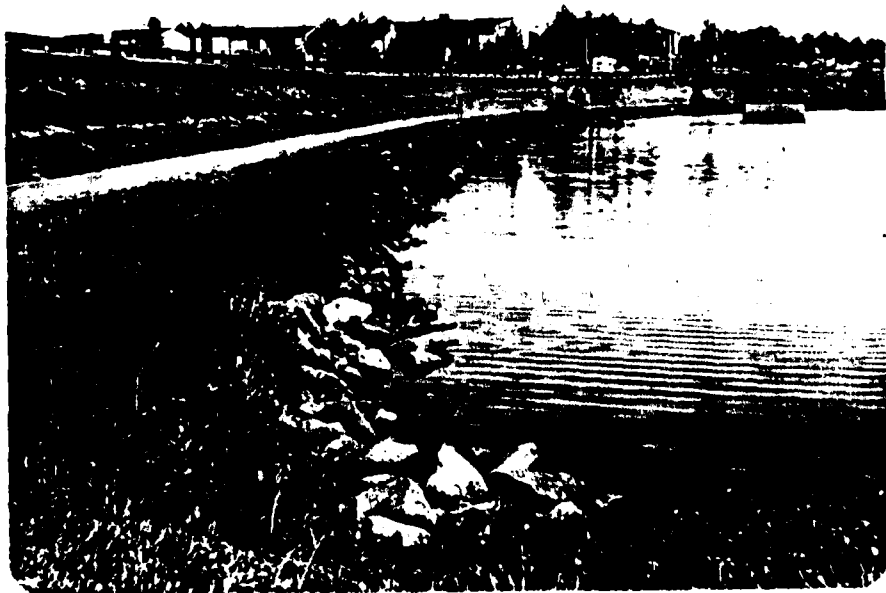
D. Riprap slope protection

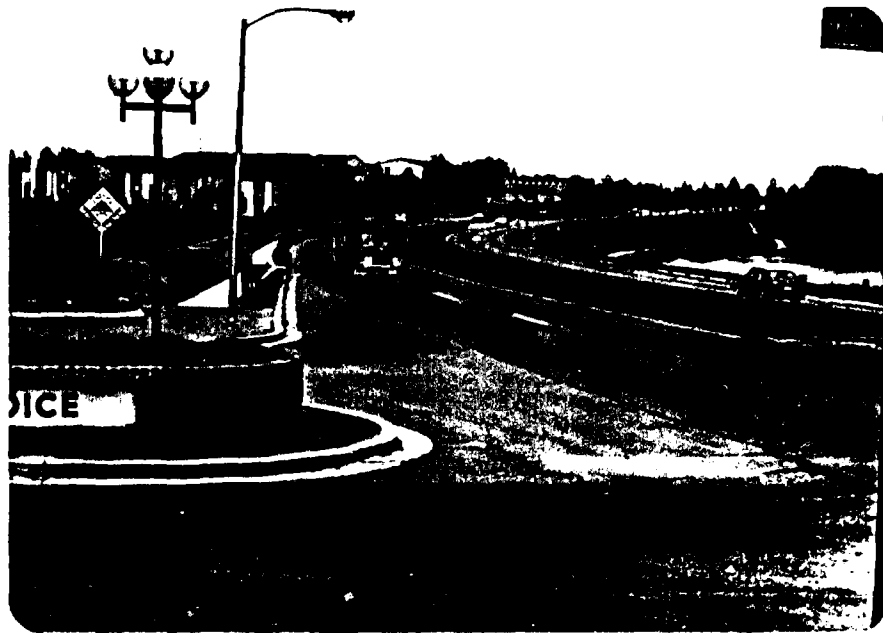
E. Montgomery Village Avenue over crest of dam

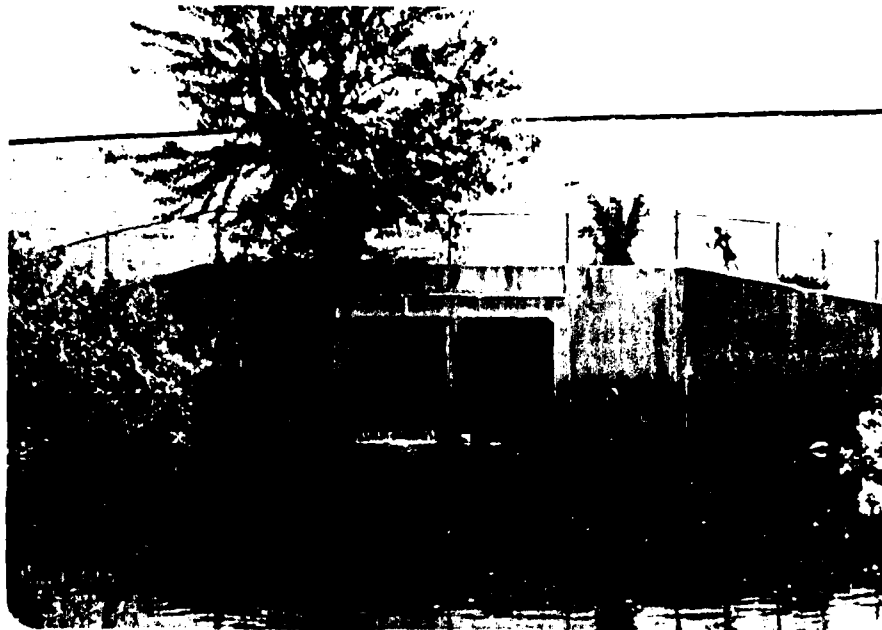
- c. Appurtenant Structures. The appurtenant structures were satisfactory with the exception of the right headwall and left wingwall located at the outlet of the twin box culvert and a potential blockage in the left side of the twin box culvert. The right headwall is cracked, the toe drain outlet through the right headwall is partially obstructed by a corrosion deposit, and erosion was noted behind the left wingwall. The ability of the left side of the twin-box culvert to function as designed may presently be impaired since it was observed that most of the flow from the spillway riser was being conveyed through the right side of the culvert.

G. Outlet conduits and toe drains

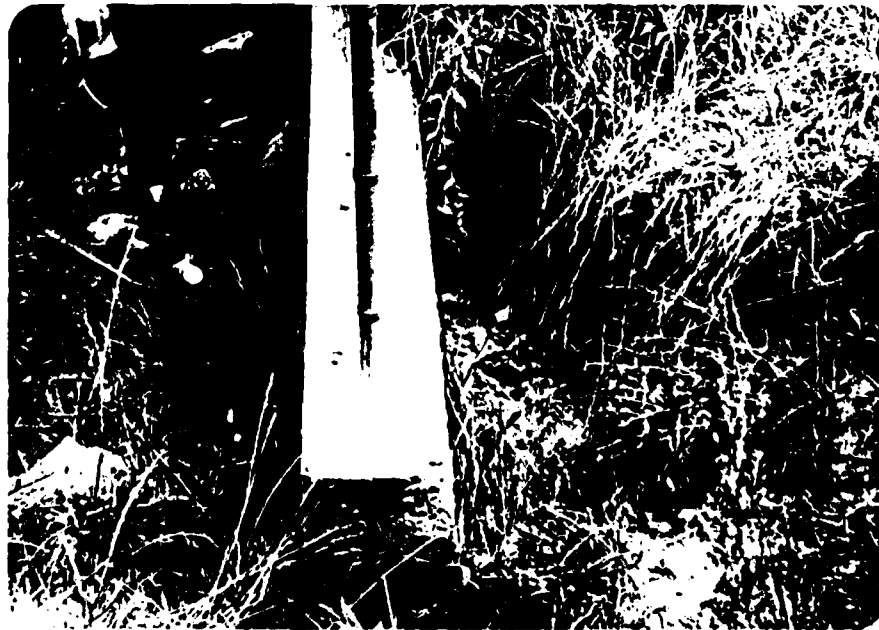
- (1) Embankment. Visual examination of the dam embankment indicates that there are no wet spots, seepage, slumps or other features that suggest embankment instability.
- (2) Appurtenant Structures: A structural crack was noted across the right headwall of the outlet structure. Erosion was noted behind the left wingwall of the outlet structure.

| VISUAL EXAMINATION OF | OBSERVATIONS | REMARKS OR RECOMMENDATIONS |
|---|---|---|
| SLOUGHING OR EROSION OF EMBANKMENT AND ABUTMENT SLOPES | Slight erosion at base of upstream slope directly above riprap at north end of dam. Erosion behind left wingwall of outfall conduit | Erosion behind left wingwall should be repaired |

H. Erosion behind left wingwall of outlet structure

- a. Repair the structural crack on the face of the north headwall of the outlet structure.
- b. Remove the corrosive build-up which is partially obstructing the northern toe drain outlet.
- c. Repair the erosion behind the south wingwall of the outlet structure.
- d. Inspect the chamber of the drop inlet spillway to determine if there is a blockage to the left side of the twin box culvert, and remove any obstructions which exist.
- e. Schedule formal periodic inspections of the dam embankment and appurtenant structures.
- f. Develop a formal warning system to alert downstream residents in the event of emergencies.

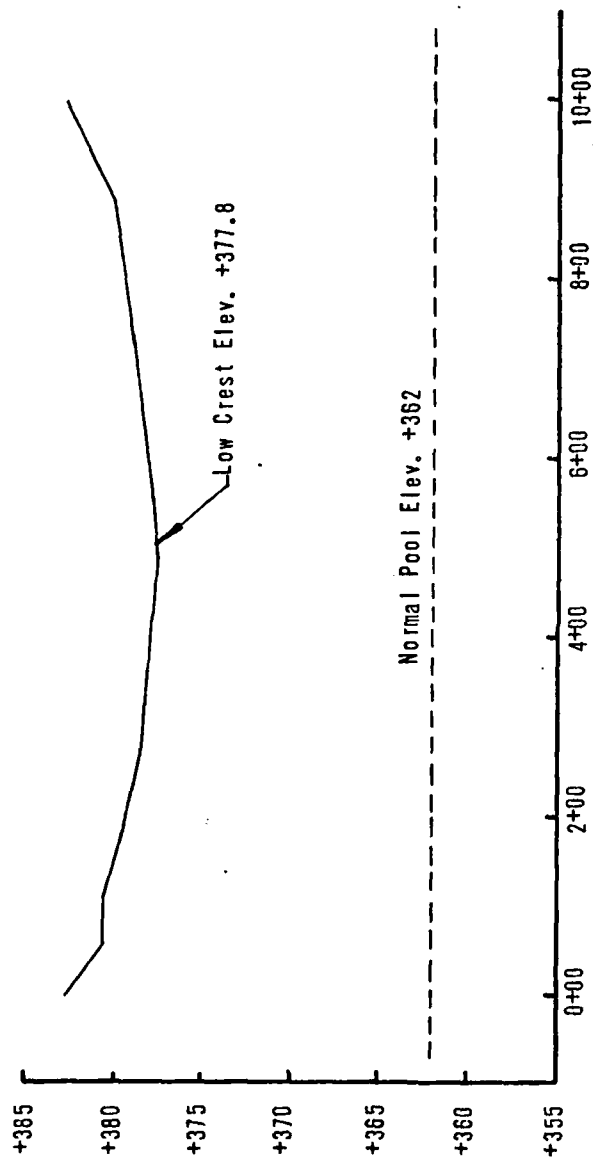
The crest of the dam was surveyed and the variance in elevation was 5 feet between the high and low point. This variance is due to the vertical curve of the roadway across the dam crest. The low point on the crest is approximately 8 inches below the design crest elevation of 378.5, and is located 50+ feet left of the intersection of the twin box culverts of the spillway and the embankment. Freeboard at the time of inspection was approximately 16 feet, and under maximum pool (i.e. design flood) conditions would be approximately 3.5 feet. The dam crest profile is included as Plate C-2.

**DAM CREST PROFILE**  
(LOOKING DOWNSTREAM)
