# MARTINDALE DAM

NDI No. PA 00444  
PennDER No. 11-17

## PHASE I INSPECTION REPORT NATIONAL DAM INSPECTION PROGRAM

AUGUST 1980

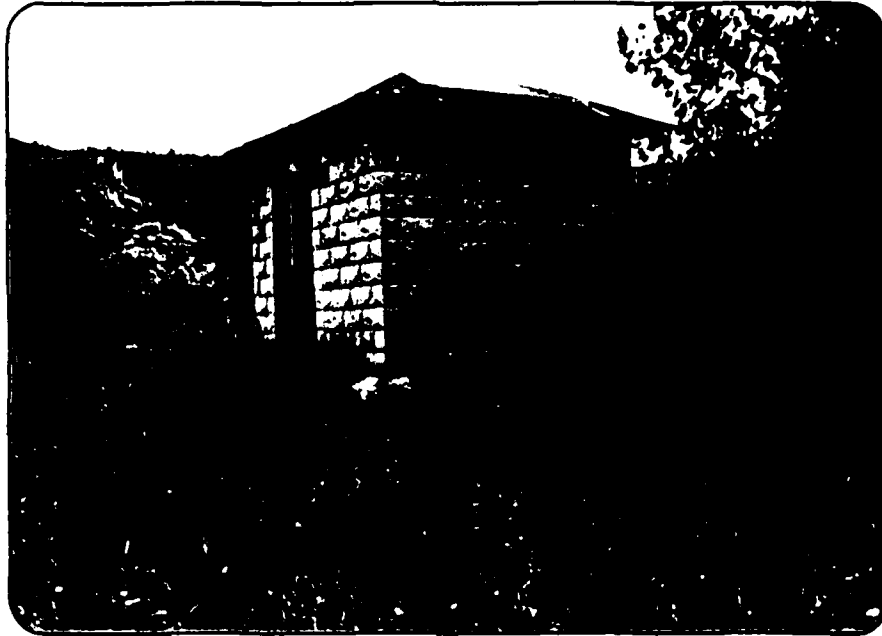
PHOTO 5. View of Downstream Valve House for Outlet Conduit

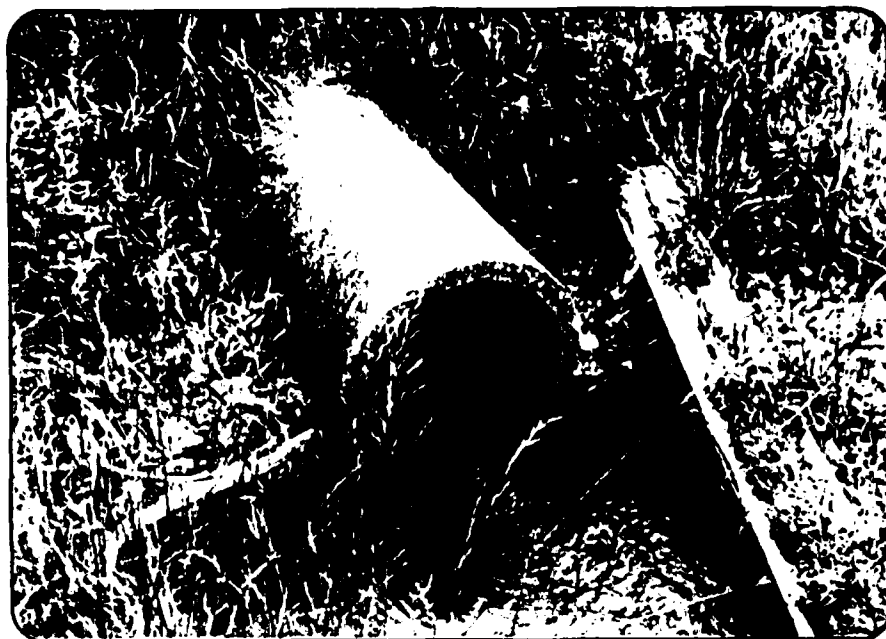
**PHOTO 7. View of Concrete Pipe Outlet into Stream Channel**

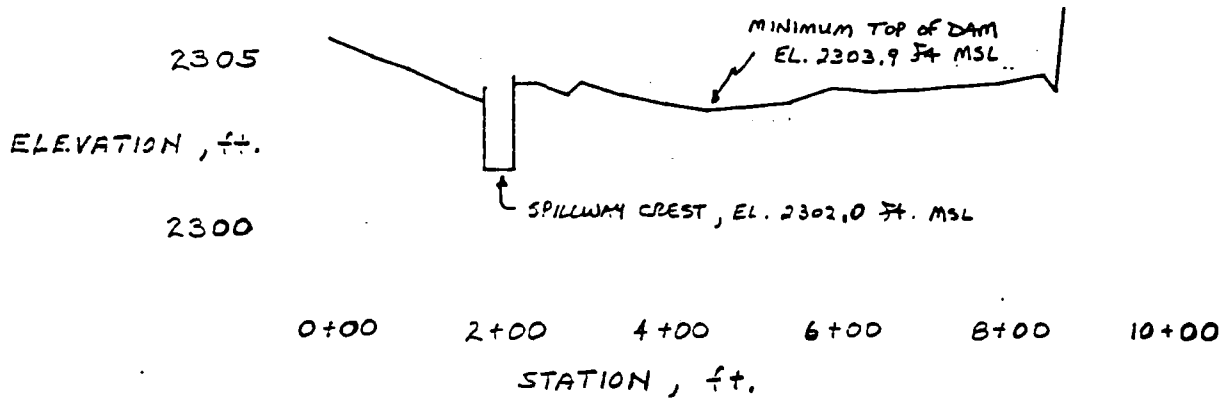
TOP OF DAM PROFILE

| VISUAL EXAMINATION OF | OBSERVATIONS | REMARKS OR RECOMMENDATIONS |
|---|---|---|
| VERTICAL AND HORIZONTAL ALIGNMENT OF THE CREST | There is a low area at Station 4+60 on the top of dam profile included at the end of this appendix. This area is only 1.9 ft. above the crest of the spillway weir. A large portion of the crest of the dam is irregular and below the design top of dam elevation. | The low areas should be repaired. |
