Structures Technical Memorandum 321

STRAIN MEASUREMENTS ON MIRAGE WING SPAR WITH BFRP
PATCH FITTED TO DRAIN-HOLE REGION

B.C. HOSKIN and A.A. BAKER

JULY 1980

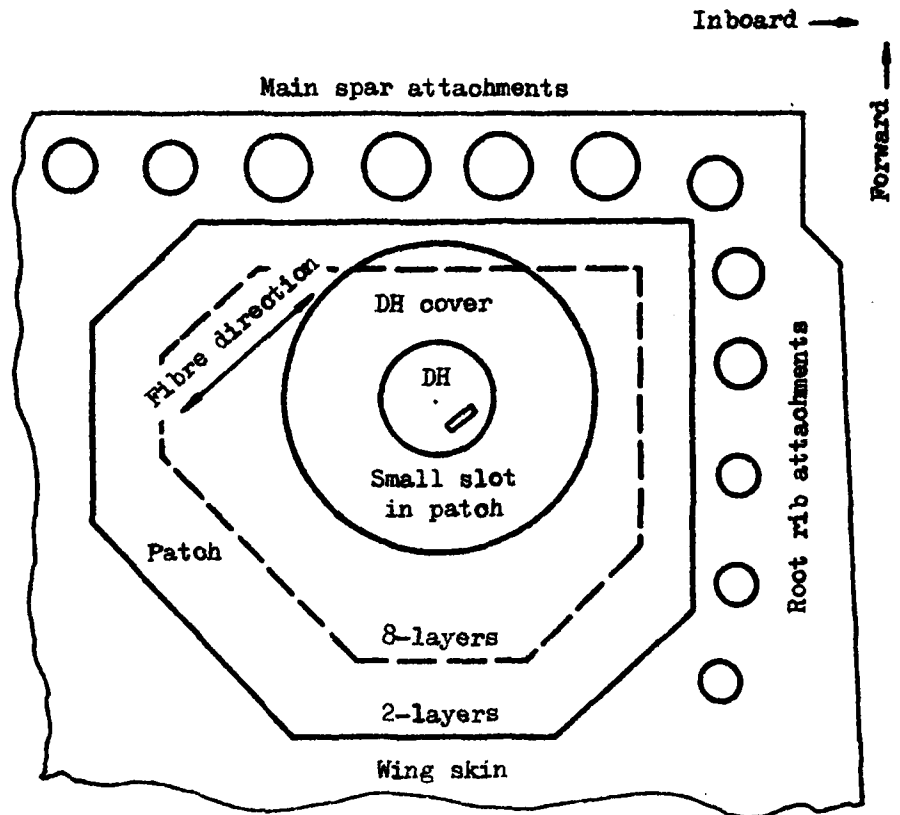
FIG.1 BFRP PATCH FOR DRAIN HOLE REGION OF STRAIN SURVEY WING
(approx. half scale)

The BFRP patch was fitted to the left wing of the Mirage which was being utilised in the ground-loading strain survey conducted at Avalon, Victoria. The location of the patch (on the external surface of the lower wing skin) is as shown in Fig. 1. The patch is stepped in thickness, one layer of BFRP at a time, from a minimum of two layers to a maximum of eight layers; each layer of BFRP is approximately 0.13 mm thick. Whilst the diameter of the drain hole in the skin is 32 mm, there is no such matching hole in the patch; instead the patch has a small slot 12 mm X 3 mm in it. (This modification was accepted by the RAAF.) The patch does have the eight holes (each of approximately 4 mm diameter and not shown in Fig. 1) which permit the bolting on of the standard metal drain hole cover and drainage nozzle; this last is sometimes referred to as the "decant boss". The patch was bonded to the wing using a cold setting adhesive, namely, CIBA AY105, HY956; contact pressure was applied to the patch during the bonding. A view of the patch as fitted to the wing is shown in Fig. 2.

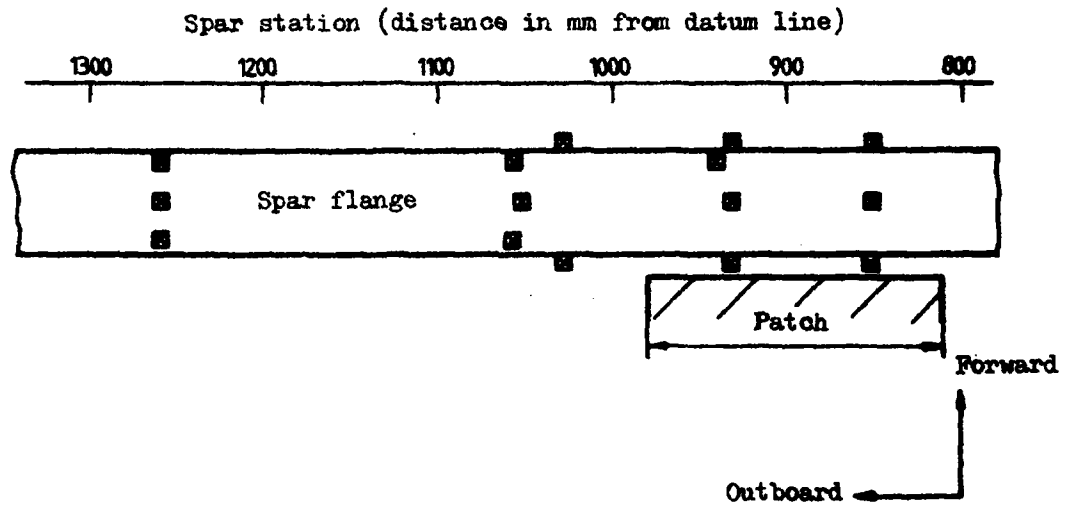
FIG.3 LOCATION OF STRAIN GAUGES ON LOWER SPAR FLANGE OF TEST WING.

The main spar of the test wing had fifteen electric resistance strain gauges fitted to its lower spar flange between stations 850 and 1260. (Spar stations are actually the distances in mm outboard of the fuselage centreline. The BFRP patch extends in the spanwise direction from station 810 to 980.) Gauges were variously fitted on the front (two possible positions), centre (one possible position) and rear (two possible positions) of the spar flange as shown in Fig. 3a. The spanwise positioning of the gauges is shown in Fig. 3b. Complete details on gauge locations are given in ref. 1. All gauges measured tensile strains in the spanwise direction.

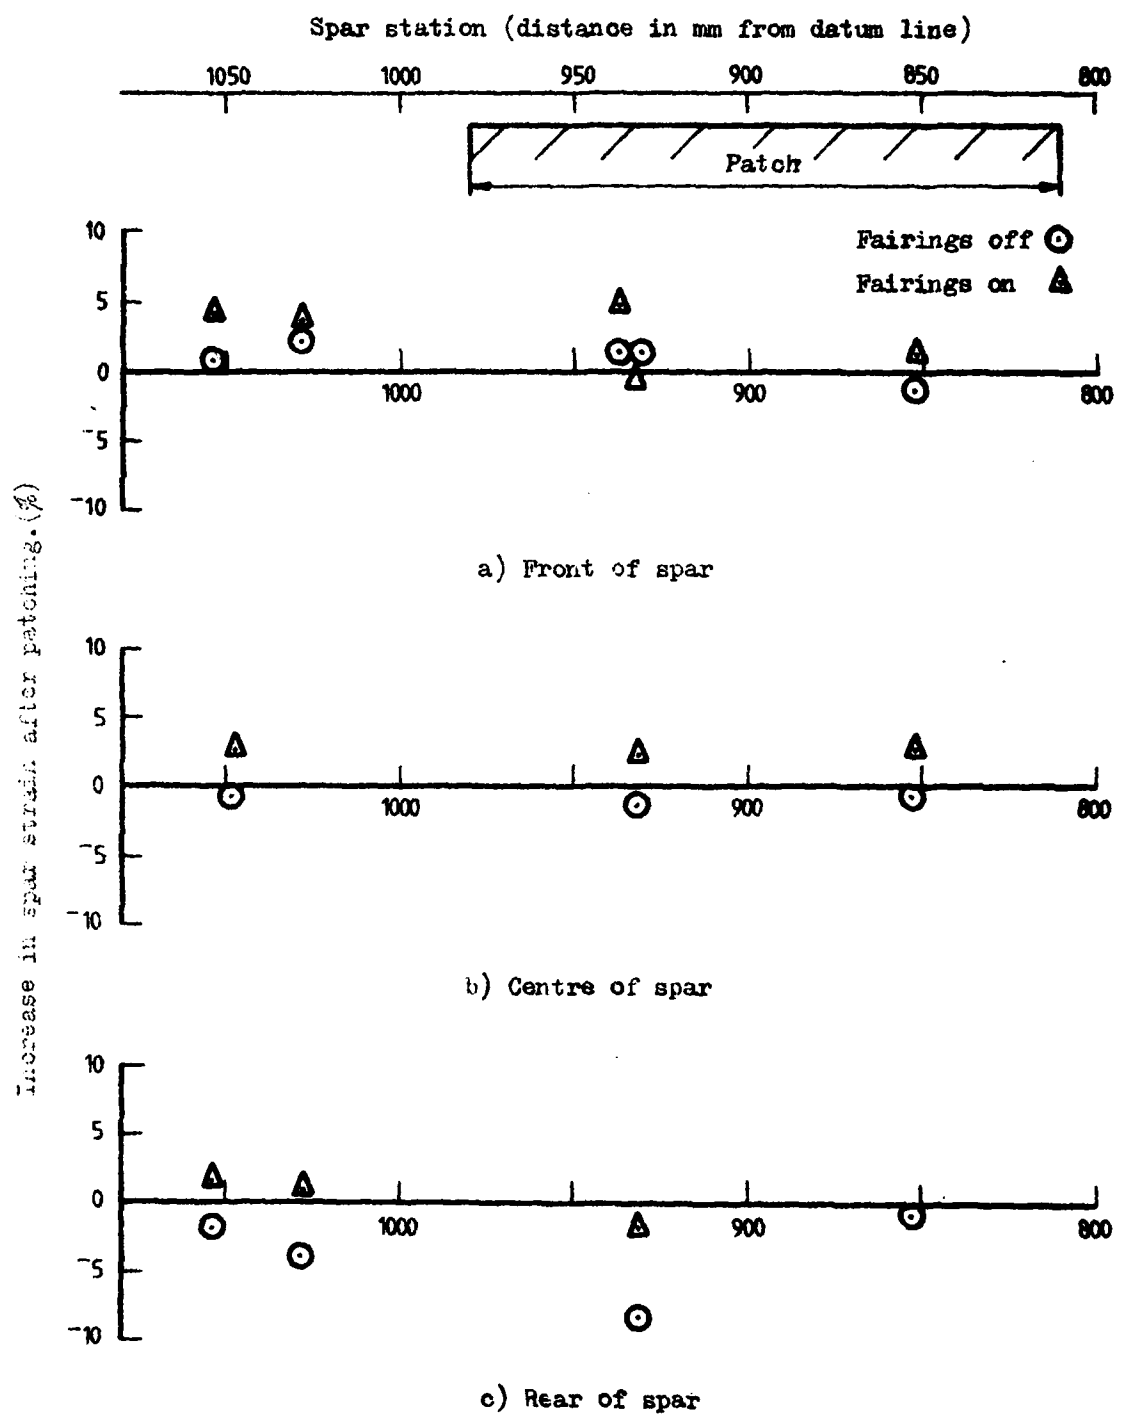
FIG.4 CHANGE IN SPAR STRAINS AFTER PATCHING; LOAD AT MAIN STORE POSITION.

The results are shown in Tables 1 and 2, where all strains have been cited as microstrains. In all cases the strain as actually measured at the maximum applied load has been standardised to the value corresponding to an applied load of 9.80 kN (1000 kgf); this standardisation was made on the assumption of a linear variation of strain with load. Corresponding values of strain before and after patch application are shown alongside one another, and the percentage increase in strain after patching has also been calculated. This last is defined as $((\text{patched value} - \text{unpatched value}) / \text{unpatched value}) \times 100$. The percentage increase in measured strain is also shown in Figs. 4 and 5. (For convenience of presentation, the results for the three gauges at station 1256 - which is well beyond the end of patch - have been omitted from Figs. 4 and 5).

Considering first the case of "fairings off", the maximum increase in measured strain anywhere is 2.5% at gauge 324T for loading at the Sidewinder position. With the exception of this result, and the measured decreases of 8.8% and 8.6% at gauge 323.2T, and 4.1% and 3.2% at gauge 1.7T, all other measured changes lie within the range +2.5% to -2.5%. In fact the only other increase in excess of 2% is for gauge 1.6T (Table 1).

For the case of "fairings on", the maximum increase in measured strain is 4.8% at gauge 323.4T for loading at the main store position. There are also several other apparent increases in excess of 2.5%, including two such results for the gauges at station 1256 (Table 1). However, it should be stated that experience in strain measurements on the Mirage wing has shown that the degree of tightening of the fairing attachment bolts affects the spar strains in the "fairings on" cases. This was not fully appreciated at the time some of these tests were done and, bearing in mind the relatively small differences that are being measured, there are doubts as to whether the apparent increase in spar strain at some locations can be properly attributed to the presence of the patch. For example, on intuitive grounds, it

In discussions with the RAAF (ref. 2), it was agreed that the criterion for acceptance of the patch as far as any possible effects on spar strains go, was that the increase in strain after patching should not exceed 5%. In the case of results obtained with "fairings off", and these results are considered the most reliable, the maximum increase in strain after patching was found to be 2.5%. For what are considered the less reliable results, with "fairings on", the maximum increase was 4.8%. Hence, in both cases, the 5% criterion is satisfied.
