Technical Report 574

HARDWARE AND PERFORMANCE EVALUATION: TETHERED FLOAT BREAKWATER NEAR-SHORE OCEAN MODEL

JD Clinkenbeard
July 1980

Final Report: April 1978 - February 1980

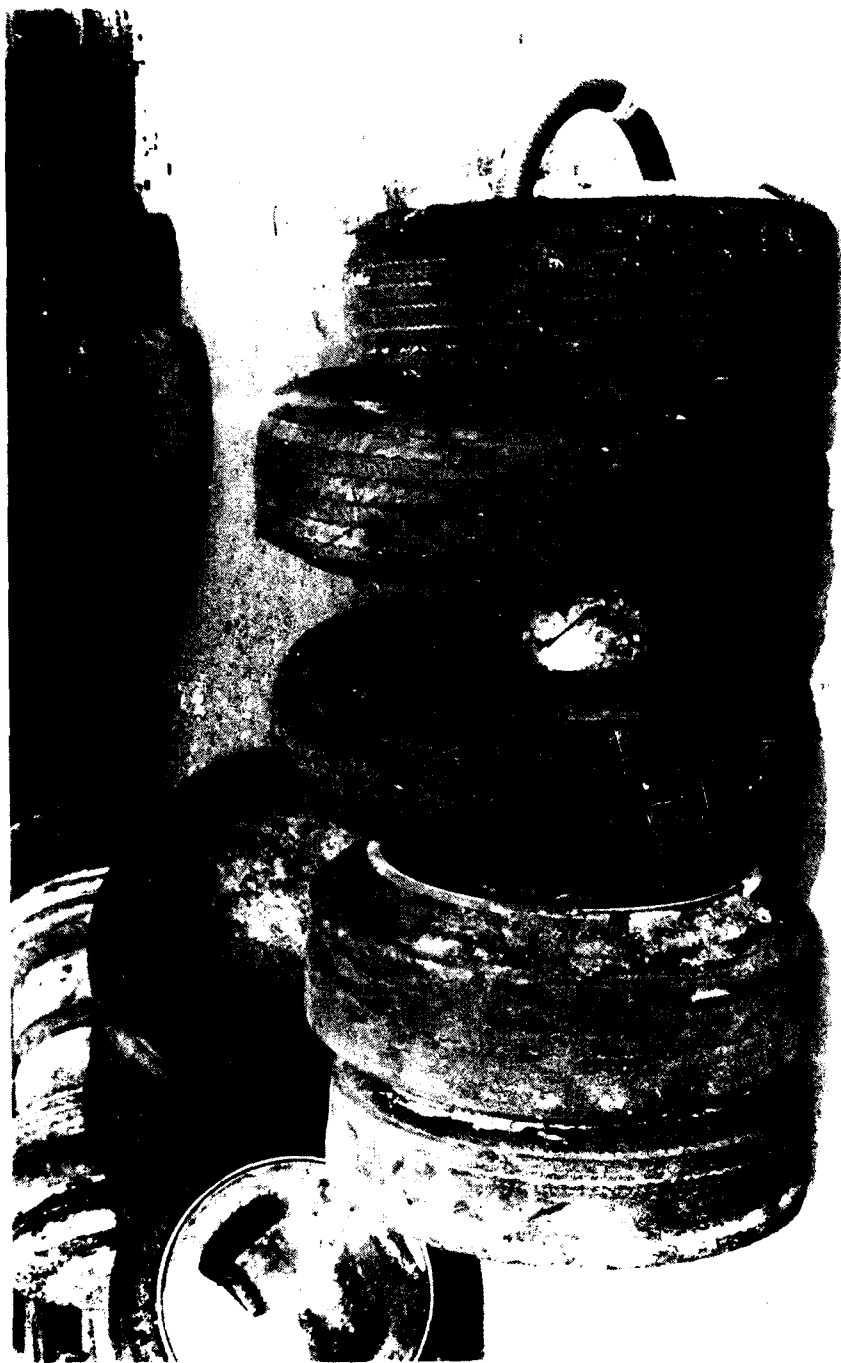
Figure 15. Recovered float showing tire separation.

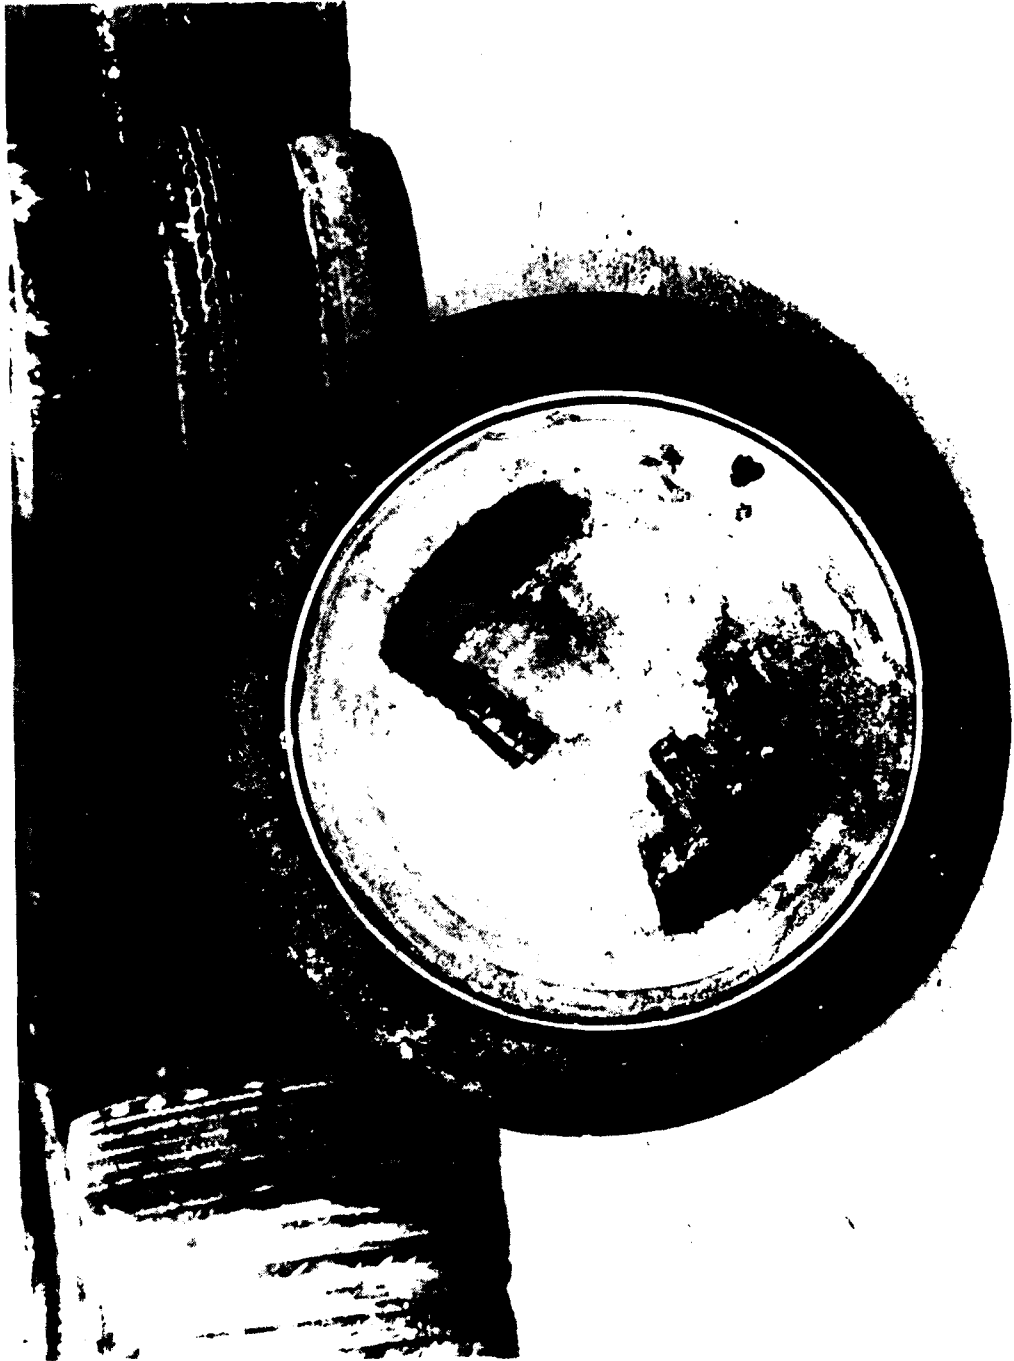
Figure 18. Void caused by sawing action of reinforcing rod.

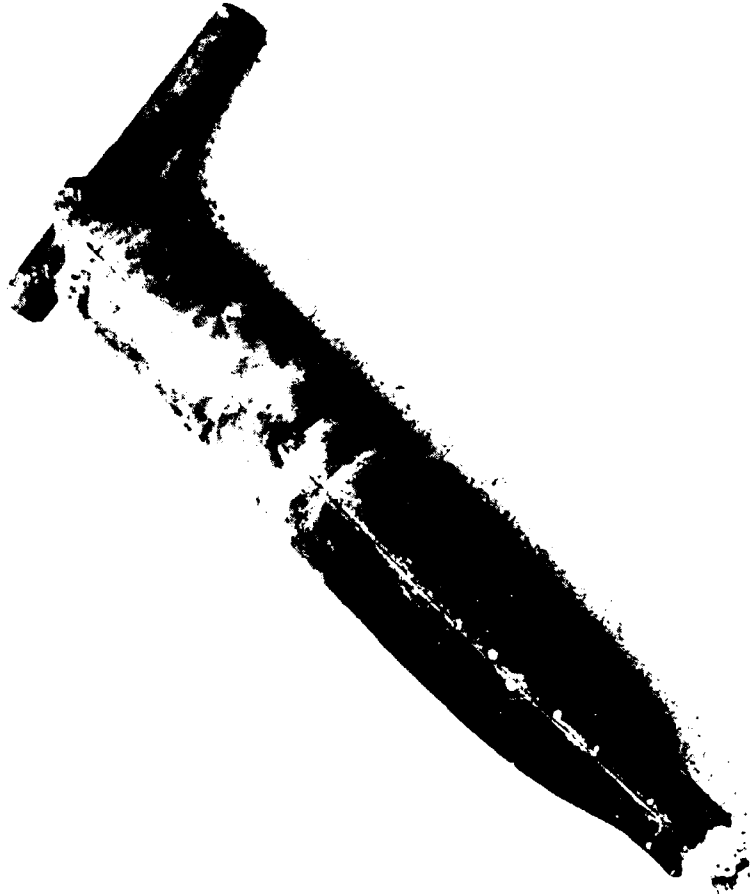
The majority of the tether separations (92% of the original units recovered) occurred at the same location in the line—a discontinuity 1/2 to 1 inch above the boot. This change in tether cross-section resulted from terminating the eye splice at the lower end of the tether. Figures 22 and 23 illustrate this type of failure. Note that all line fibers are approximately the same length, indicating a possible cutting action.

Figure 22. Termination boot after tether failure.

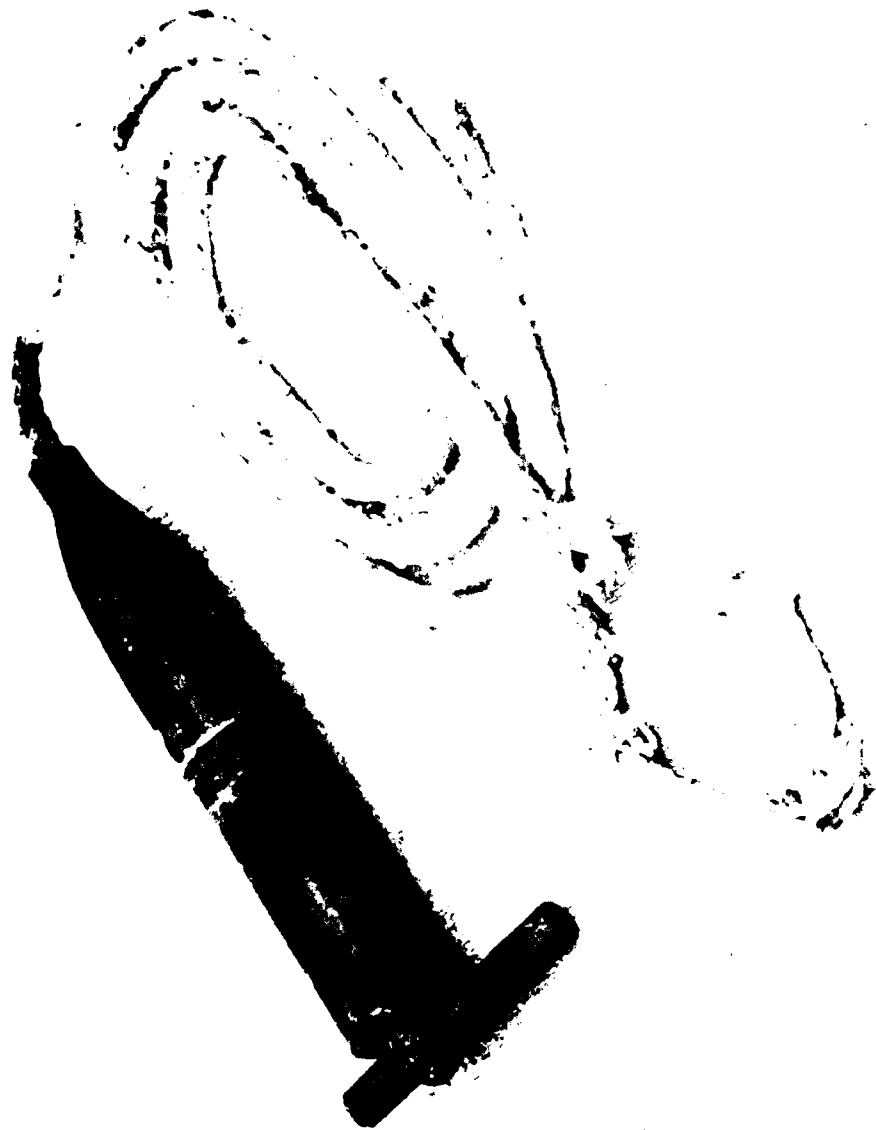
Two boots cracked at the top of the tether socket (figure 25). This resulted from insufficient radius on the inner edge of the tether socket which caused concentrated bending stress.

Figure 25. Boot cracked at top of tether socket.

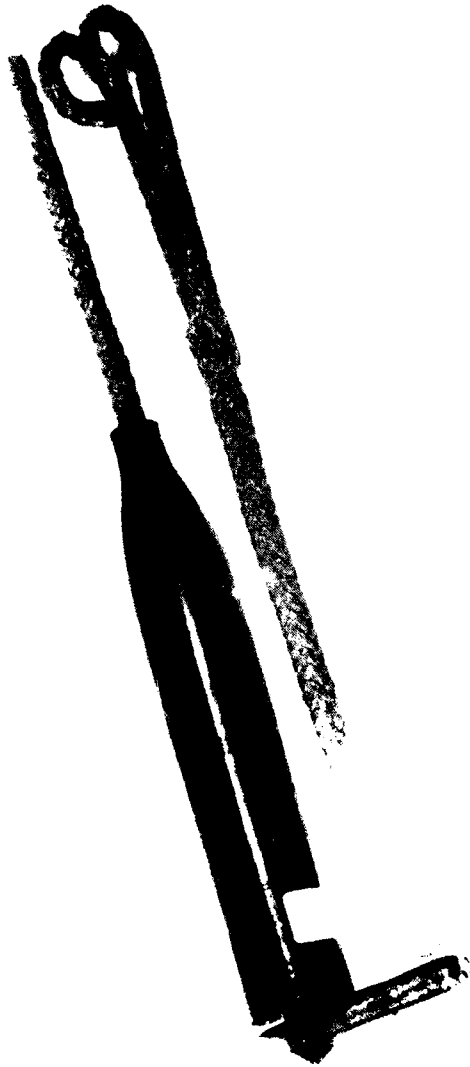
Figure 26. Modified tether assembly (Type B).

In an effort to substantially reduce the failure rate, the tether design was modified. The basic configuration remained unchanged. However, a low modulus elastomer was used to impregnate and encapsulate the line at the buried end of the splice to prevent entrance of particulate matter into the line core, and minimize fiber-to-fiber abrasion during cyclic axial loading. During 12-14 December 1978, 36 tethers were replaced in the field with two modified versions. Type A was original construction, but with the area above the boot impregnated with polyurethane for a length of 7 inches. The end of the eye splice was lengthened in Type B to extend 6 inches above the boot to further separate the line discontinuity from the molded termination; the tether was impregnated as in Type A. Modifications to tether assemblies (Types A and B) also included lengthening and impregnating the upper eye splice to guard against abrasion at the bail. Figure 26 shows a modified tether assembly (Type B). These proved to be more durable than the former design. Internal abrasion at the lower termination is no longer considered a problem. During the Ocean Model refurbishment in late May 1979, Type B assemblies were used exclusively. A new unit is shown installed in figure 27.
