NEW YORK STATE DEPT OF ENVIRONMENTAL CONSERVATION ALBANY F/G 13/13  
NATIONAL DAM SAFETY PROGRAM. TIVOLI LAKE DAM (INVENTORY NUMBER --ETC--)  
SEP 80 E O'BRIEN DACW51-79-C-0001

| REPORT DOCUMENTATION PAGE | | READ INSTRUCTIONS<br>BEFORE COMPLETING FORM |
|---|---|---|
| Phase I Inspection Report<br>Tivoli Lake Dam<br>Hudson River Basin, Rockland County, New York<br>Inventory No. 052 | | 5. TYPE OF REPORT & PERIOD COVERED<br>Phase I Inspection Report<br>National Dam Safety Program |

PHASE I INSPECTION REPORT  
NATIONAL DAM SAFETY PROGRAM  
TIVOLI LAKE DAM  
I.D. NO. N.Y. 52  
D.E.C. NO. 306  
HUDSON RIVER BASIN  
ROCKLAND COUNTY, NEW YORK

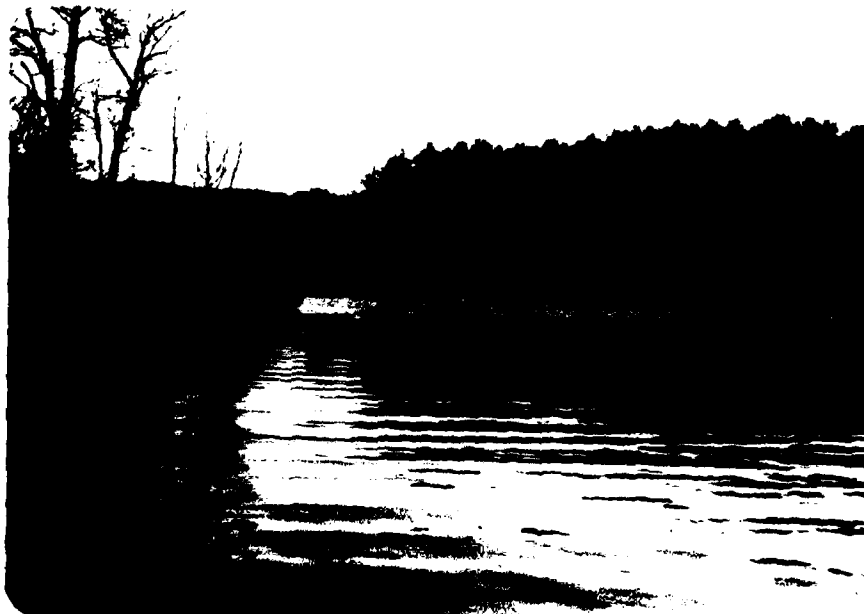
7. VIEW OF CAUSWAY ACROSS LAKE NEAR SPILLWAY.
