LAKE SUZANNE

ROCKLAND COUNTY, NEW YORK
INVENTORY NO. N.Y. 760

PHASE I INSPECTION REPORT
NATIONAL DAM SAFETY PROGRAM

AUGUST 1980

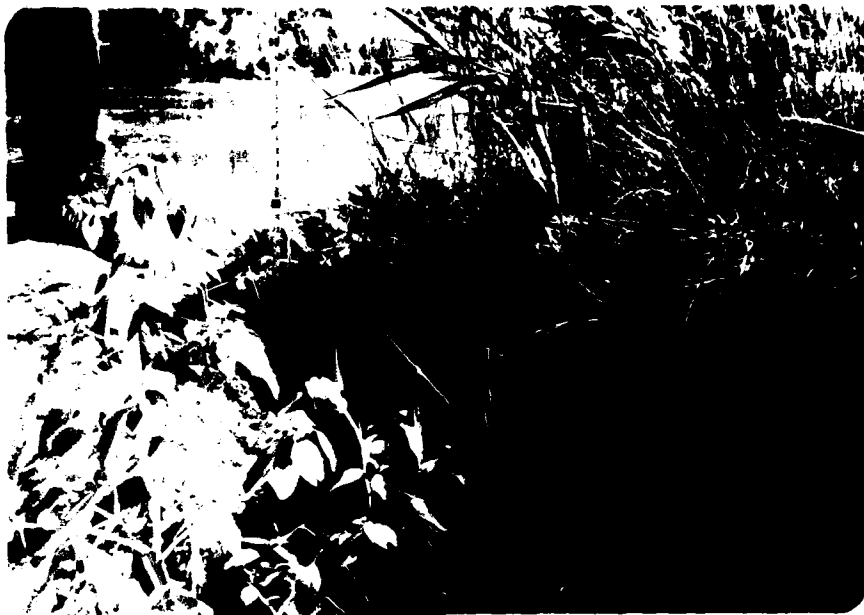
The left abutment and the downstream toe of the embankment could not be accurately located because of flat topography, heavy vegetation and ground cover. However, from available information, the length of the embankment is estimated to be about 50 feet; the upstream and downstream slopes are about 1 vertical and 4 horizontal and 1 vertical and 5 horizontal, respectively. The embankment appears generally to be in good condition except in the vicinity of the spillway-embankment contact, where the embankment fill downstream of the left spillway training wall has been eroded apparently as a result of overtopping. A portion of the eroded area was backfilled with a mass concrete blanket immediately downstream of the training wall leaving the remaining portion unrepaired. In addition, subsequent overtopping or runoff has eroded a 3 foot wide, 3 foot deep gully between the embankment and the concrete blanket (See Photograph 6).

6. VIEW AT CONTACT BETWEEN DOWNSTREAM FACE OF LEFT SPILLWAY TRAINING WALL AND THE EMBANKMENT. NOTE EROSION OF EMBANKMENT FILL.

1. The eroded area of the embankment, downstream of the left spillway training wall, should be backfilled to the level of the embankment crest.
2. The reservoir drain should be returned to operating condition.

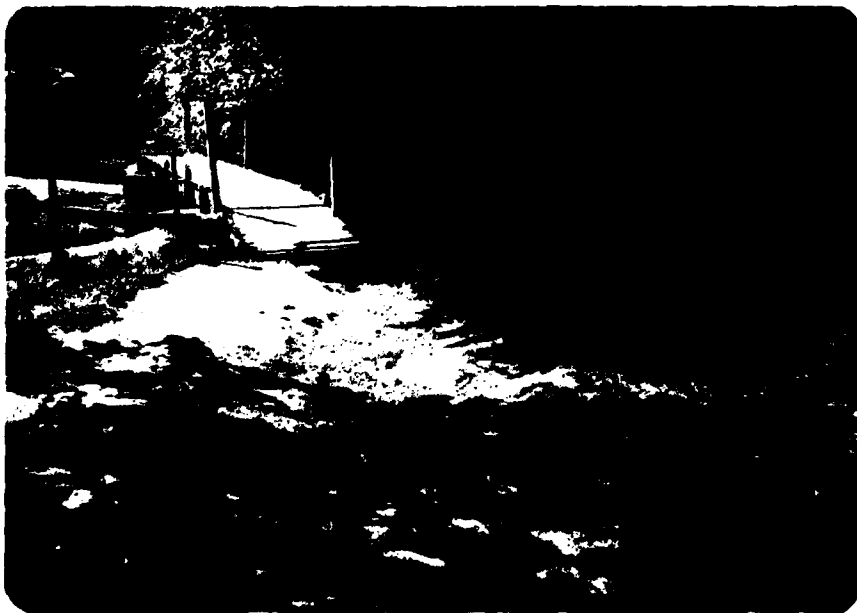
The left abutment of the dam could not be accurately located due to flat topography, heavy vegetation and ground cover. No seepage was observed at the left or right abutments. At the right abutment-spillway contact there is a shallow gully caused by surface runoff from the roadway and adjacent areas (See Photograph 7).

7. VIEW OF RIGHT ABUTMENT. NOTE GULLY CAUSED BY SURFACE RUNOFF.
