| REPORT DOCUMENTATION PAGE | | READ INSTRUCTIONS<br>BEFORE COMPLETING FORM |
|---|---|---|
| 4. TITLE (and Subtitle)<br>Phase I Inspection Report<br>Palmer Falls Dam<br>Upper Hudson River Basin, Saratoga & Warren<br>Counties, NY Inventory No. 145 | | 5. TYPE OF REPORT & PERIOD COVERED<br>Phase I Inspection Report<br>National Dam Safety Program |
| 9. PERFORMING ORGANIZATION NAME AND ADDRESS<br>Stetson-Dale Engineering Company<br>Bankers Trust Building<br>Utica, NY 13501 | | 8. CONTRACT OR GRANT NUMBER(s)<br>DACW-51-79-C-0001 |

PHASE I REPORT  
NATIONAL DAM SAFETY PROGRAM

Name of Dam Palmer Falls Dam, NY145

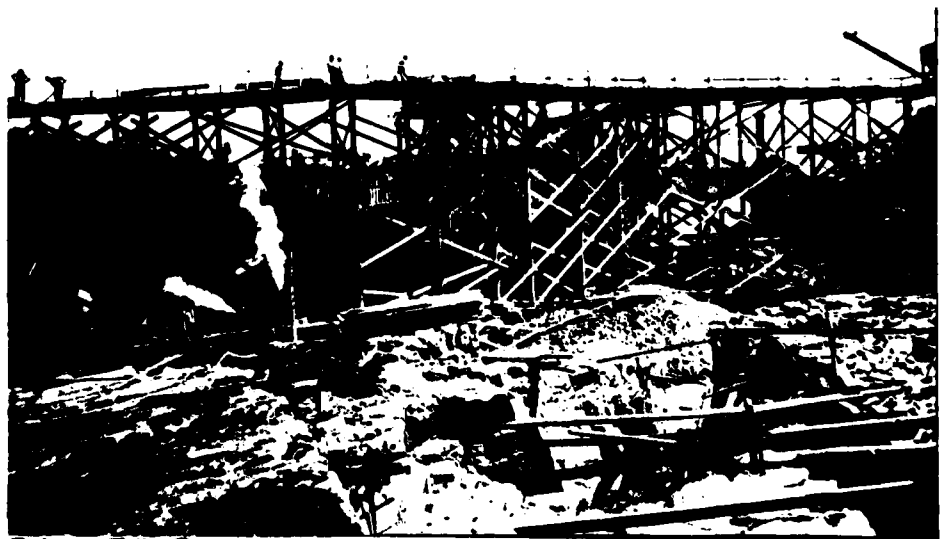
Palmer Falls Dam - July 10, 1913 - Showing Trench back of Dam
