NAVAL POSTGRADUATE SCHOOL

A-10/GAU-8 LOW ANGLE FIRINGS VERSUS
SIMULATED SOVIET TANK BATTALION
(HONEYWELL LOT NUMBER 0L78D043-016)
(ARRAY 3)
2 FEBRUARY 1979.
R.H.S. STOLFI
R.R. MCEACHIN
AUGUST 1980

Prepared for: A-10 System Program Office
Wright Patterson Air Force Base
Ohio 45433

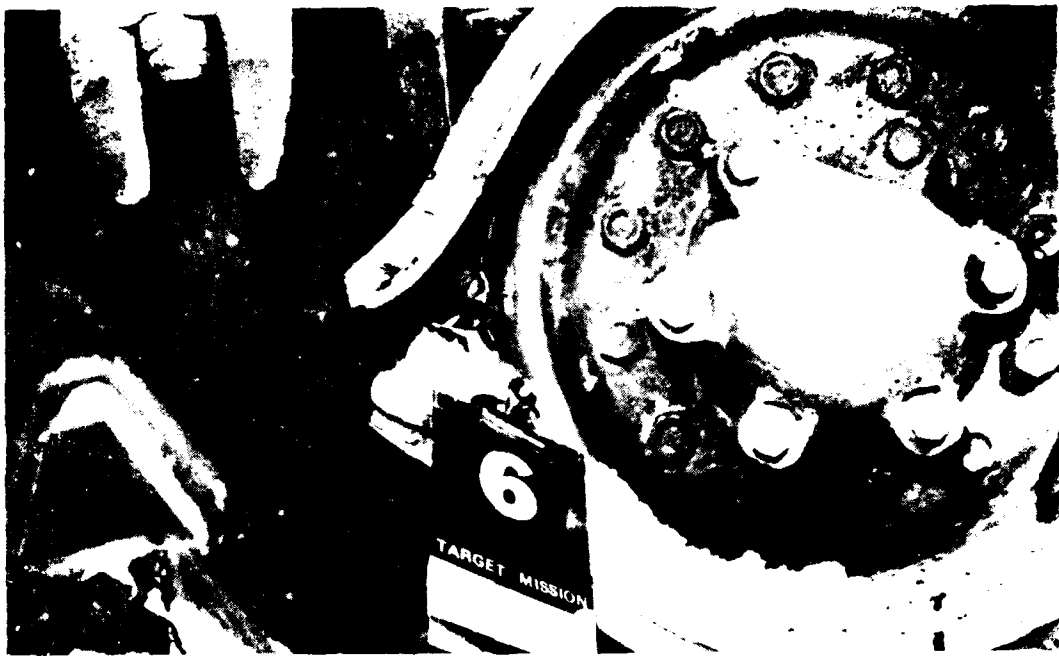
A 10% M-Kill was assessed due to the impacts on the track and suspension system. Impact 6, shown in Figure 45, is representative of the most severe damage inflicted during this attack.

FIGURE 45. Impact Six, Target 27, Showing Damage to Left Number 2 Track Support Roller.

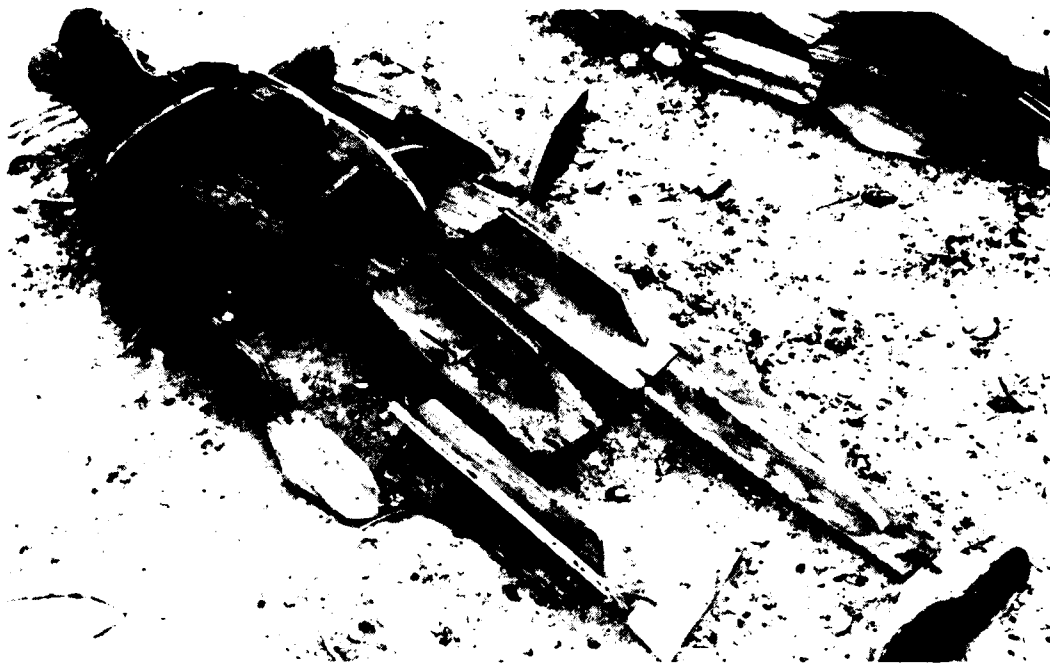
FIGURE 73. Commander Manikin, Target 35, Showing Damage from Perforations into the Fighting Compartment.

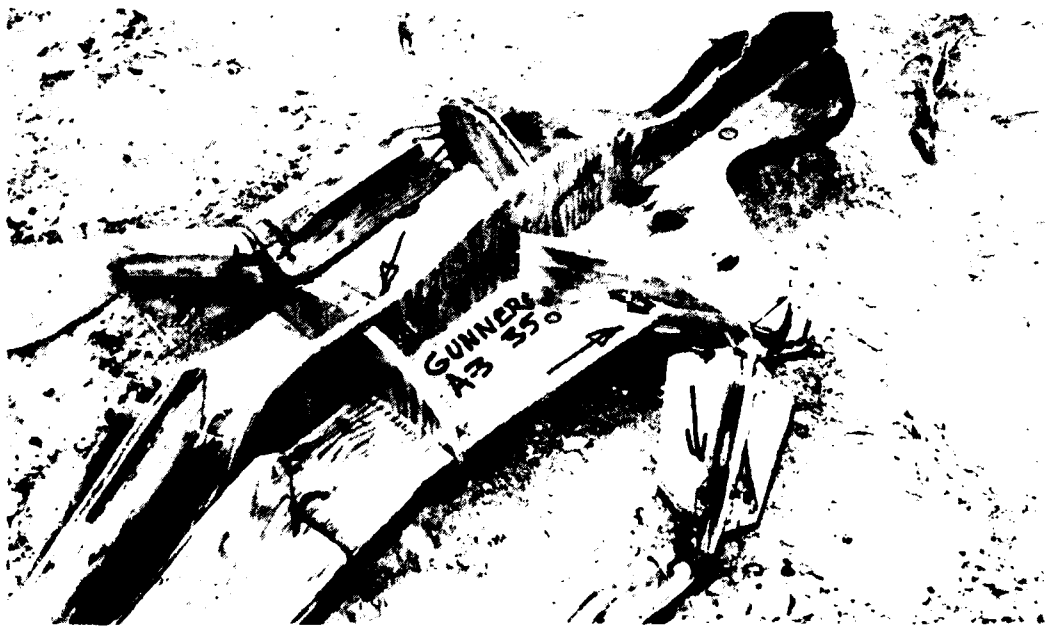
FIGURE 74. Gunner Manikin, Target 35 Showing Damage from Perforations into the Fighting Compartment.

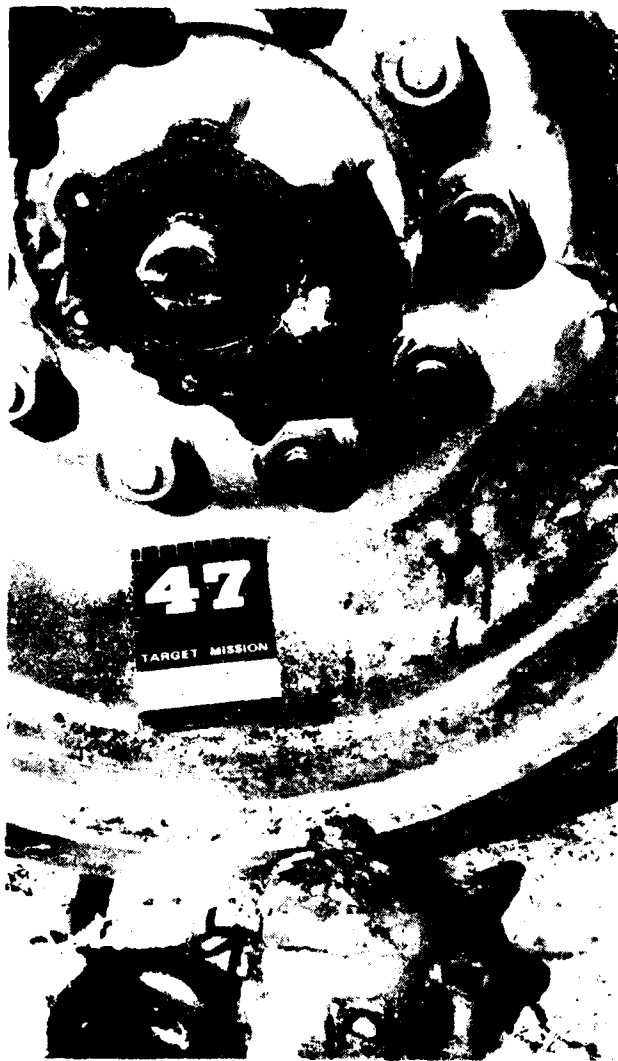
FIGURE 80. Impact Forty-seven, Target 36, which Destroyed the Left #5 Roadwheel Hub Bearings.

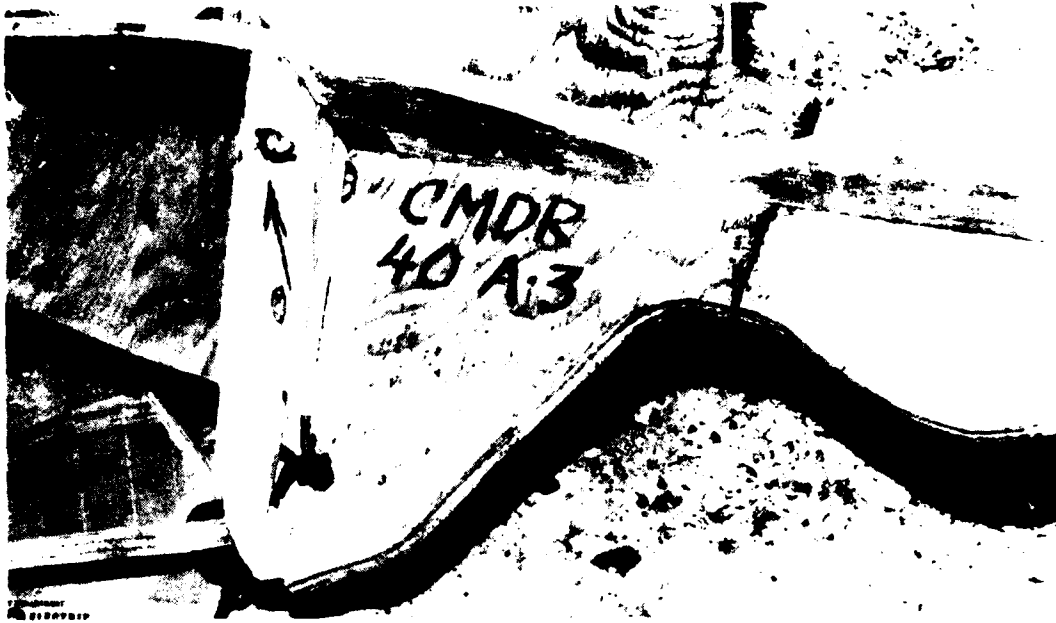
- b. F-Kill: Impact 15, shown in Figure 103, perforated the left side of the commander's cupola and made him a casualty (Figure 104). Impact 3, shown in Figure 105, jammed the turret so that it could not be traversed. Impacts 12 and 13, which destroyed the gunner's periscope head, contributed to the kill.

FIGURE 104. Commander Manikin, Target 40, Showing Damage from Impact 15.

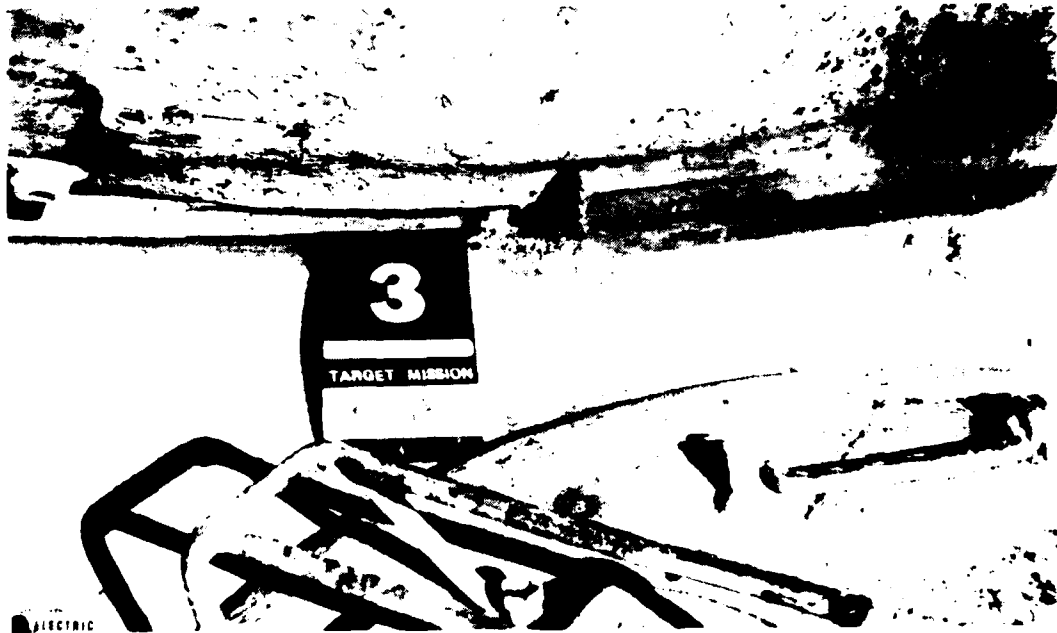
FIGURE 105. Impact Three, Target 40, which Jammed the Turret so that it would not Traverse.
