ESL-TR-80-42

## SMALL CRATER EXPEDIENT REPAIR TEST

KENNETH J. KNOX  
ENGINEERING RESEARCH DIVISION

AUGUST 1980

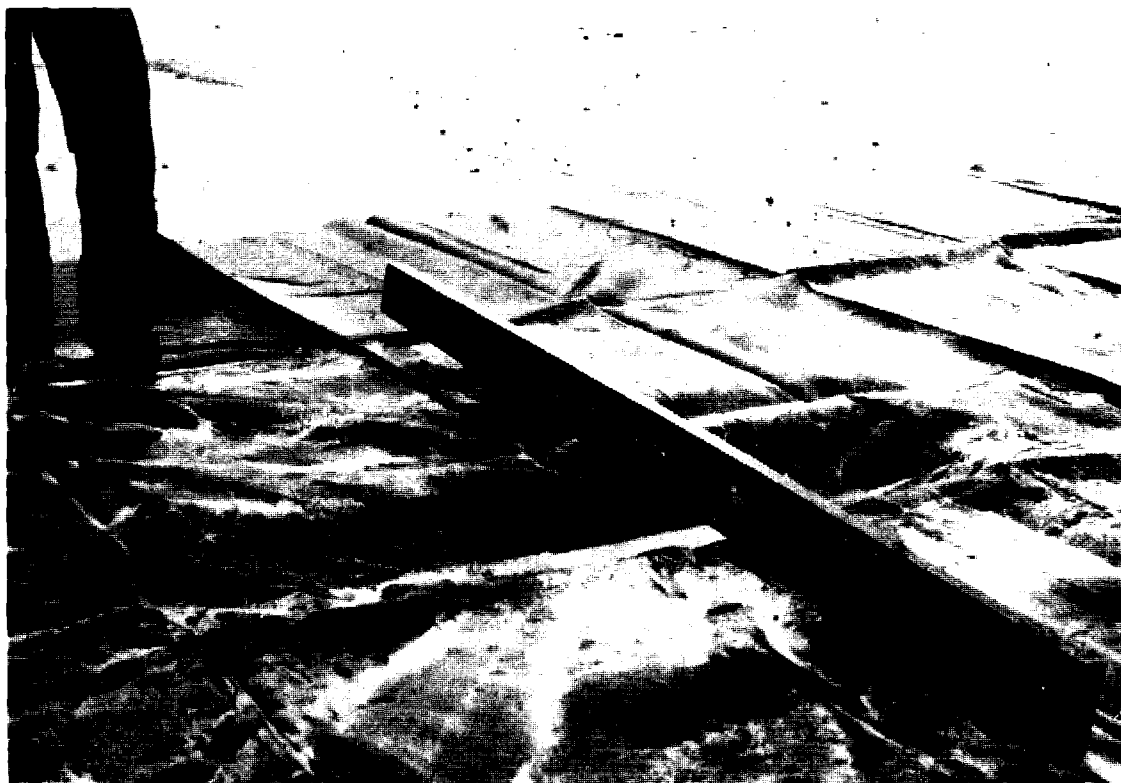
Figure 53. Rutting Failure on Crater 1

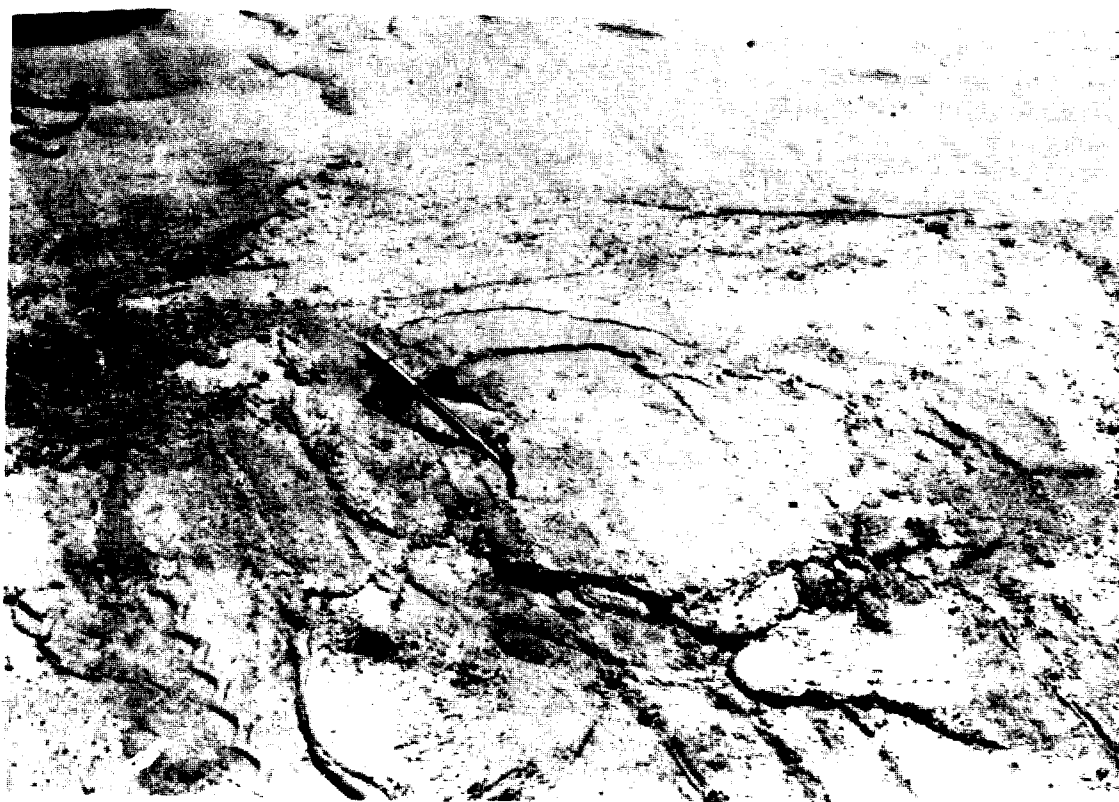
Figure 55. Quality Control Failure on Crater 4

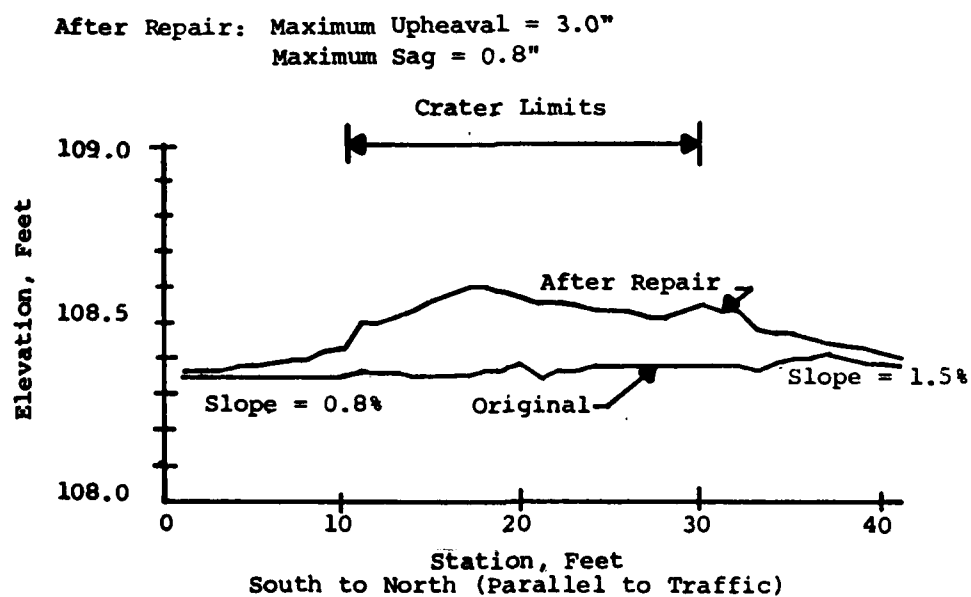
Figure 56. Crater 1 Profiles

After Repair: Maximum Upheaval = 1.6"    150 Coverages: Maximum Upheaval = 1.3"  
 Maximum Sag = 1.0"    Maximum Sag = 1.0"

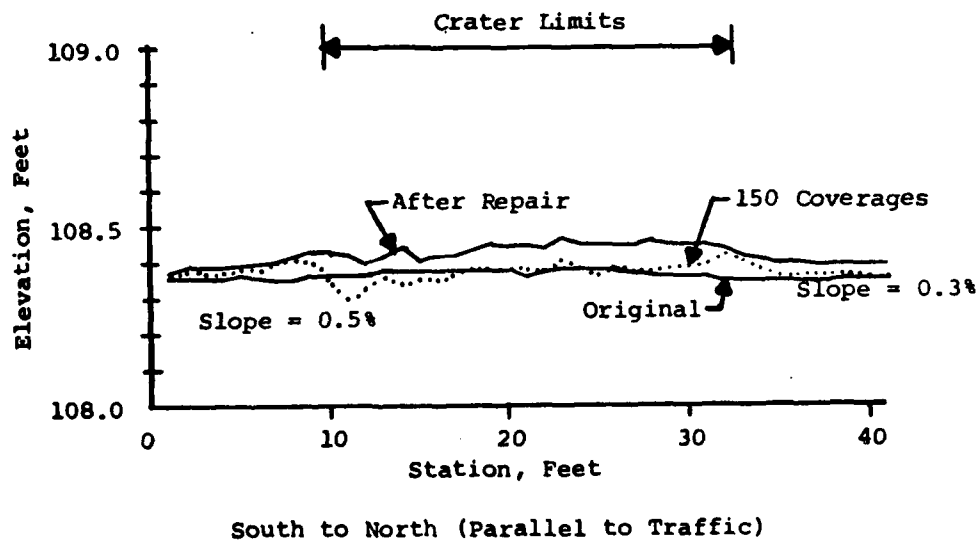
Figure 57. Crater 2 Profiles

After Repair: Maximum Upheaval = 1.2"    150 Coverages: Maximum Upheaval = 0.8"  
 Maximum Sag = 0.5"    Maximum Sag = 1.4"

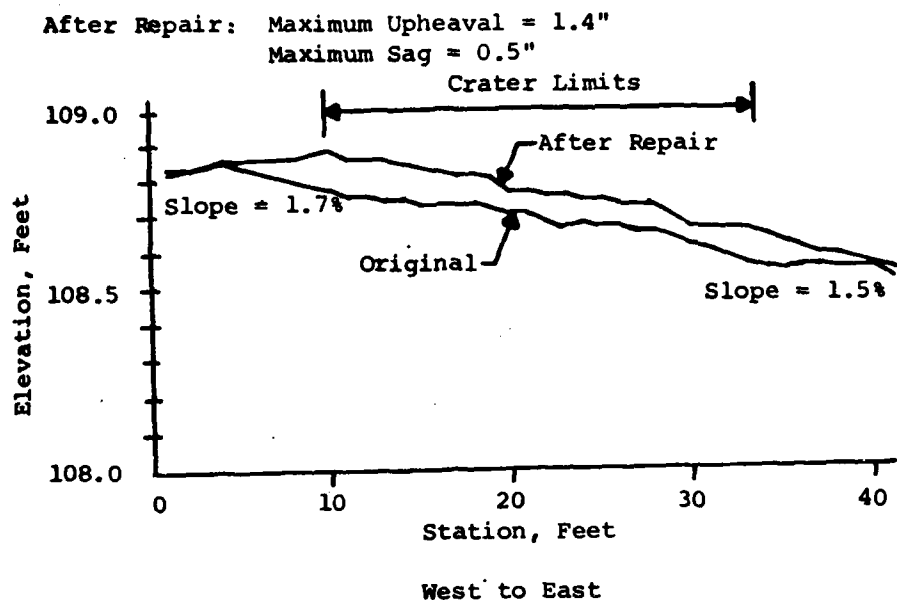
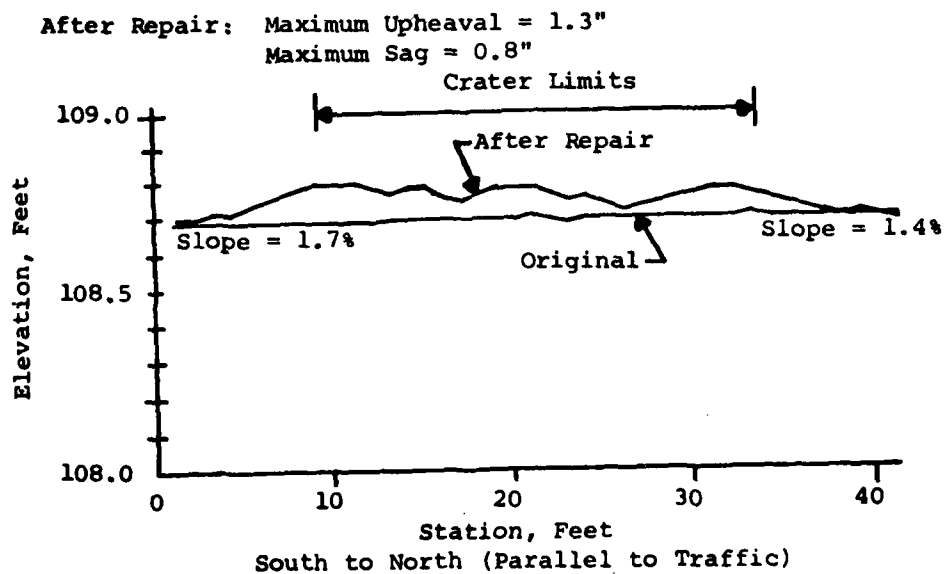
Figure 60. Crater 4 Profiles

After Repair: Maximum Upheaval = 2.5"    150 Coverages: Maximum Upheaval = 2.3"  
 Maximum Sag = 0.5"    Maximum Sag = 1.1"

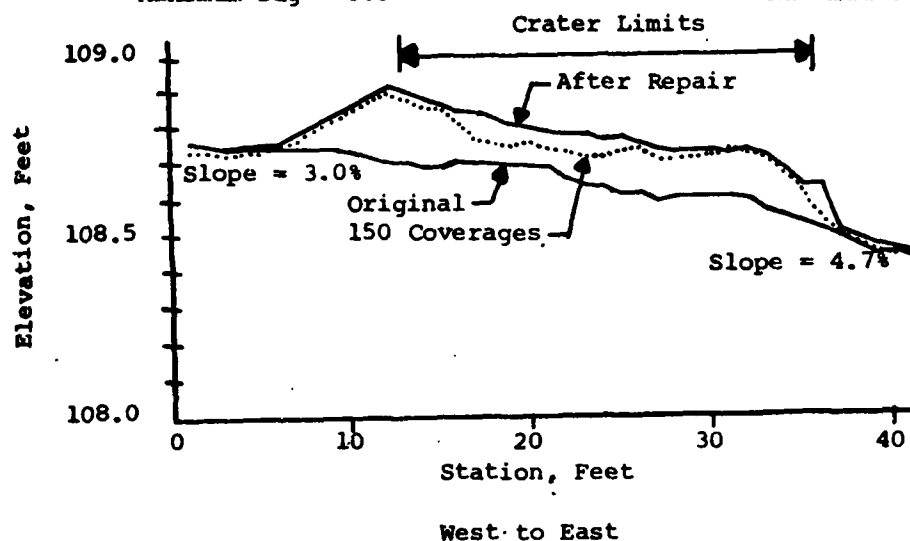
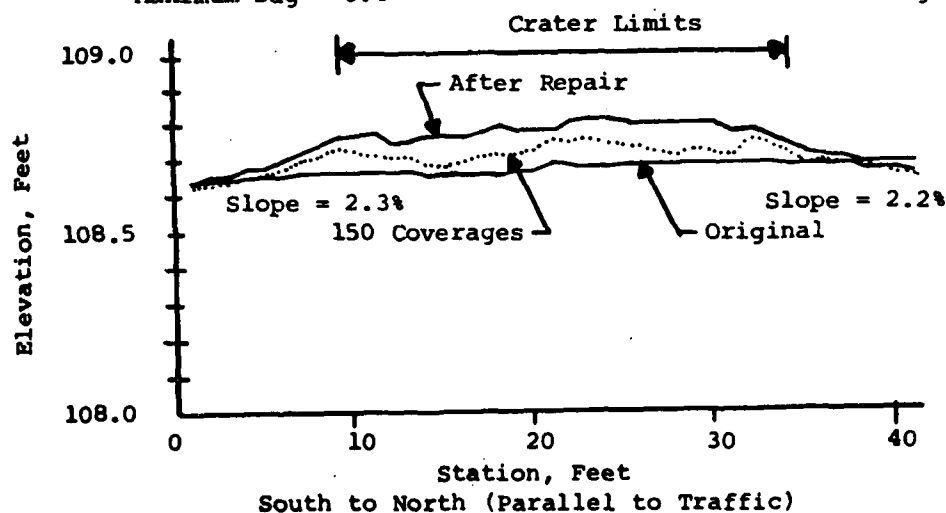
Figure 61. Crater 5 Profiles

After Repair: Maximum Upheaval = 1.7"    150 Coverages: Maximum Upheaval = 1.0"  
 Maximum Sag = 0.4"    Maximum Sag = 0.8"

After Repair: Maximum Upheaval = 2.2"    150 Coverages: Maximum Upheaval = 2.2"  
 Maximum Sag = 0.7"    Maximum Sag = 1.5"

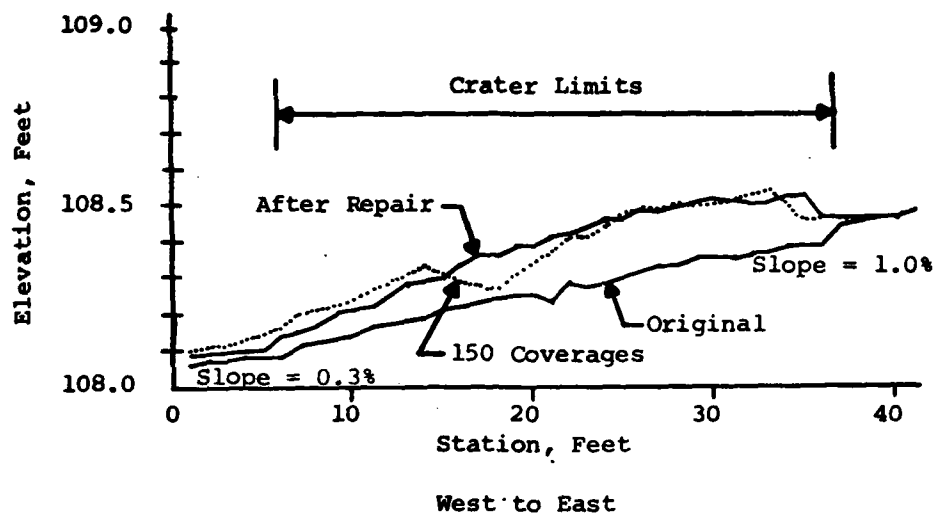
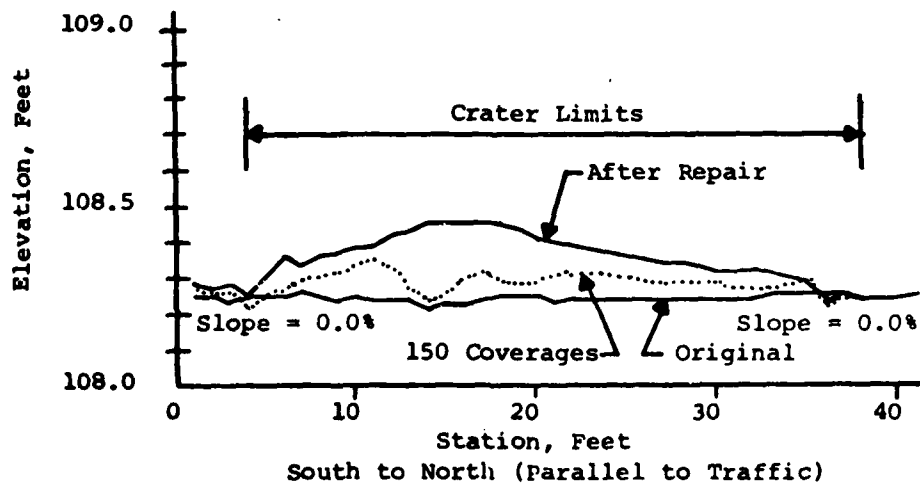
Figure 62. Crater 6 Profiles

After Repair: Maximum Upheaval = 2.8"    150 Coverages: Maximum Upheaval = 1.3"  
 Maximum Sag = 1.0"    Maximum Sag = 1.3"
