TECHNICAL REPORT GL-81-2

# 15 MILE ROAD/EDISON CORRIDOR SEWER TUNNEL FAILURE STUDY DETROIT AREA, MICHIGAN

January 1981

Final Report

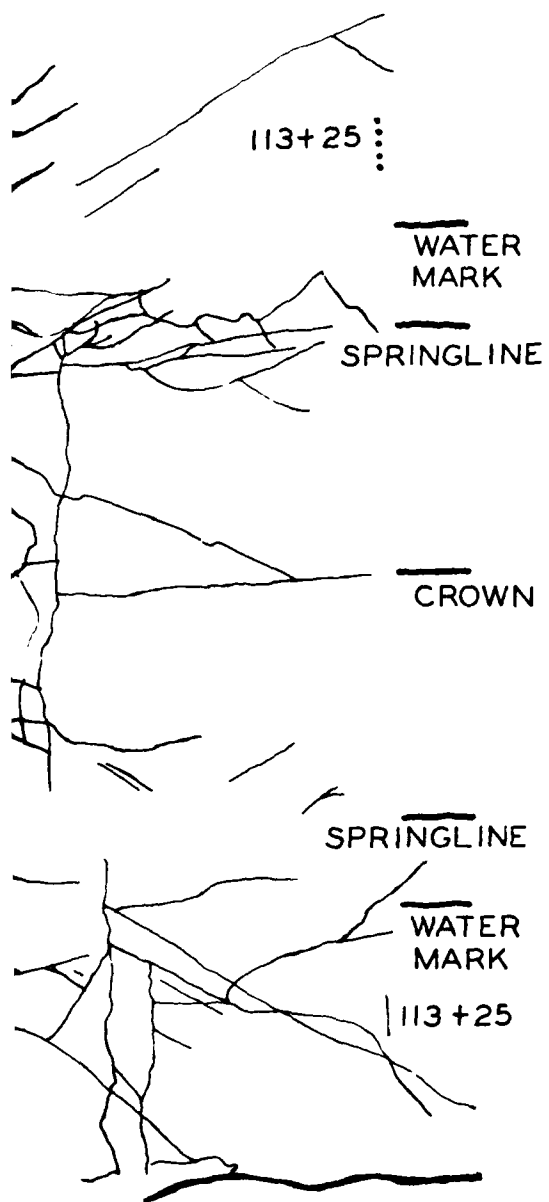
46. Crack pattern, Distressed  
Area 3
