HEILMAN DAM

(NDI NO. PA-00612,  
DER NO. 13-005)

PHASE I INSPECTION REPORT,

⑪ FEBRUARY 1981

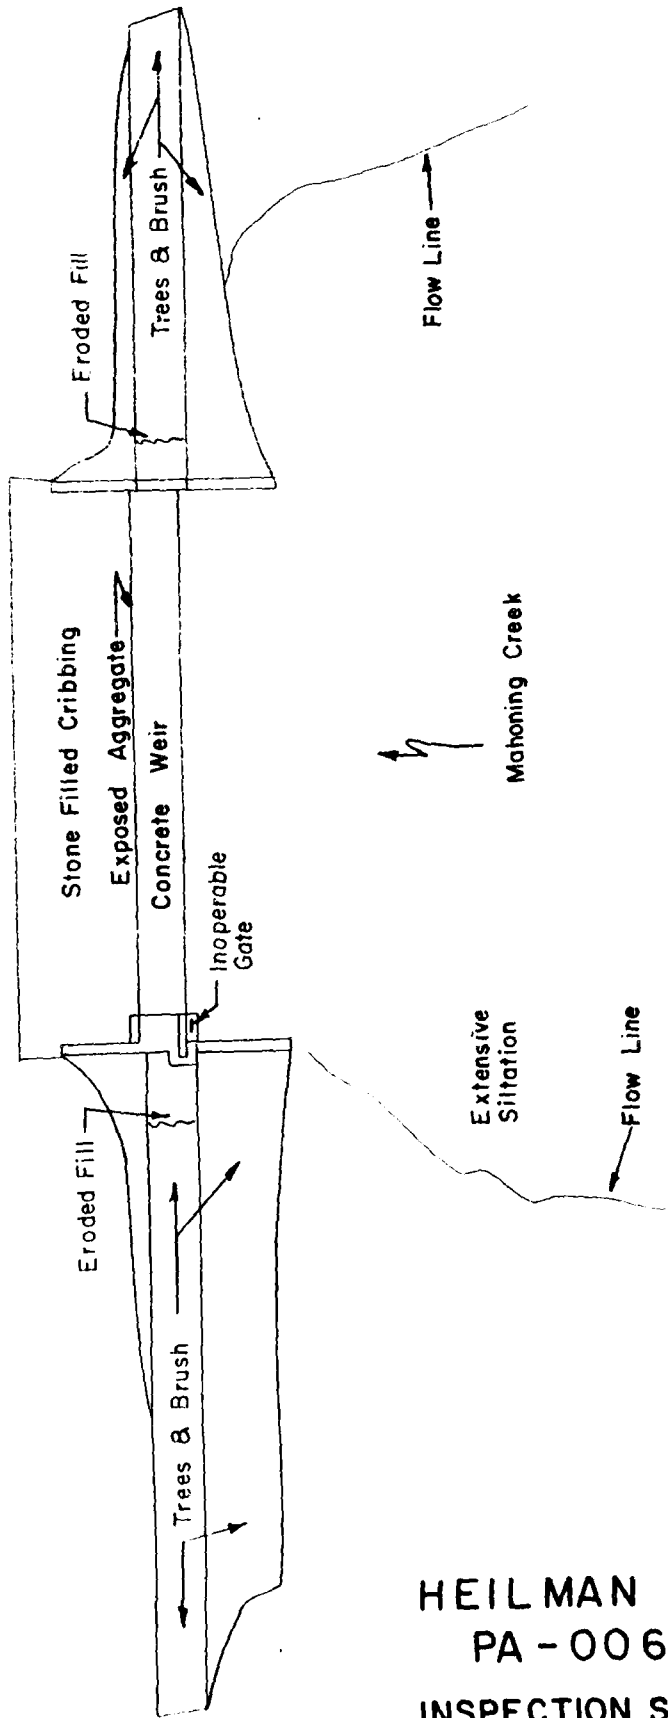
HEILMAN DAM  
PA-00612  
INSPECTION SURVEY  
PLATE A-I

Trees and brush have been permitted to grow on the embankment and there are no indications of recent maintenance. The embankment has settled and/or eroded, lowering the profile below its design crest elevation (top of spillway abutments). An increase of three feet above the normal pool elevation would cause overtopping.

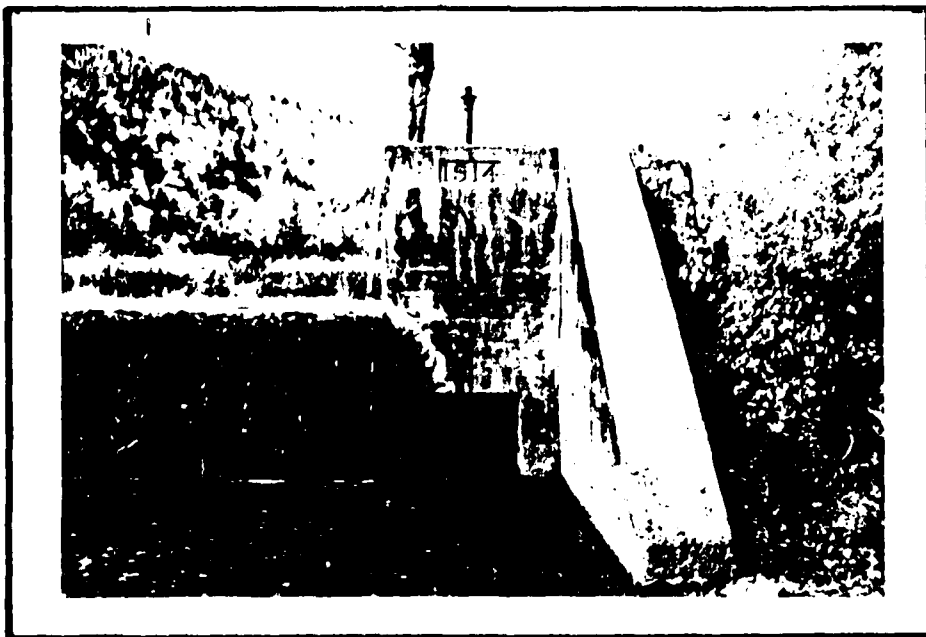
The weir has concrete abutments at each side. The left abutment contains a 4' x 4' opening, closed with a sliding gate. The gate stand and stem are broken and the gate is inoperable at the present time.

The only operating facility is a four foot sluice gate for drawdown. This gate is in the closed position, and is inoperable due to a broken stem and gate stand.

DOWNSTREAM SIDE OF OUTLET IN LEFT ABUTMENT WALL - NO. 5

3. That access above the floodplain be provided for surveillance.
4. That either a method be developed for opening the sluice gate in an emergency or the opening be permanently closed off.
5. That a formal surveillance and downstream warning system be developed for use during periods of high or prolonged rainfall.
6. That an operation and maintenance manual be prepared for guidance in the operation of the dam during normal and emergency conditions, and that a schedule be developed for the annual inspection of the dam and its appurtenant structures. The operational manual should include regular maintenance of the embankment.

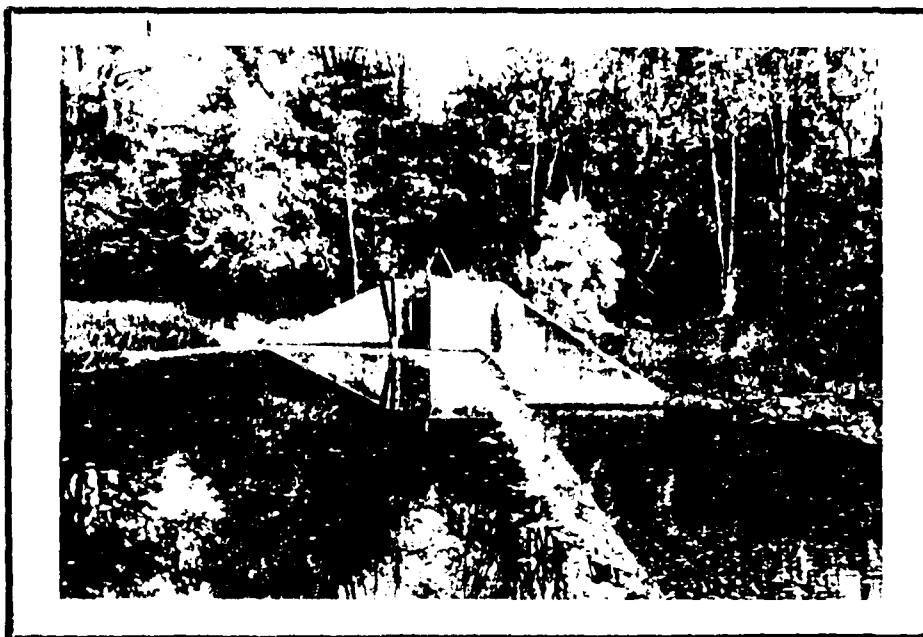
LEFT SIDE OF SPILLWAY AND ABUTMENT - NO. 6

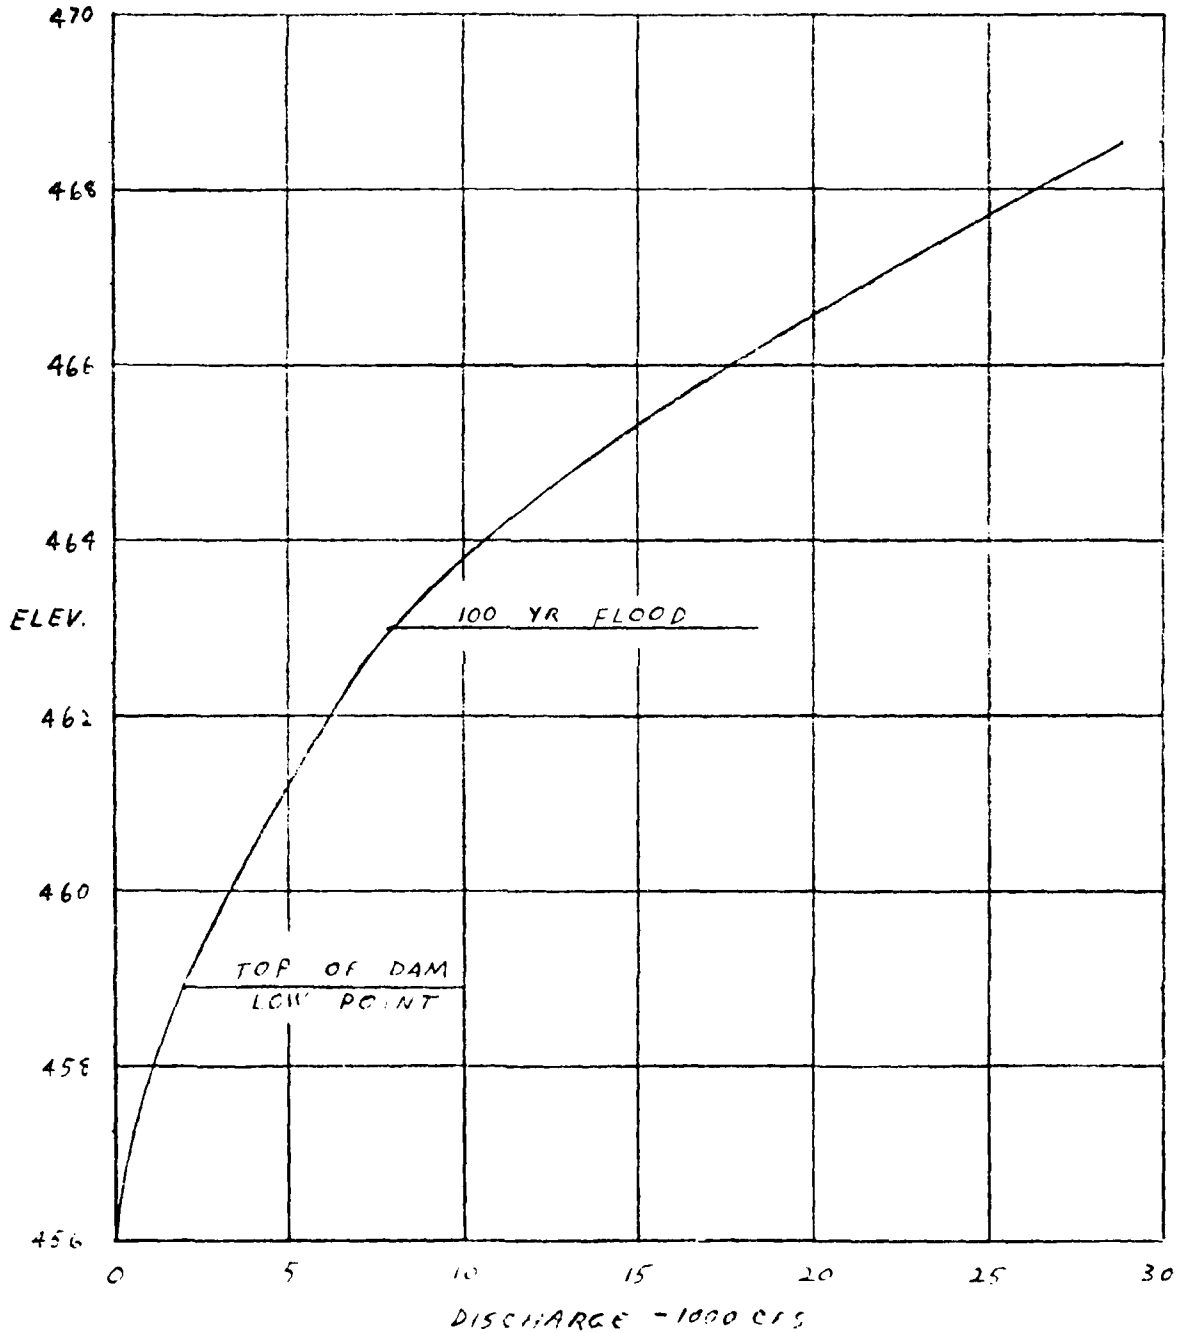
SPILLWAY CAPACITY CURVE

Since the total spillway discharge and reservoir storage capacity cannot pass the SDF without overtopping, and since the dam is not classified as high hazard, the spillway is considered to be inadequate but not seriously inadequate.
