National Dam Ins. Prog.  
~~DELAWARE RIVER BASIN~~  
LONG RUN RESERVOIR NO. 1 DAM  
~~LEIGHTON WATER AUTHORITY~~

(NDI NO. PA-00882,  
DER NO. 13-004)

CARBON COUNTY, PENNSYLVANIA.  
PHASE I INSPECTION REPORT,  
NATIONAL DAM INSPECTION PROGRAM

FEBRUARY 1981

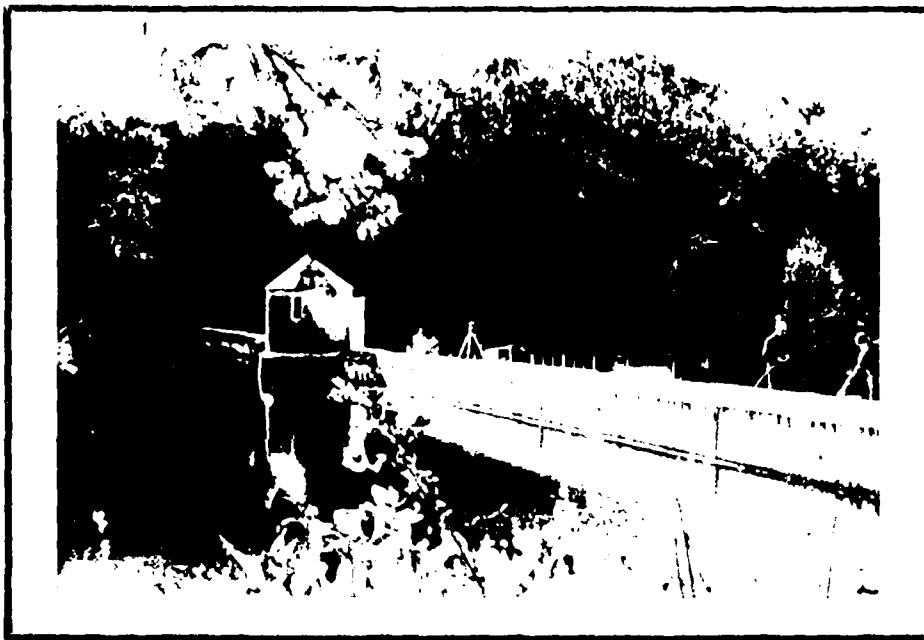
UPSTREAM FACE FROM RIGHT ABUTMENT - NO. 2

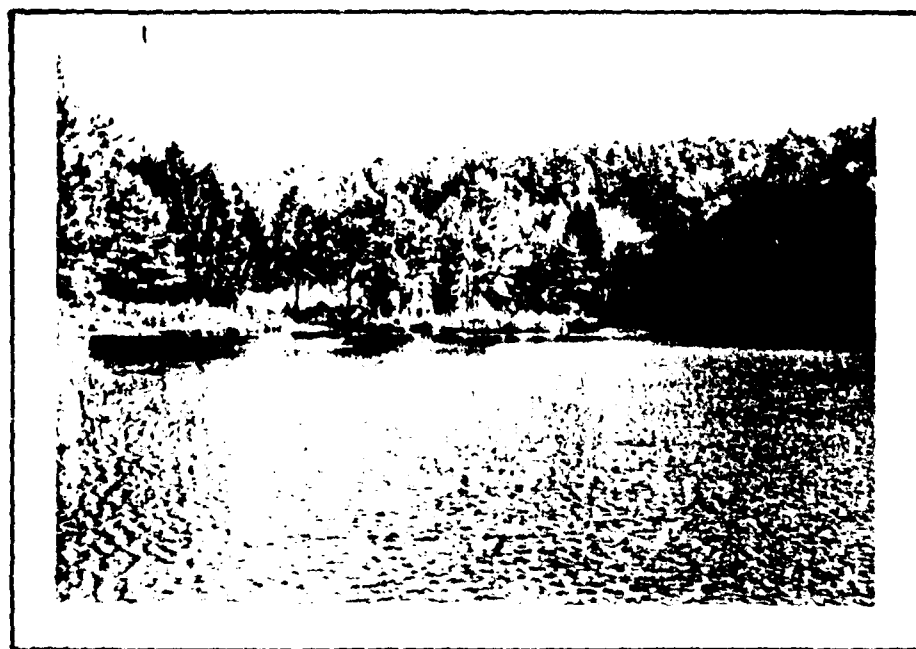
RESERVOIR AREA - NO. 7
