LAKE LEHMAN DAM

(NDI <sup>Number</sup> NO. PA-00341  
DER <sup>Number</sup> NO. 67-480), Susquehanna River Basin,

PHASE I INSPECTION REPORT,  
NATIONAL DAM INSPECTION PROGRAM

11 FEBRUARY 1981

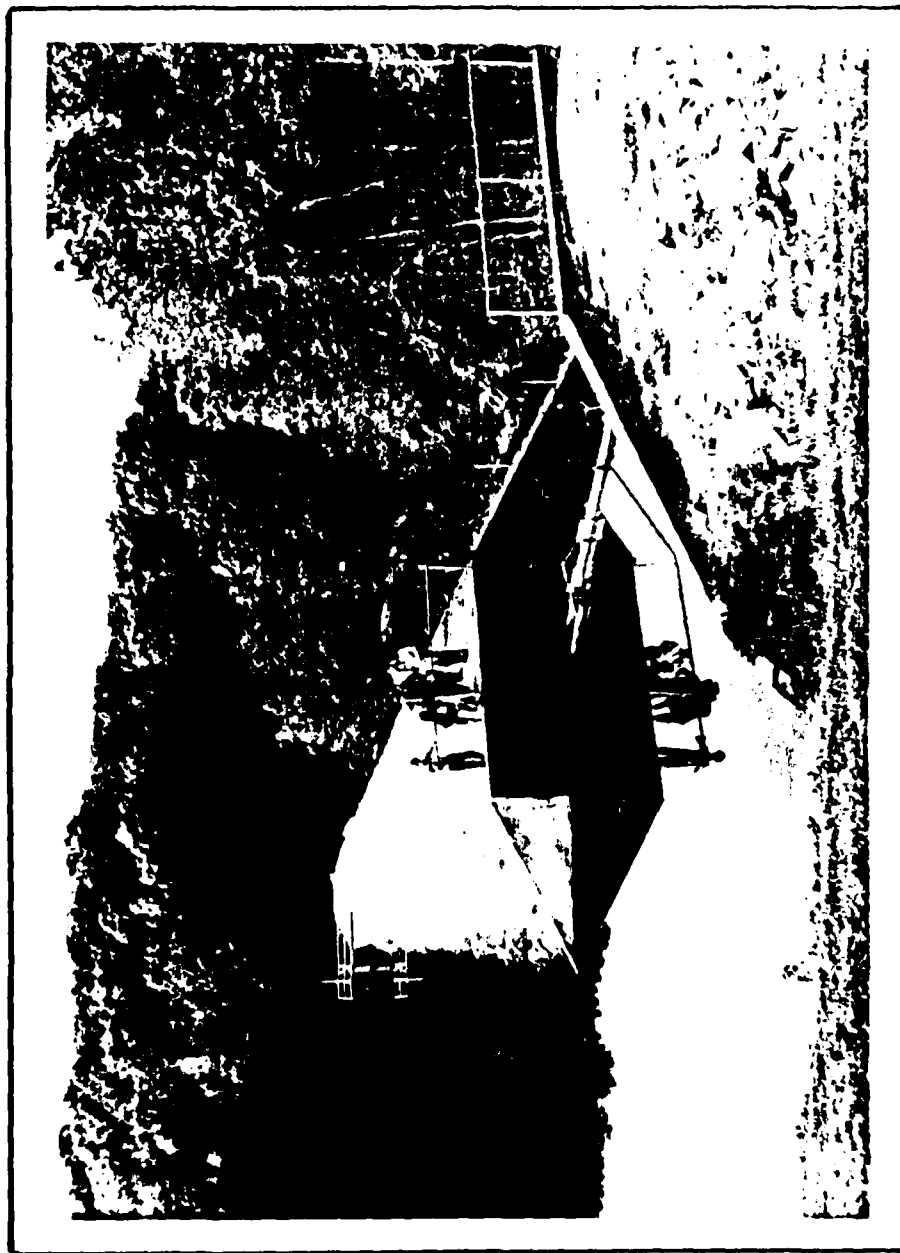
Photograph No. 1

OVERVIEW

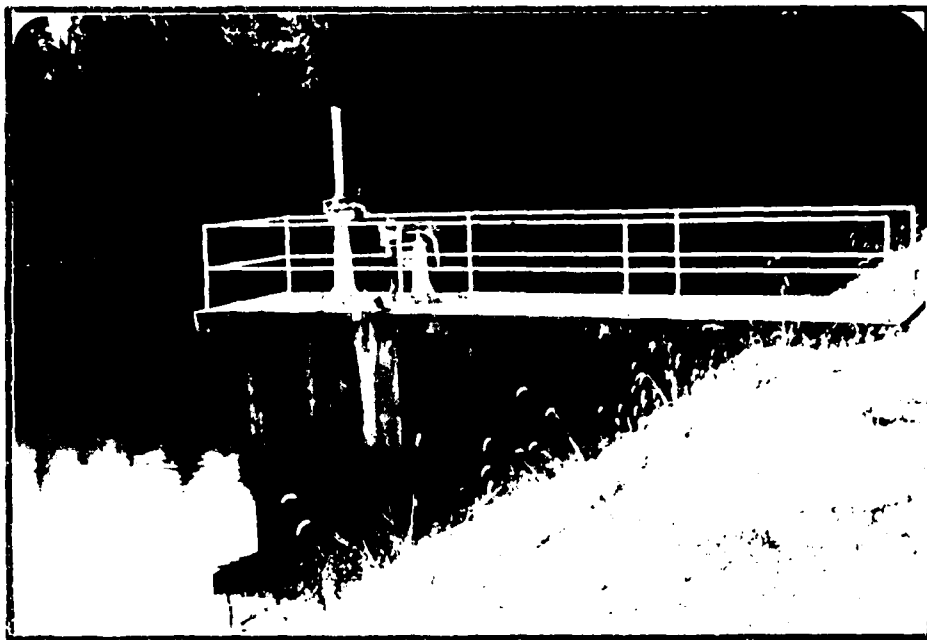
UPSTREAM CONTROL TOWER WITH FOOTBRIDGE - NO. 4

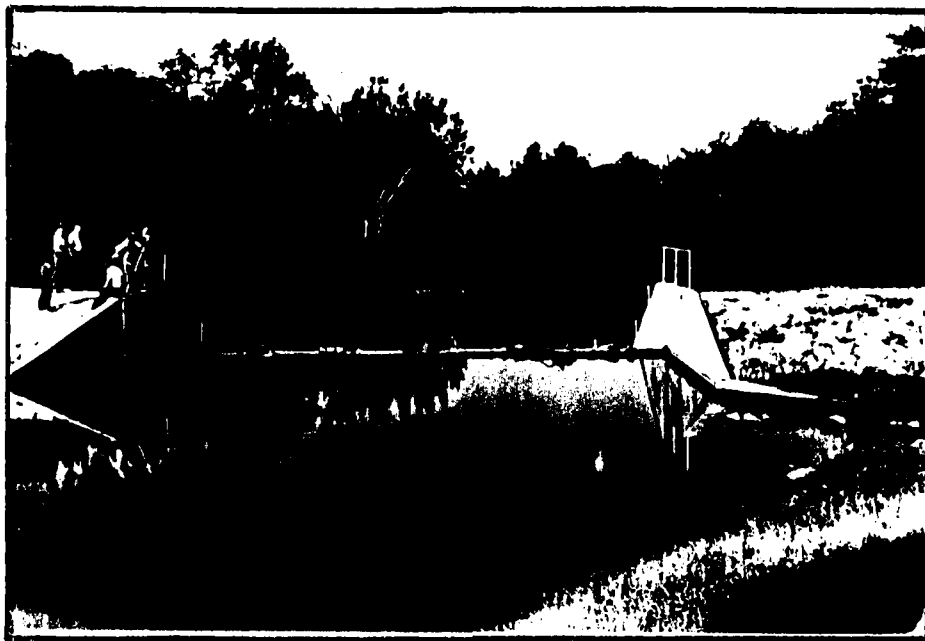
FOREBAY & SPILLWAY ABUTMENT WALLS - NO. 6

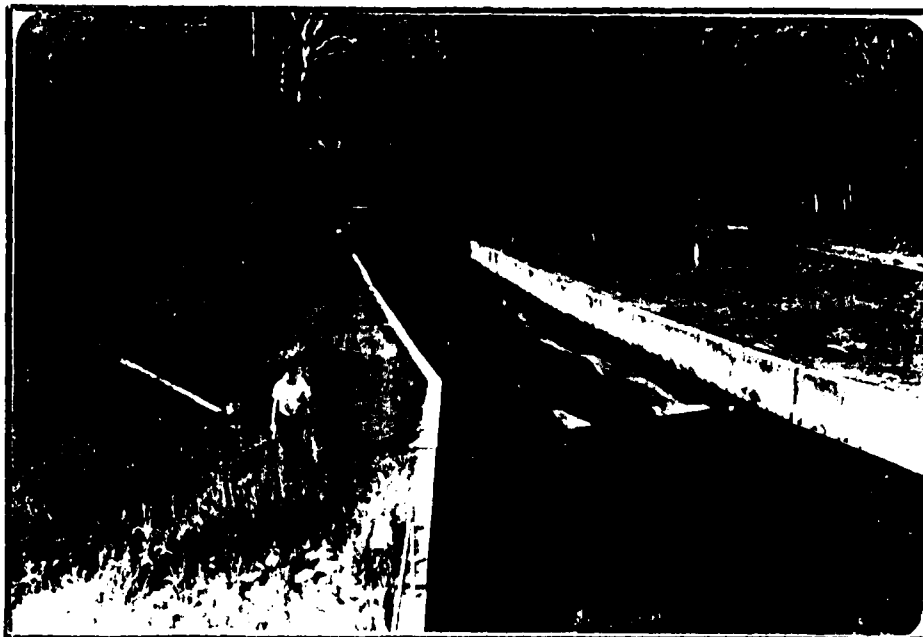
SPILLWAY CHANNEL WITH FOOTBRIDGE -- NO. 8

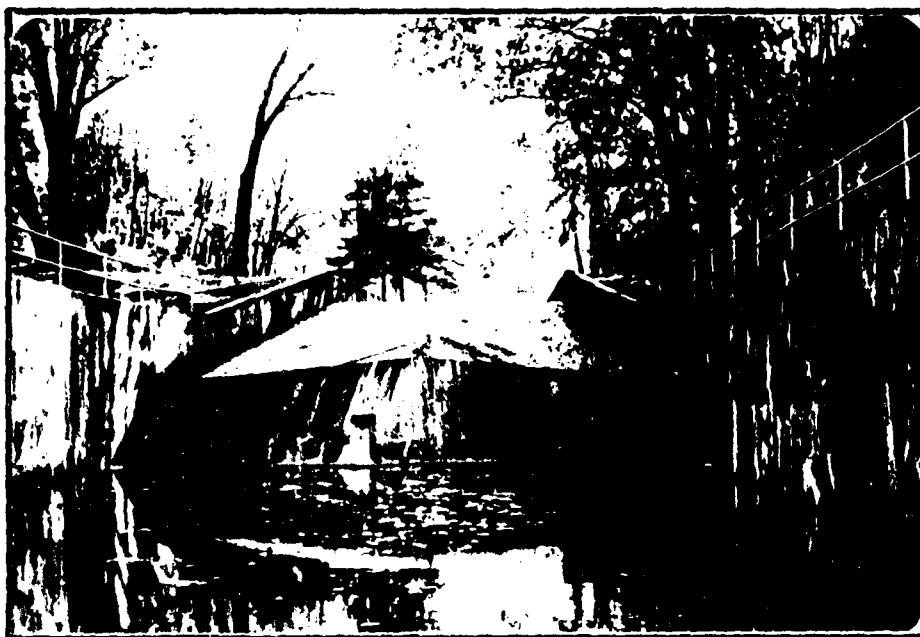
STILLING BASIN LOOKING UPSTREAM - NO. 10

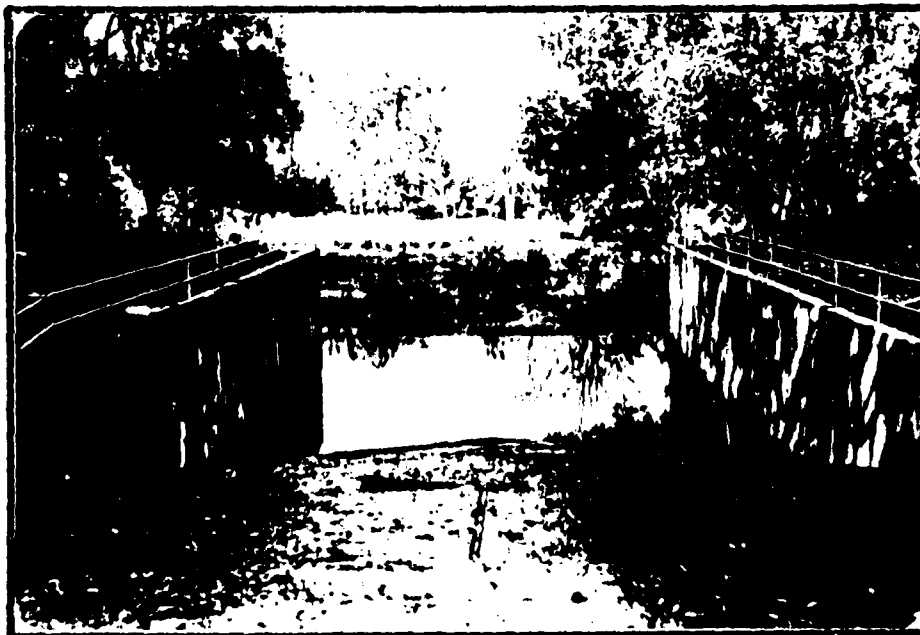
DOWNSTREAM CHANNEL - NO. 11  
NOTE: TILTED WALL

5. That close observation be maintained of the tilted walls in the spillway. If additional movement is recorded, measures shall be taken to correct this condition.
6. That an operation and maintenance manual be prepared for guidance in the operation of the dam during normal and emergency conditions, and that a schedule be developed for the annual inspection of the dam and its appurtenant structures.
