SHEPPARD DAM

National Dam Inspection Program.

PHASE I INSPECTION REPORT,  
NATIONAL DAM INSPECTION PROGRAM

Name of Dam: SHEPPARD DAM  
State & State No.: PENNSYLVANIA, 1-071  
County: ADAMS  
Stream: TRIBUTARY OF SOUTH BRANCH CONEWAGO CREEK  
Date of Inspection: October 9, 1980

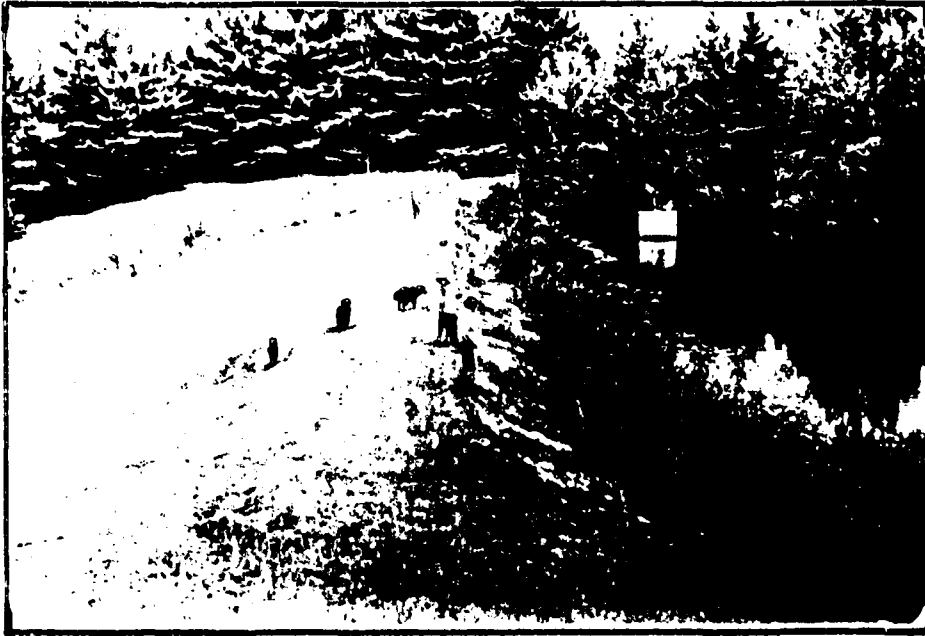
OVERVIEW FROM LEFT END - NO. 2  
NOTE - WIDE CRACKS ON UPS FROM SLAP.

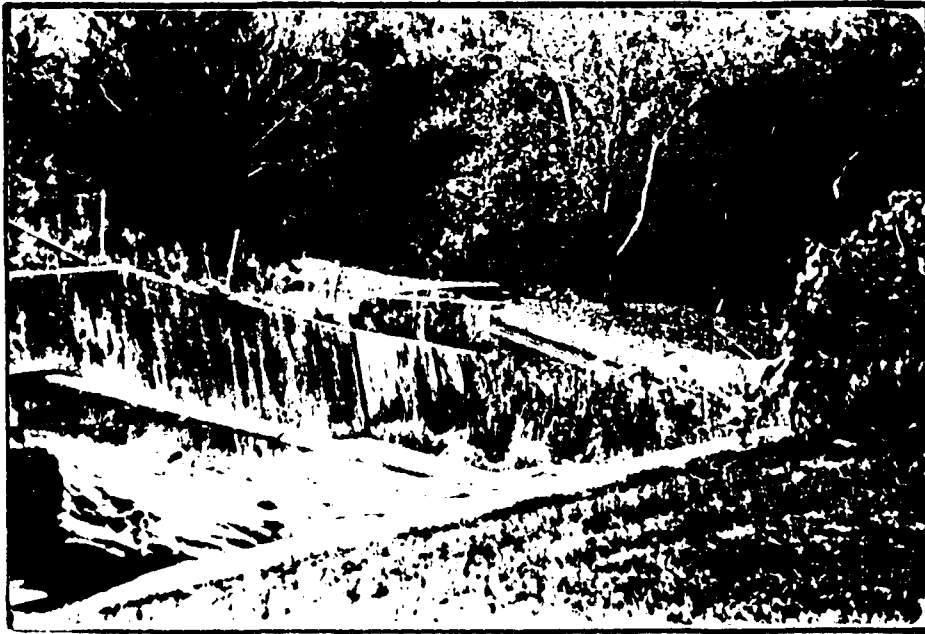
VIEW FROM RIGHT END - NO. 3  
NOTE - CRACKS IN TOP OF WALL

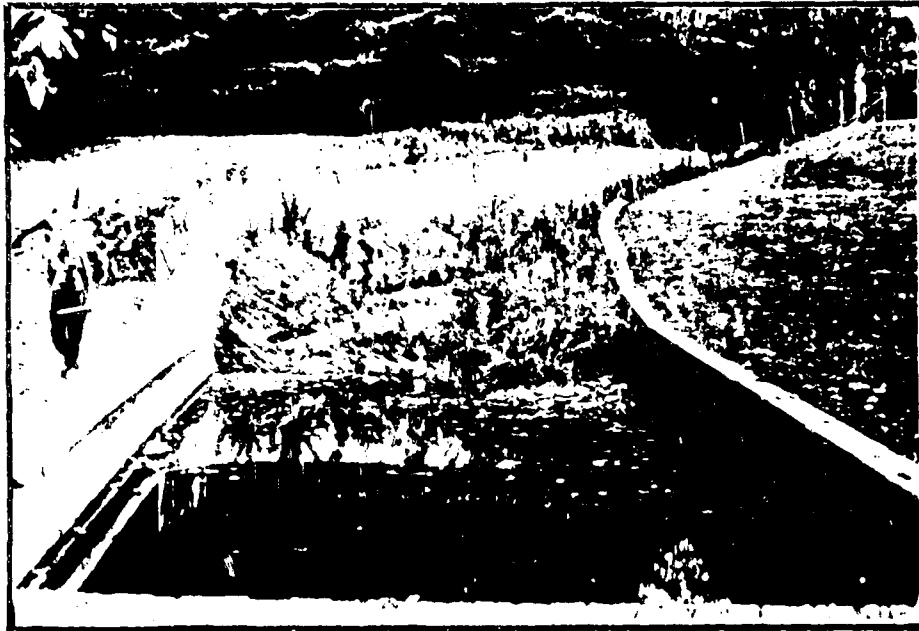
SPILLING BASIN AND SPILLWAY CHANNEL - NO. 6

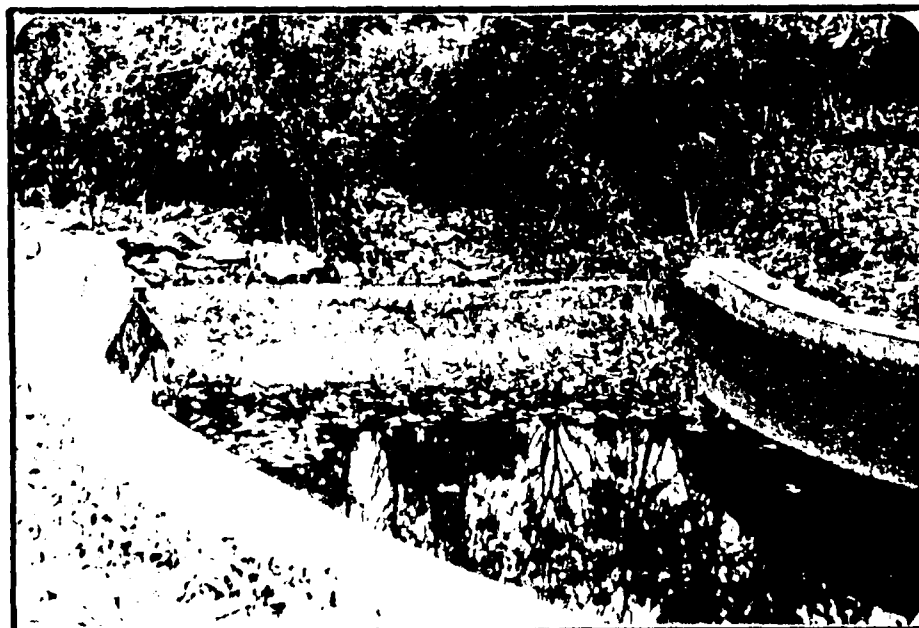
END OF SPILLING BASIN WITH SCREEN - NO. 7

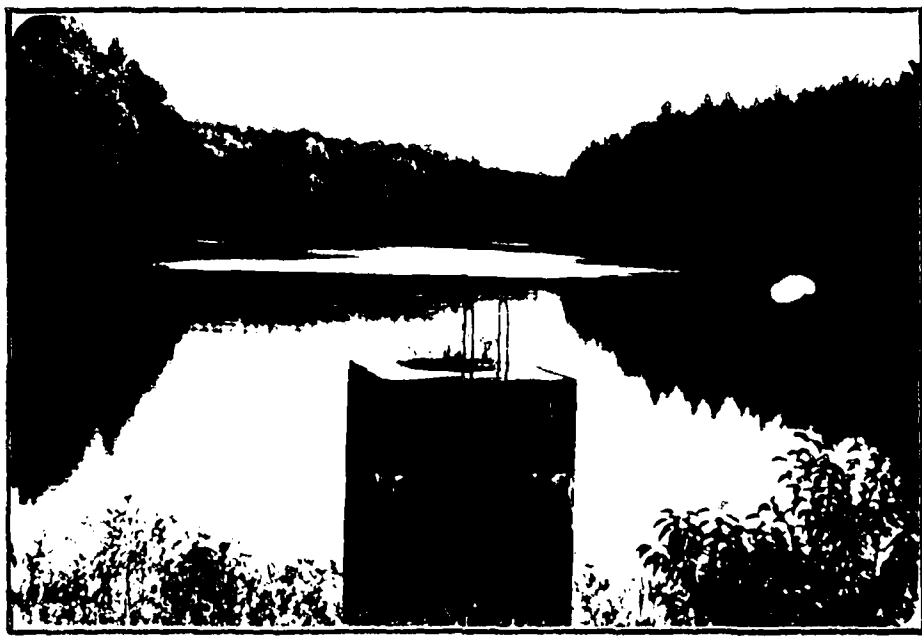
The control tower (Photograph No. 8) is located near the upstream toe and is accessible only by boat. The gate control in this structure, to operate the blow off, has not been used in at least 20 years. The blow-off pipe outlets into the spillway discharge channel. This is a variation from the design drawings.

RESERVOIR AREA AND INTAKE STRUCTURE - NO. 8
