LAKE CAROLINE DAM

PHASE I INSPECTION REPORT.

NATIONAL DAM INSPECTION PROGRAM.

FEBRUARY 1981

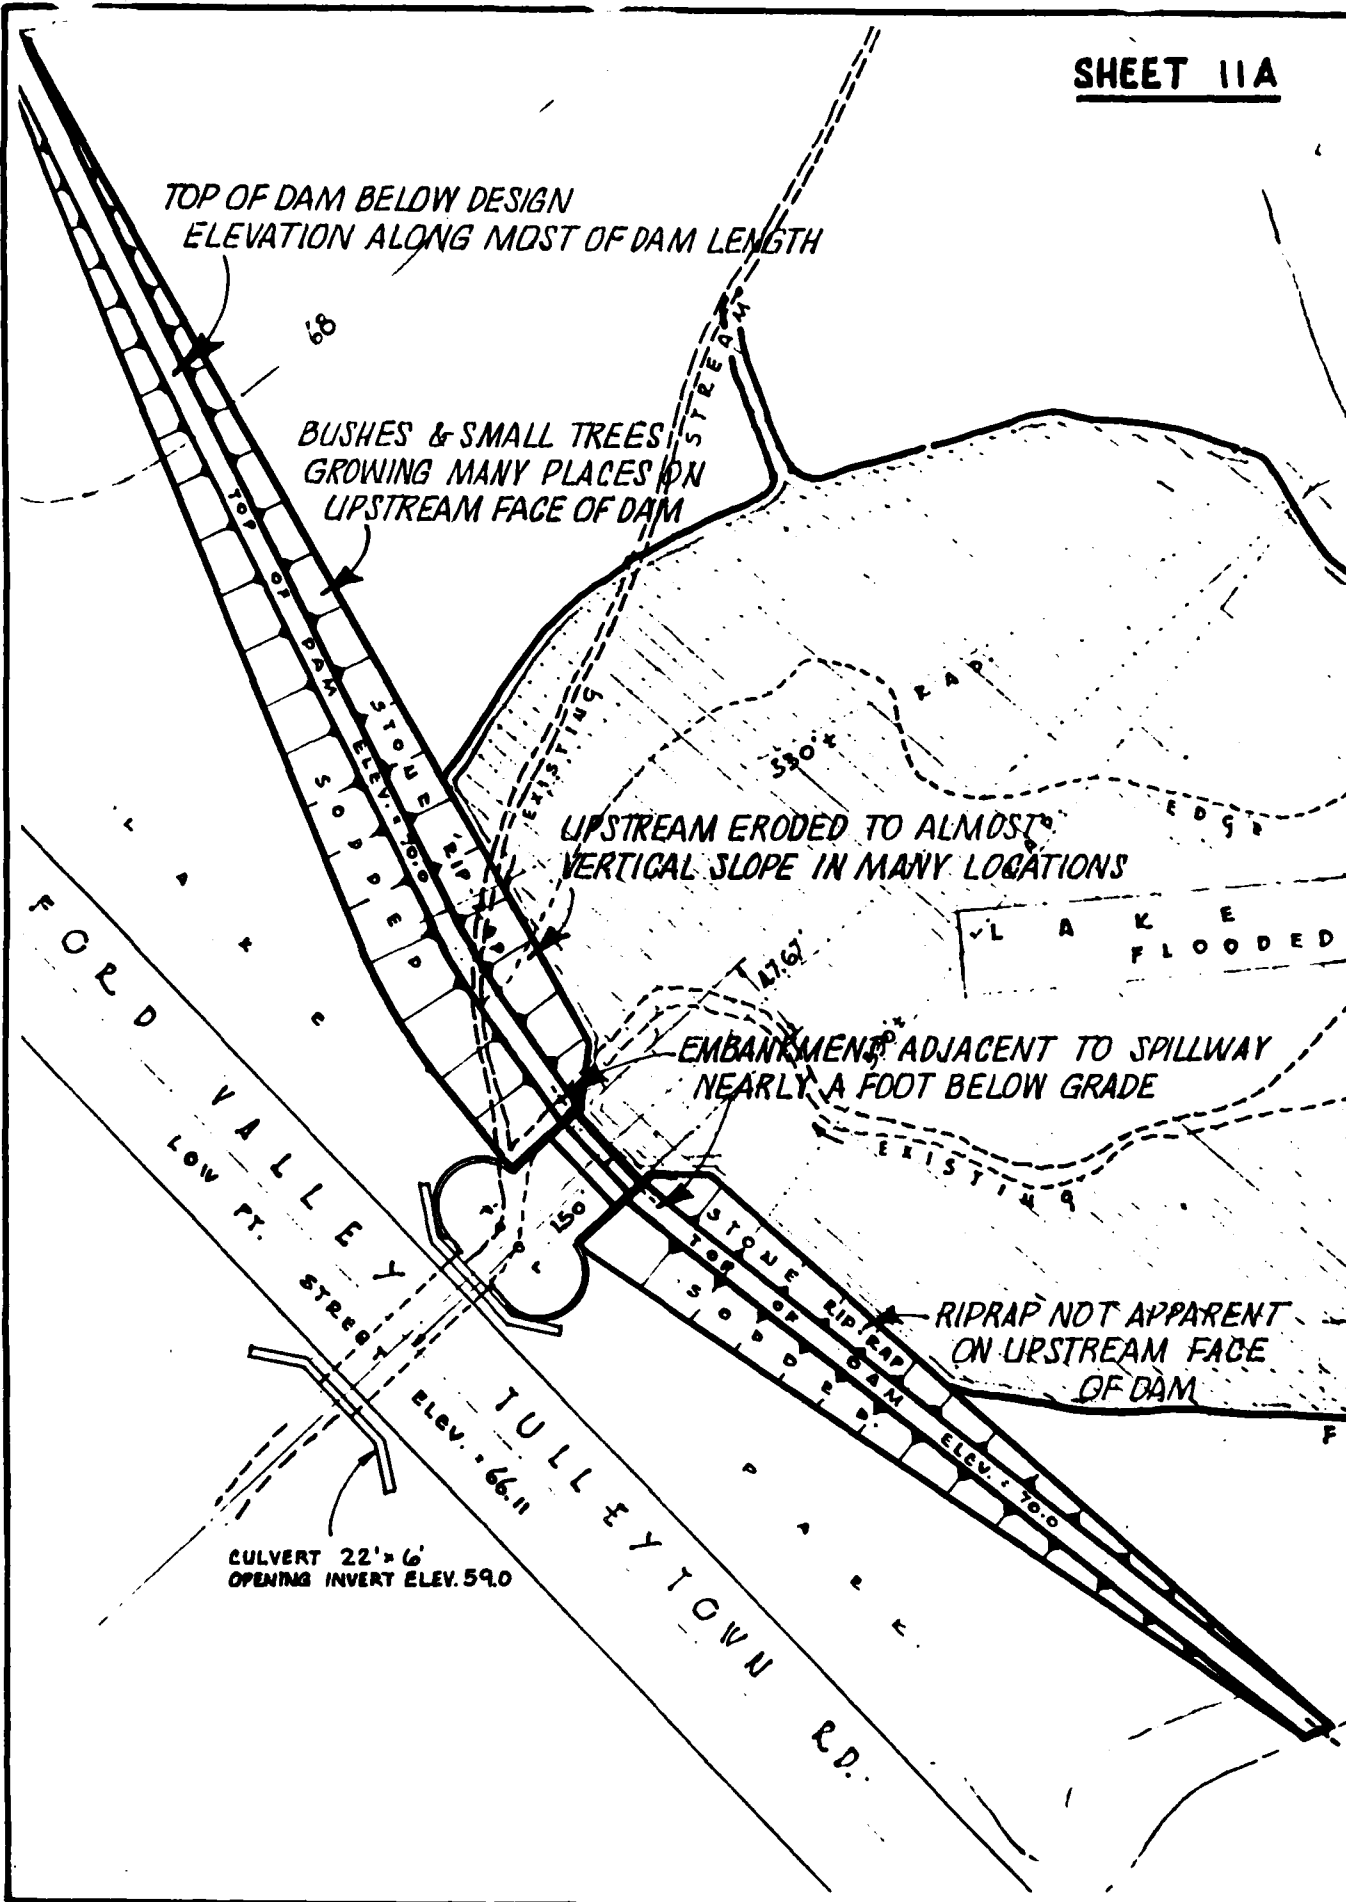
PROJECT Lake Caroline Dam, Field Observation Profile	SHEET 11B	BY R. R. B.	DATE 12/23/80	JOB NO. 1841-014
---------------------------------------------------------	--------------	----------------	------------------	---------------------

RIPRAP NOT APPARENT
ON UPSTREAM FACE
OF DAM

CULVERT 22' x 6'
OPENING INVERT ELEV. 59.0
