NATIONAL DAM INSPECTION PROGRAM. NORTH LAKE DAM

PENNSYLVANIA  
NORTH LAKE DAM

NDI I.D. NO. PA-00268,  
PENNDER I.D. NO. 52-180

PHASE I INSPECTION REPORT,  
NATIONAL DAM INSPECTION PROGRAM

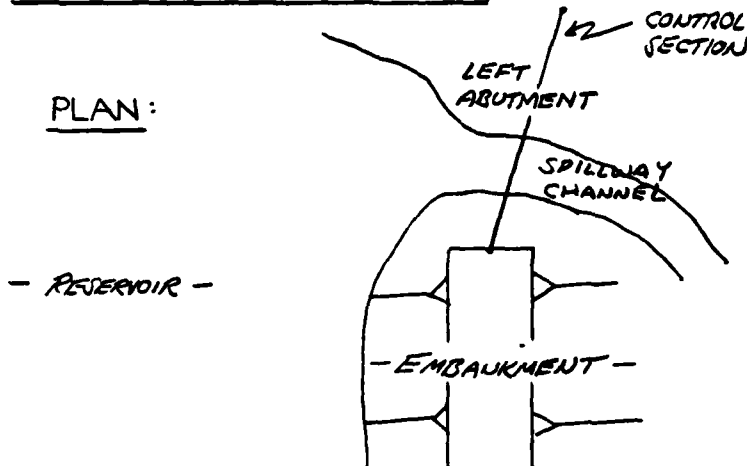
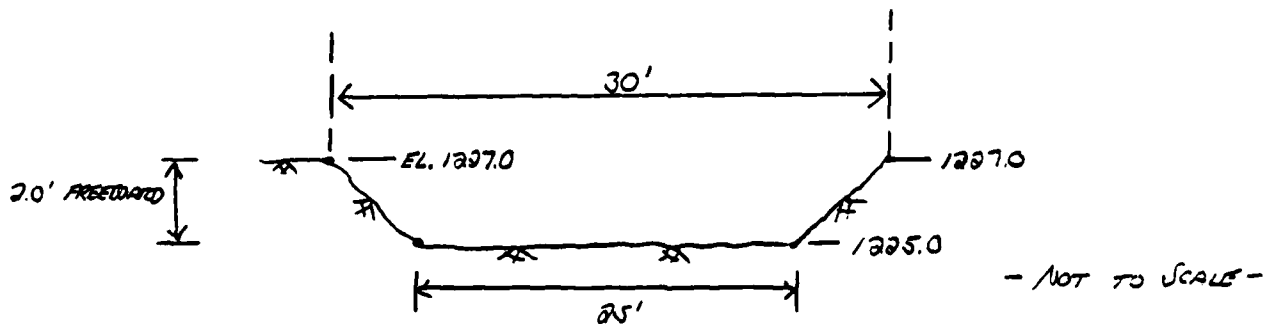
## SPILLWAY CAPACITY

THE SPILLWAY CONSISTS OF AN UNCONTROLLED, ROUGHLY TRAPEZOIDAL CHANNEL CUT THROUGH SOIL AND ROCK AT THE LEFT ABUTMENT. AT THE TIME OF INSPECTION, THERE WAS A SMALL EARTH AND ROCK DIKE CONSTRUCTED ACROSS THE SPILLWAY CHANNEL, FOR THE PURPOSE OF RAISING THE RESERVOIR LEVEL. IT WILL BE ASSUMED IN THE SPILLWAY COMPUTATIONS THAT THE SMALL DIKE IS REMOVED (THE AVAILABLE FREEBOARD WITH THE DIKE IN PLACE IS ONLY 0.2 FT, RESULTING IN A GREATLY REDUCED SPILLWAY CAPACITY).
