LOWER ALFORD LAKE DAM

NDI No. PA 00053

PHASE I INSPECTION REPORT.  
NATIONAL DAM INSPECTION PROGRAM

Lower Alford Dam, Susquehanna County, Pennsylvania  
NDI No. PA 00053, PennDER No. 58-47  
Martins Creek  
Inspected 30 October 1980

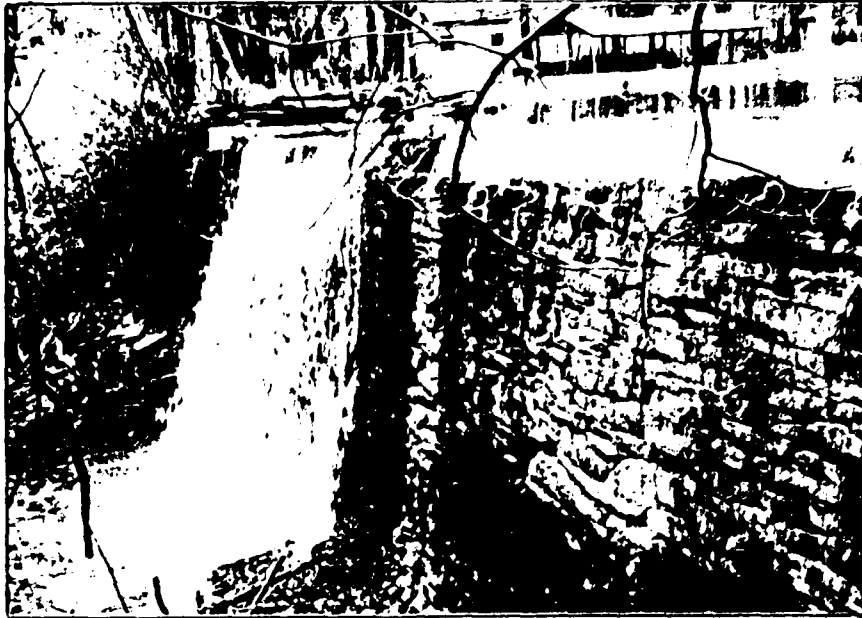
- b. Dam - Some trees and brush were observed on the right downstream face of the dam. These should be cut.
- c. Appurtenant Structures - The spillway crest is slightly irregular, however, this should not significantly affect the performance of the spillway.

PHOTO 5. View of Downstream Side of Dam from Left Abutment

- 1) Initiate an engineering study to further evaluate the spillway capacity in order to develop recommendations for remedial measures to eliminate the overtopping potential of the dam.
- 2) Cut the brush and trees located on the right downstream face of the dam.
- 3) Remove the debris and cut the vegetation in the downstream channel.
- 4) Provide means to draw down reservoir during an emergency.
