DEER LAKE DAM

(NDI ID NO. PA-00698,  
DER ID NO. 64-202)

PHASE I INSPECTION REPORT  
NATIONAL DAM INSPECTION PROGRAM

JANUARY 1981

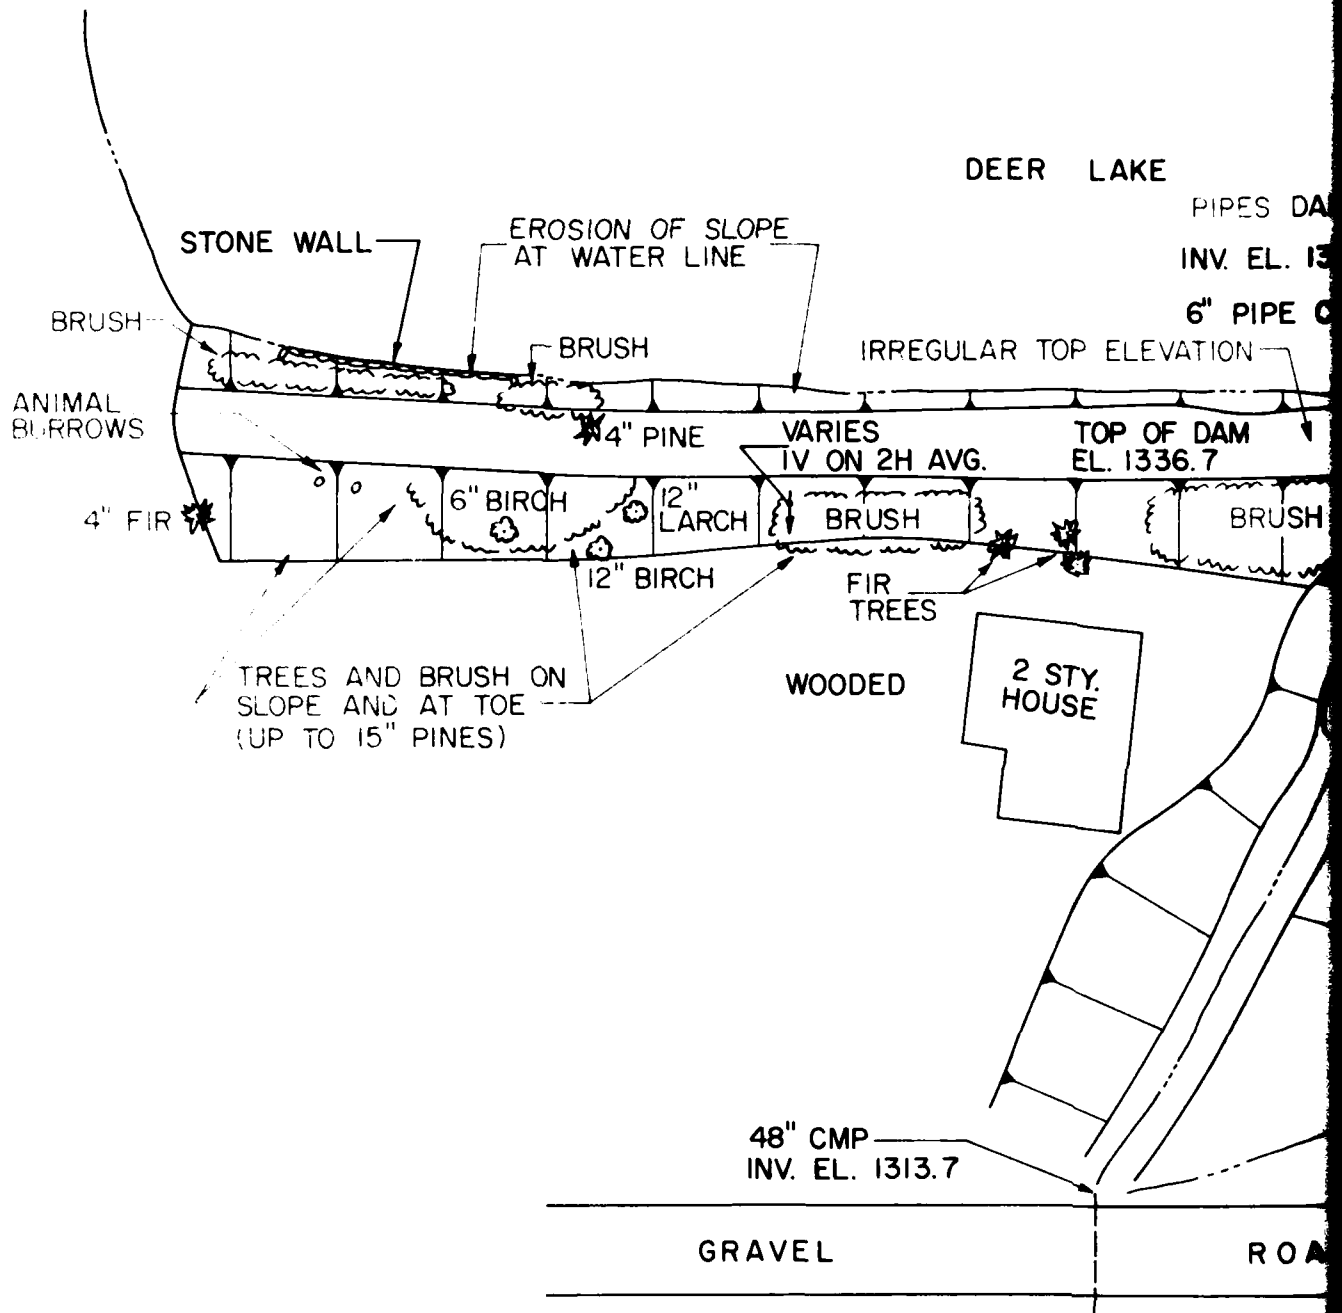
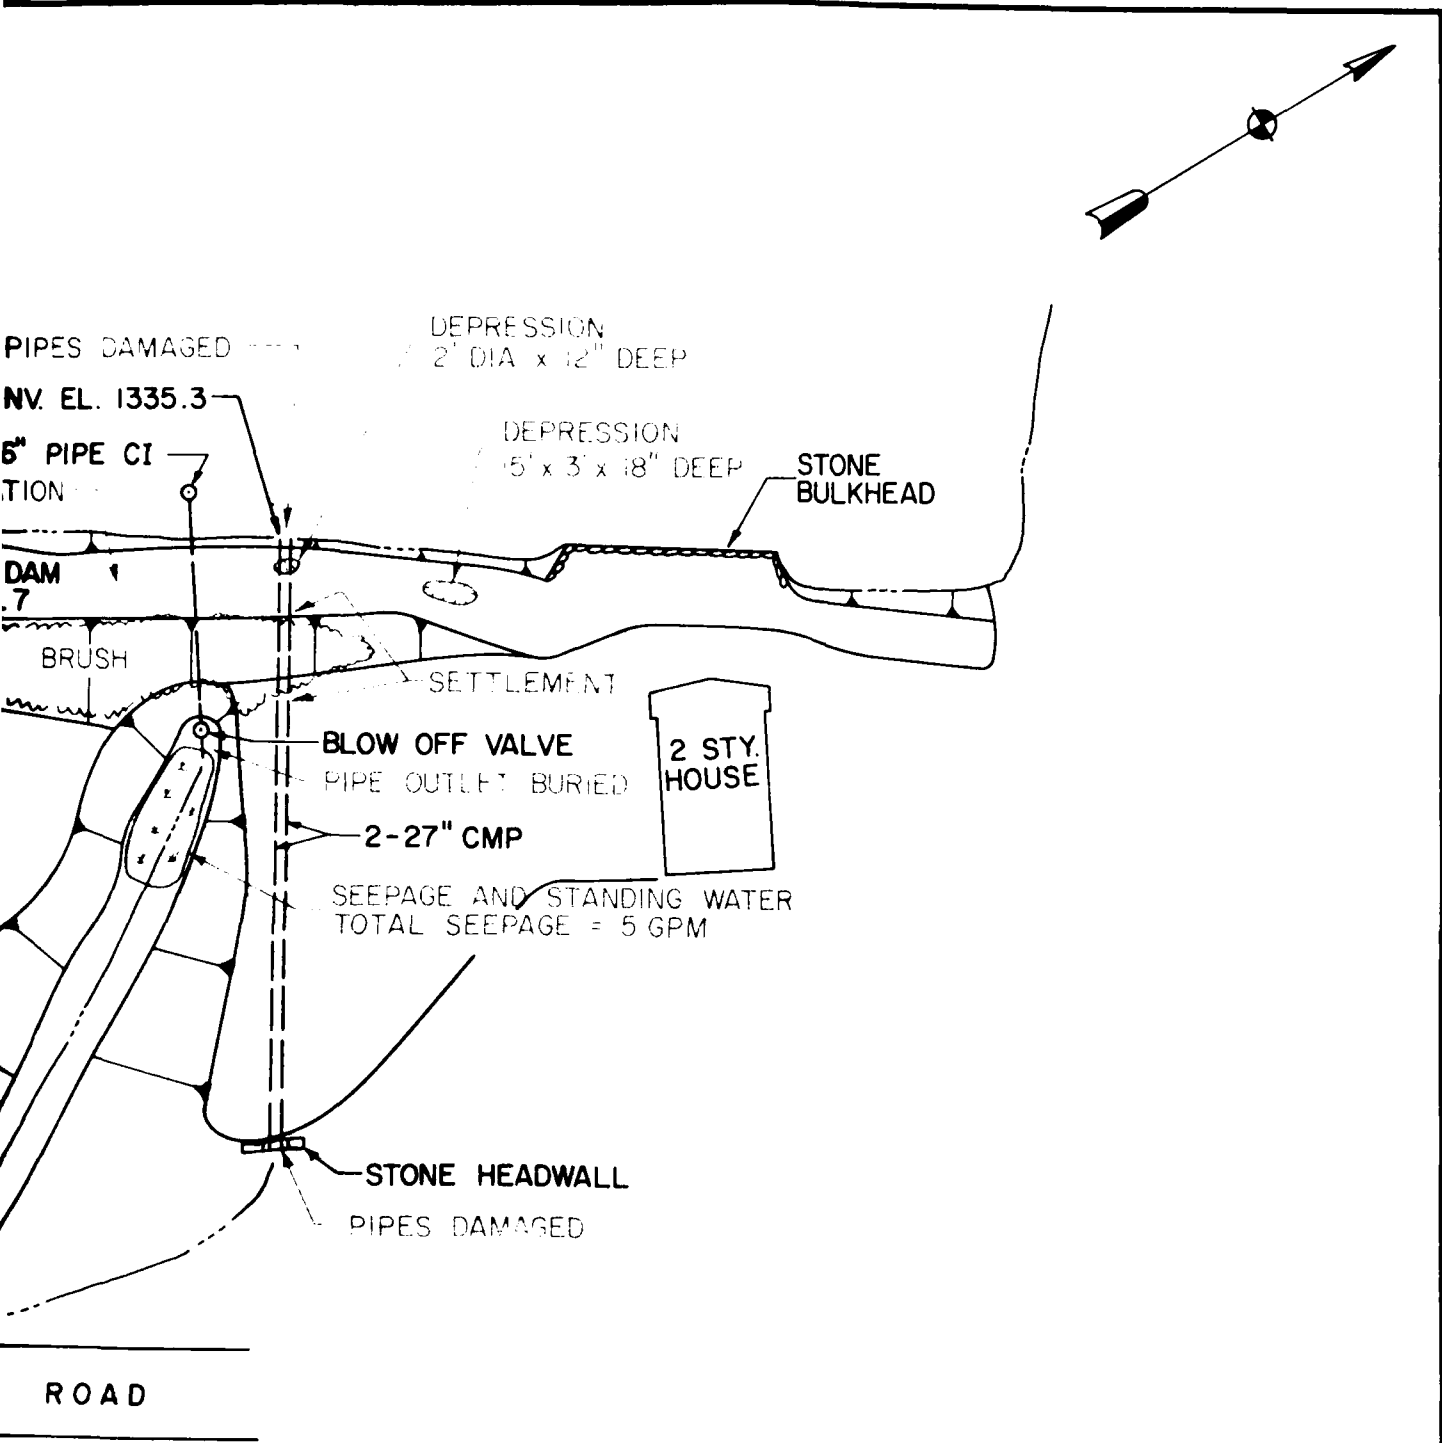
PHASE I INSPECTION REPORT  
 NATIONAL DAM INSPECTION PROGRAM  
 DEER LAKE DAM  
 WALLEMPAUPACK LAKE ESTATES  
 RESULTS OF  
 VISUAL INSPECTION  
 JANUARY 1981 EXHIBIT B-1

a. General. The overall appearance of the dam is fair. Some deficiencies were observed as noted below. A sketch of the dam with the locations of the deficiencies is presented on Exhibit B-1 in Appendix B. Survey information acquired for this Report is summarized in Appendices B and E. Datum for the survey was taken at the water surface, Elevation 1335.0, which is also the elevation of the 6-inch diameter cast iron pipe outlet.

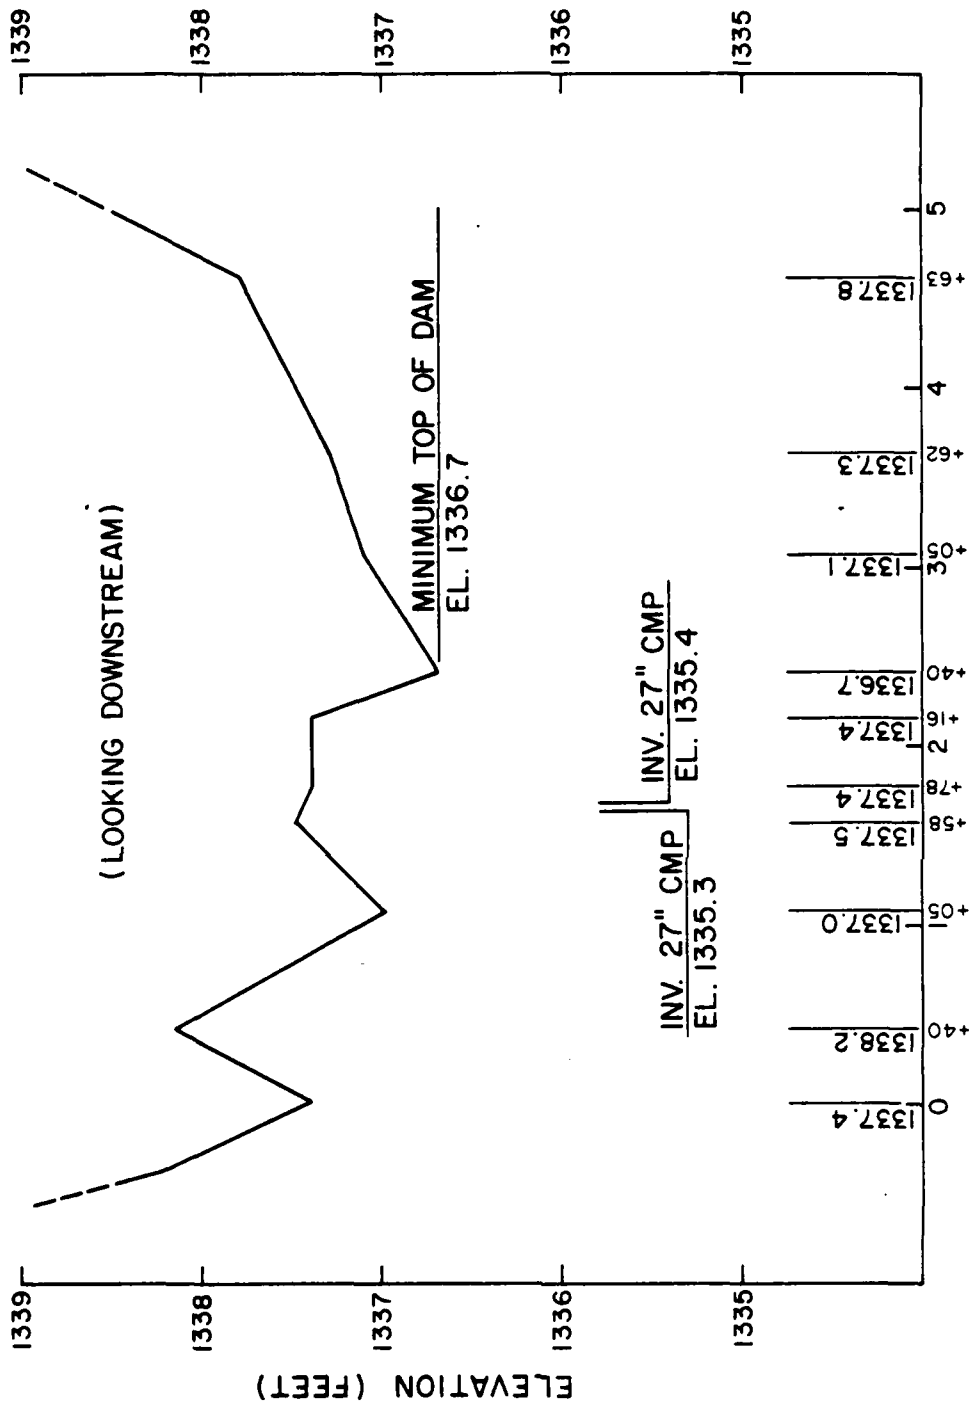
PHASE I INSPECTION REPORT  
 NATIONAL DAM INSPECTION PROGRAM  
 DEER LAKE DAM  
 WALLENPAUPACK LAKE ESTATES  
 PROFILE-TOP OF DAM  
 JANUARY 1981  
 PLATE E-2

b. Embankment. The embankment is in generally fair condition. The upstream slope has eroded at the waterline over the entire length of embankment. The top of dam is very irregular and varies in elevation from 1336.7 to 1338.2. The results of the survey performed for this inspection are shown on Plate E-2. Two low areas were observed on the top of dam in the vicinity of the spillway and outlet pipes. One area, about 120 feet from the left abutment is 15 feet x 3 feet x 18 inches deep (Photograph F). A second area is about 12 inches low and is located over the spillway pipes. Seepage was observed at the toe of the dam in the excavated channel for the 6-inch diameter outlet pipe (Photograph E). Trees and brush cover the upstream and downstream slopes particularly on the right half of the dam. Numerous pine trees grow along the toe and on the downstream slope (Photograph D). Animal burrows were observed on the downstream slope near the right abutment.
