LAKE ELLYN DAM

(NDI ID NO. PA-00138
DER ID NO. 64-32)

PHASE I INSPECTION REPORT
NATIONAL DAM INSPECTION PROGRAM

LAKE ELLYN DAM
 NDI ID No. PA-00138, DER ID No. 64-32
 PHASE I INSPECTION REPORT
 NATIONAL DAM INSPECTION PROGRAM

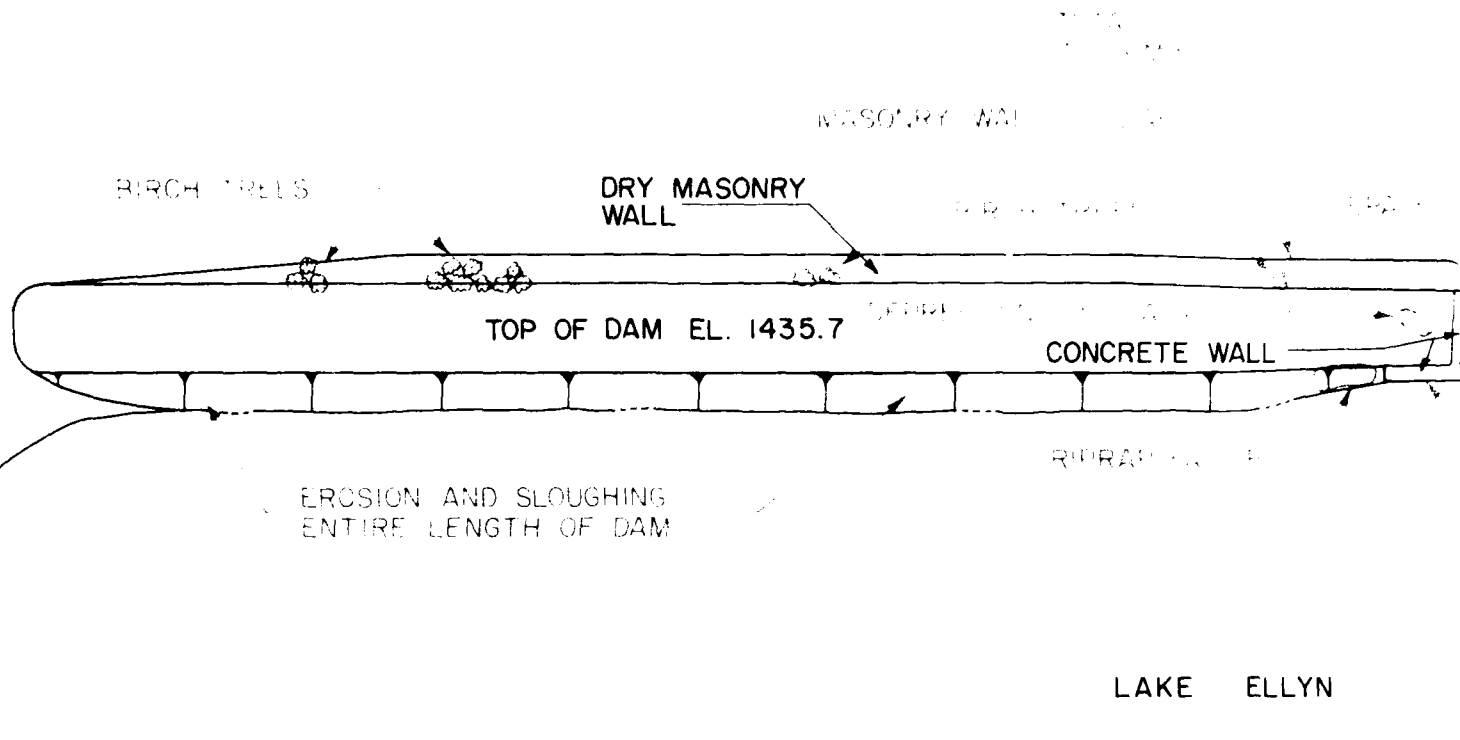
a. General. The overall appearance of the dam is poor. Some deficiencies were observed as noted below. A sketch of the dam with the locations of the deficiencies is presented on Exhibit B-1 in Appendix B. Survey information acquired for this Report is presented in Appendices B and E. Datum for the survey was taken at the spillway crest, elevation 1434.0. On the day of the inspection the pool was at elevation 1433.4.

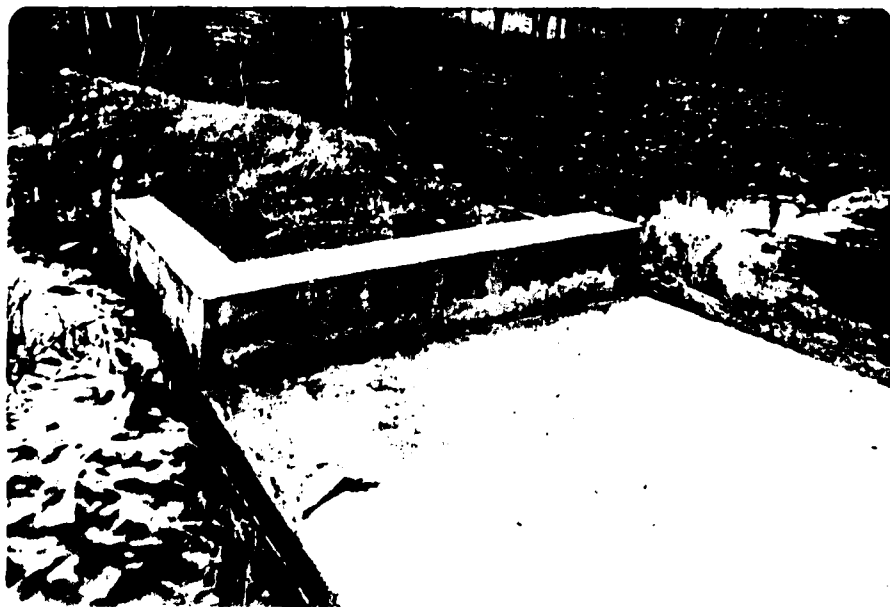
c. Appurtenant Structures. Physically the spillway is in fair condition (Photographs D, E and F). The left concrete wingwall on the upstream end of the spillway is spalled at the base. Some minor cracking of the left wall is evident. The spalling and cracking of the spillway walls is of no concern at the present time. The foundation for the spillway slab is uncertain but the spillway appears to have been constructed directly on the earthfill and masonry sections of the dam. The spillway discharges in a straight drop to the natural stream channel. Rock, logs, and debris cover the channel just downstream from the dam.

D. Spillway

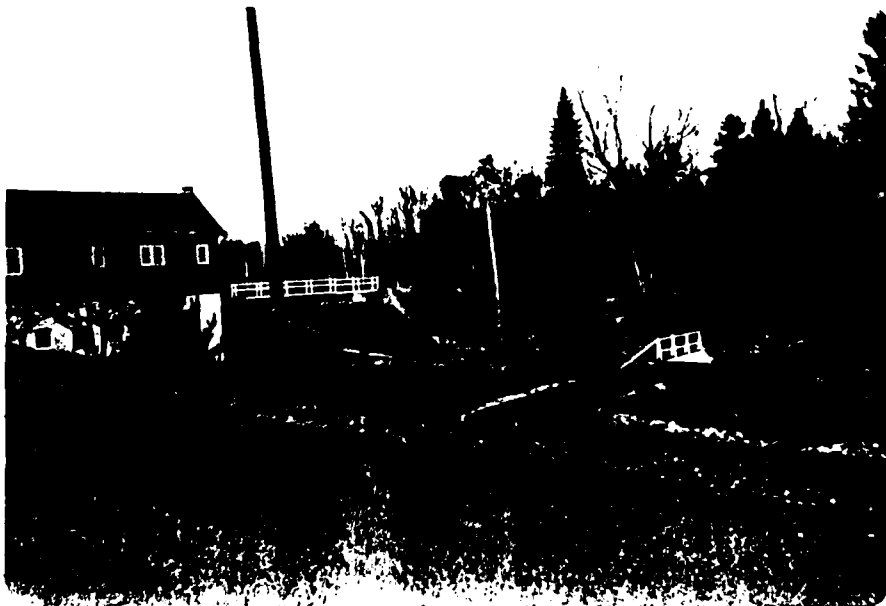
H. Craft Pond Dam - Two Miles
Downstream
