LAKE LEHIGH DAM

(NDI ID <sup>Number</sup> PA-00151  
DER ID <sup>Number</sup> 64-51)

PHASE I INSPECTION REPORT.  
NATIONAL DAM INSPECTION PROGRAM

GANNETT FLEMING CORDDRY AND CARPENTER, INC.  
Consulting Engineers  
P.O. Box 1963  
Harrisburg, Pennsylvania 17105

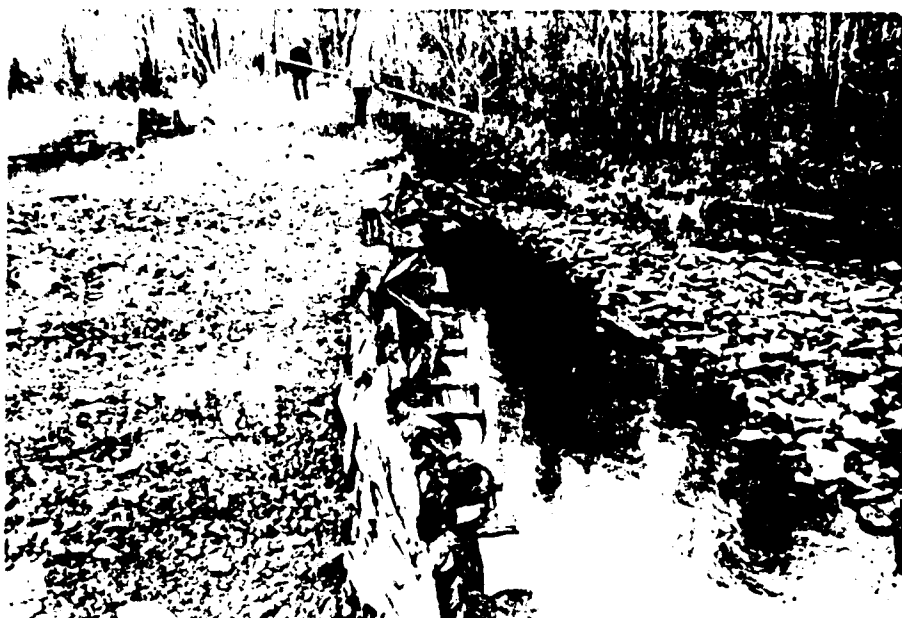
c. Principal Spillway. The timbers forming the spillway are very badly deteriorated. This is probably the result of continuous wetting and drying during the 80-year life of the structure. The crest of the spillway has been altered substantially from its original configuration. This alteration was probably performed in an attempt to delay deterioration of the structure. The crest is now surfaced with stone and small rock and is contained on the downstream edge by wooden planks and corrugated sheet metal. The vertical wooden planks at each end of the spillway are also badly deteriorated which tends to create voids within the dam. Although the downstream toe of the structure was submerged, it is estimated that a substantial percentage of the total seepage from the dam is flowing under or through the spillway. Overall the spillway is in very poor condition.

C. Crest of principal spillway looking toward left abutment.
