NDI ID PA-00803

VILLAGE TWO AT NEW HOPE DAM

PHASE I INSPECTION REPORT
NATIONAL DAM INSPECTION PROGRAM

Name of Dam:	Village Two at New Hope Dam
State Located:	Pennsylvania
County Located:	Bucks County
Stream:	Unnamed tributary of Delaware River
Coordinates:	Latitude N 40° 21.5', Longitude W 74° 57.3'
Date of Inspection:	December 15, 1980

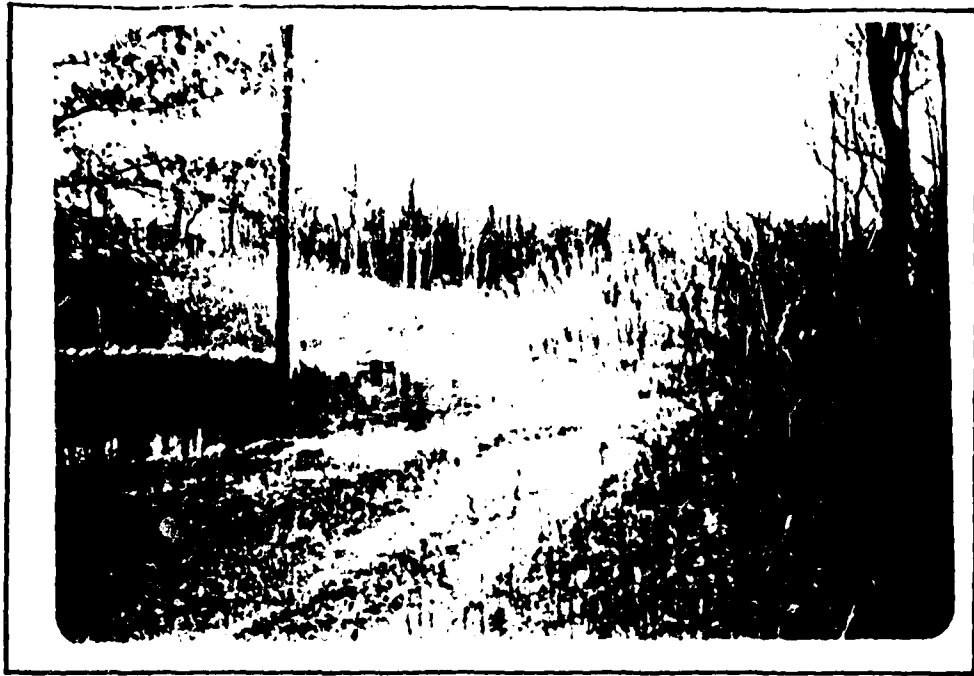
UPSTREAM OVERVIEW FROM THE RIGHT ABUTMENT.

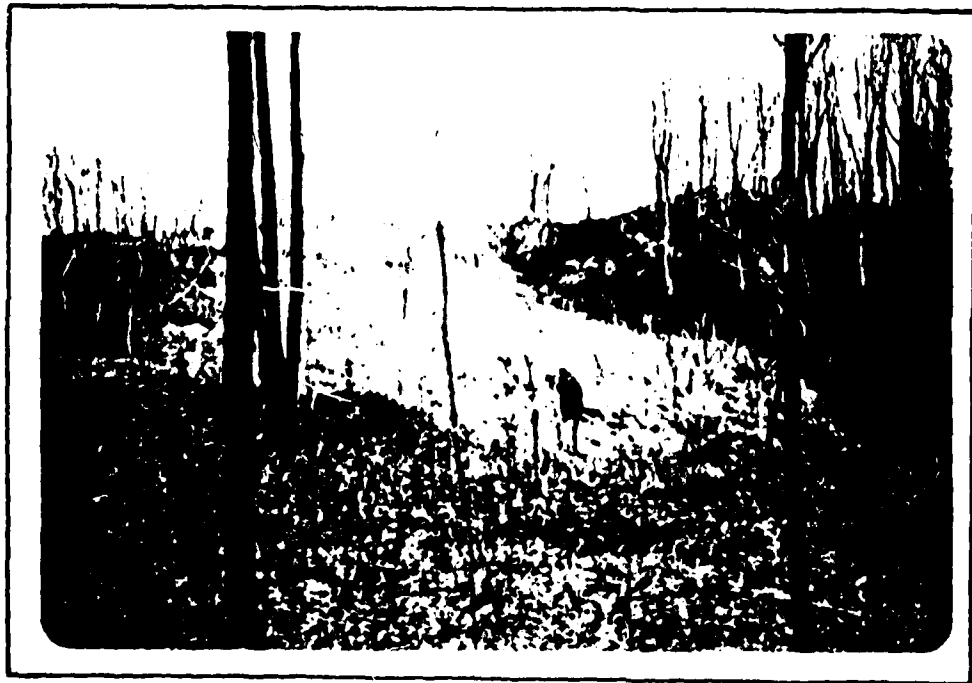
DOWNSTREAM OVERVIEW FROM THE RIGHT ABUTMENT.

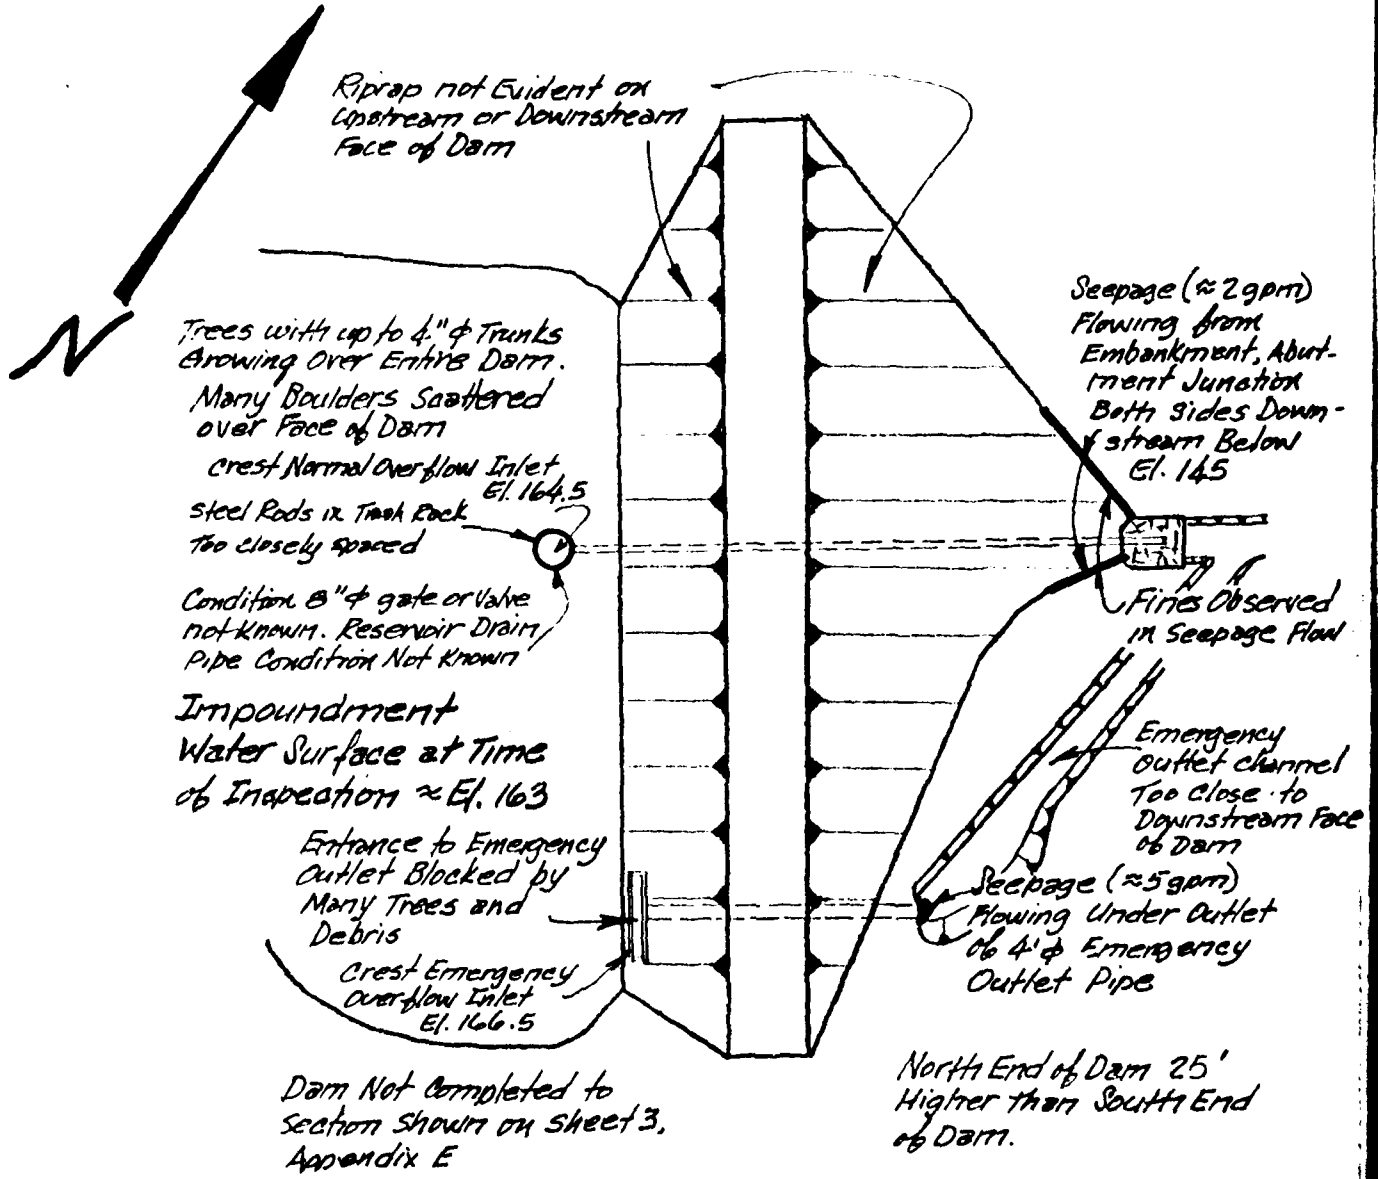
Riprap not Evident on Upstream or Downstream Face of Dam

Trees with up to 4" ϕ Trunks Growing Over Entire Dam.
Many Boulders Scattered over Face of Dam
Crest Normal Overflow Inlet El. 164.5
Steel Rods in Trash Rack Too closely spaced

Condition 8" ϕ gate or valve not known. Reservoir Drain Pipe Condition Not Known

Fines Observed in Seepage Flow

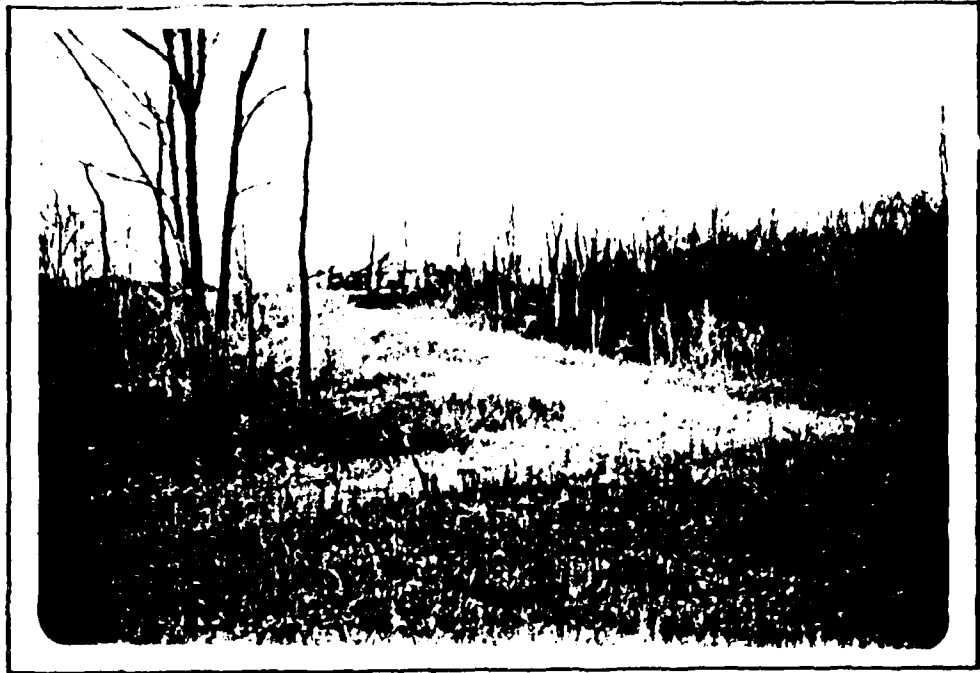
a. Visual Observations. The top of the dam, which has a variable width averaging about 40 feet, is used as a roadway and contains no vegetative cover. The slopes of the upstream and downstream faces of the embankment are very irregular and contain small trees (up to 4-inch diameter trunks) and thick brush. No riprap is present on the upstream face. The riprap on the downstream face is randomly placed and ranged in size from four inch rock to 5-foot boulders. Seepage (2 gpm in each case) was observed at the downstream embankment, abutment junctions below El. 145 and around the 30-inch diameter normal spillway outlet pipe. Seepage (5 gpm) was observed flowing from beneath the outlet end of the four foot diameter emergency overflow spillway outlet pipe.

1. VIEW ALONG THE TOP OF THE DAM FROM
THE RIGHT ABUTMENT. (12/15/80)

1. The right side of the embankment should be built up to the design top of dam Elev. 170 and both the upstream and downstream faces of the embankment

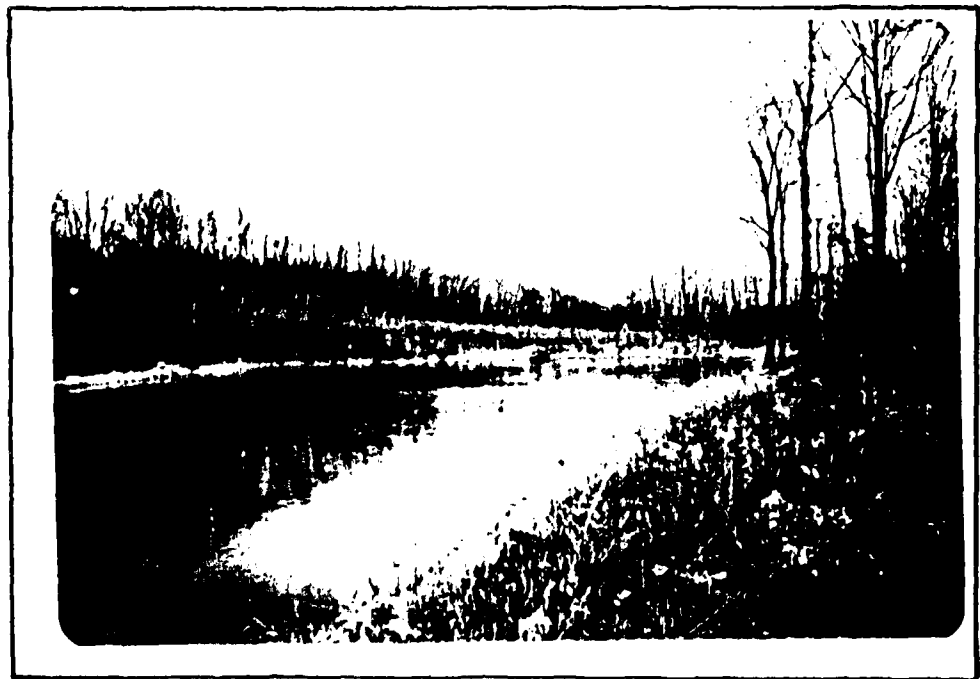
2. IMPOUNDMENT WITH DAM IN THE BACKGROUND
SHOWING VARIATION IN TOP OF DAM ELEVATION.
(12/15/80)

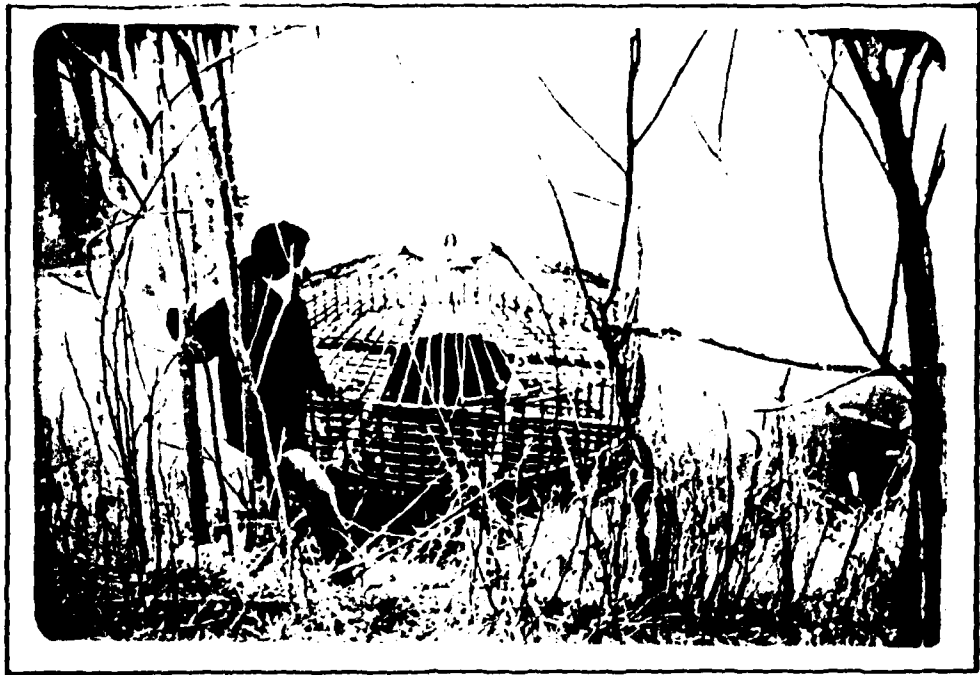
c. Appurtenant Structures. The 36-inch diameter steel riser pipe of the normal overflow spillway appears to be in good condition. Steel rods on the trash rack are too closely spaced, thus discharge would be impeded because of trash build-up. The 8-inch diameter gate valve could not be examined because it is at the base of the 21-foot intake tower. The trash rack must be removed to gain access to the intake riser. No valve stem was observed. The 30-inch diameter steel outlet pipe and the outlet channel appear to be in satisfactory condition.

3. NORMAL OVLRFLOW SPILLWAY ENTRANCE
WITH STEEL ROD TRASHRACK .(12/15/80)

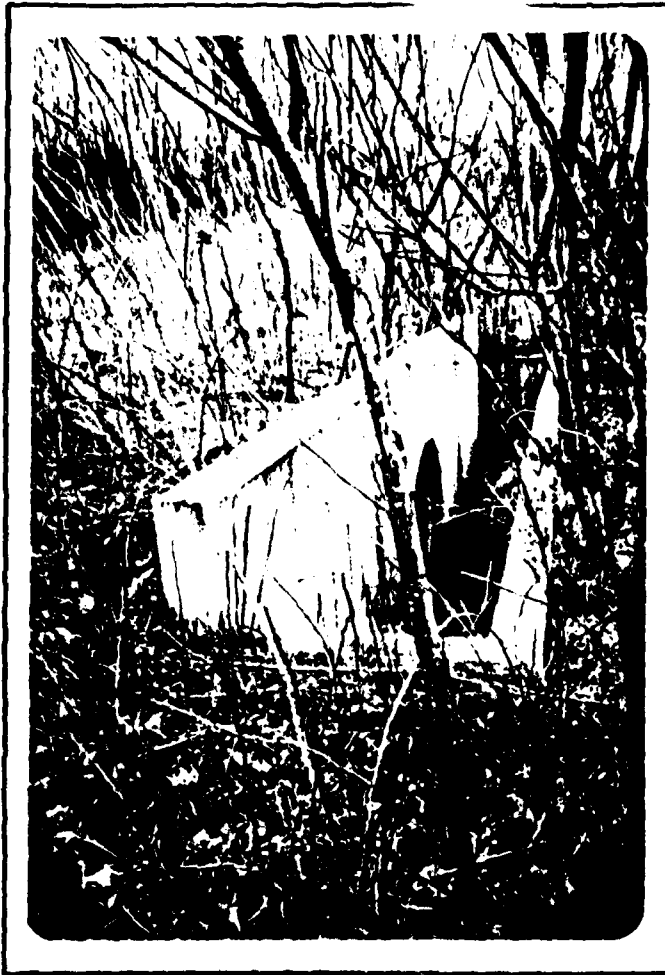
Small trees (up to 4-inch diameter trunks) and brush obstruct flow to the emergency overflow spillway inlet structure. The emergency overflow inlet structure appears to be in good condition except for some honeycombing observed in the concrete. Gaps were left around the perimeter of the 48-inch diameter reinforced concrete outlet pipe where it joins the downstream wall of the inlet structure (see Appendix C, Photographs No. 6). The invert of the four foot outlet pipe is about 26 feet above the valley floor where it outlets on the right abutment downstream within a few feet of the downstream face of the dam. Discharge from the emergency overflow spillway outlet pipe would tend to erode the downstream

5. ENTRANCE TO EMERGENCY
OVERFLOW SPILLWAY.
(12/15/80)

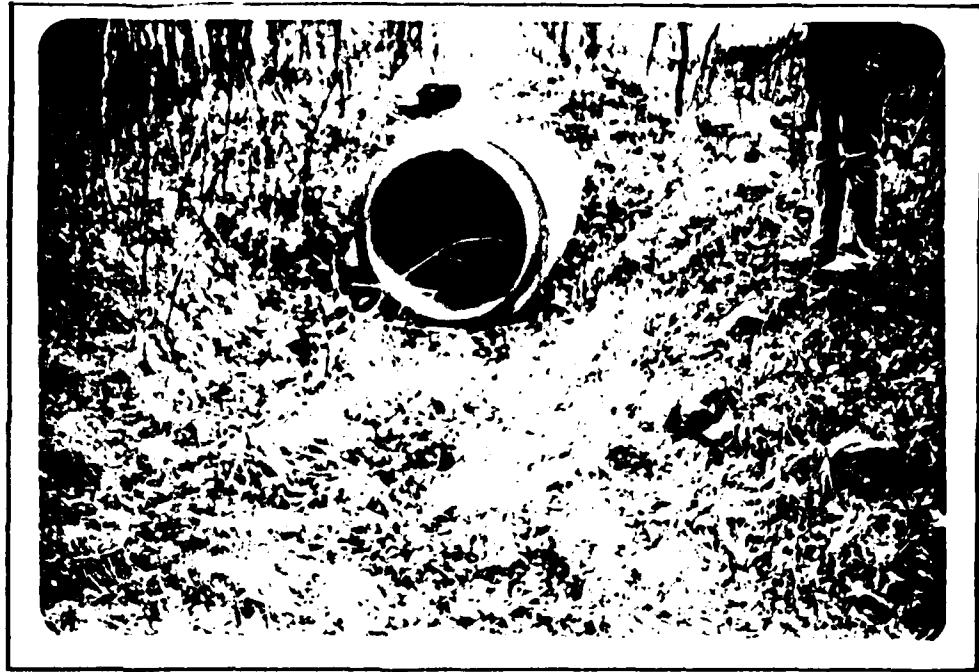
The invert of the outlet of the emergency overflow spillway four foot diameter outlet pipe is located about 26 feet above the outlet channel near the downstream face of the dam. Discharge from the outlet pipe would flow over the unprotected embankment. The fitting of this pipe into the emergency overflow spillway inlet structure's downstream wall is in poor condition.

7. OUTLET OF 48-INCH DIAMETER EMERGENCY SPILL-
WAY PIPE .(12/15/80)

4. Provisions should be made to insure that discharge from the 48-inch diameter emergency overflow spillway outlet pipe will not damage the downstream embankment. Repairs should be made to the connection of this pipe into the downstream wall of the emergency overflow spillway inlet structure.
