CRYSTAL LAKE DAM

NDI ID NO. PA-00096
DER ID NO. 64-6

PHASE I INSPECTION REPORT
NATIONAL DAM INSPECTION PROGRAM

JANUARY 1981

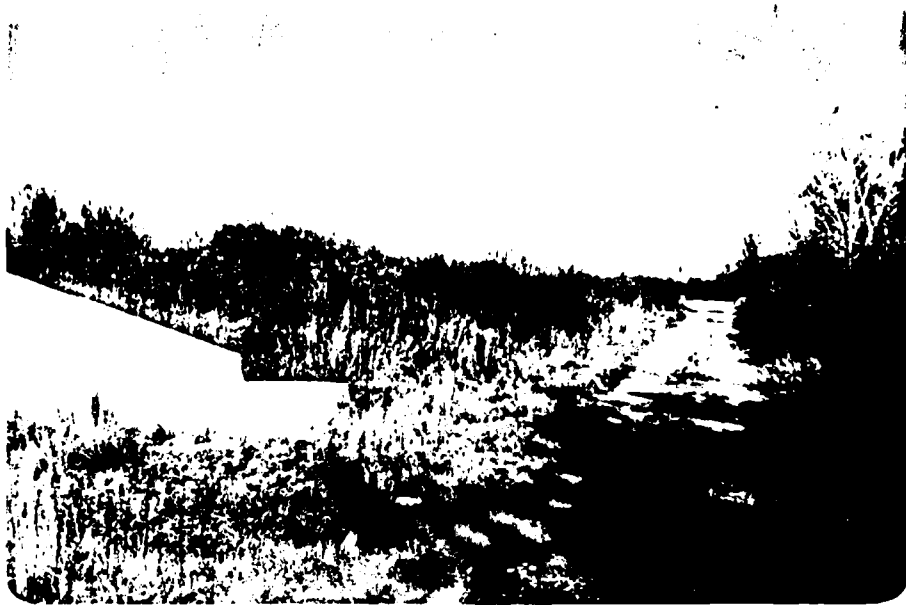
A. Downstream Slope Looking Toward
Left Abutment

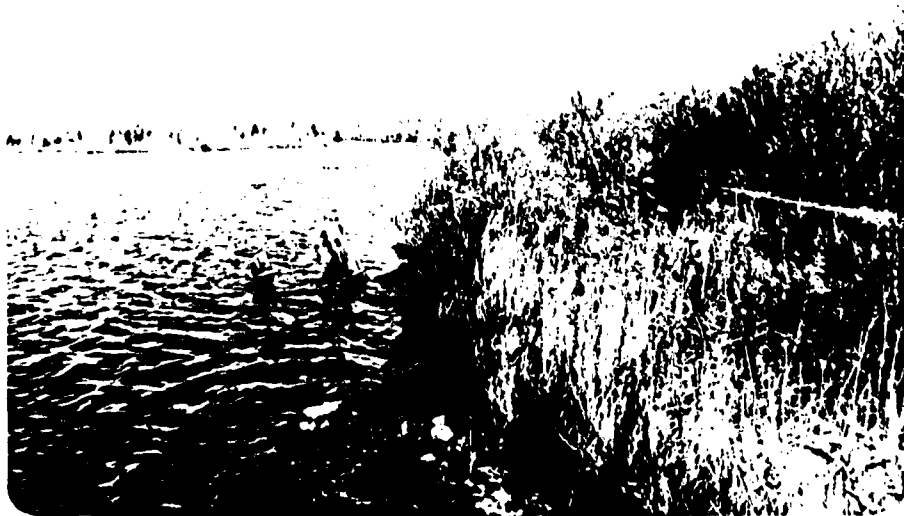
B. Upstream Slope Looking Toward
Left Abutment

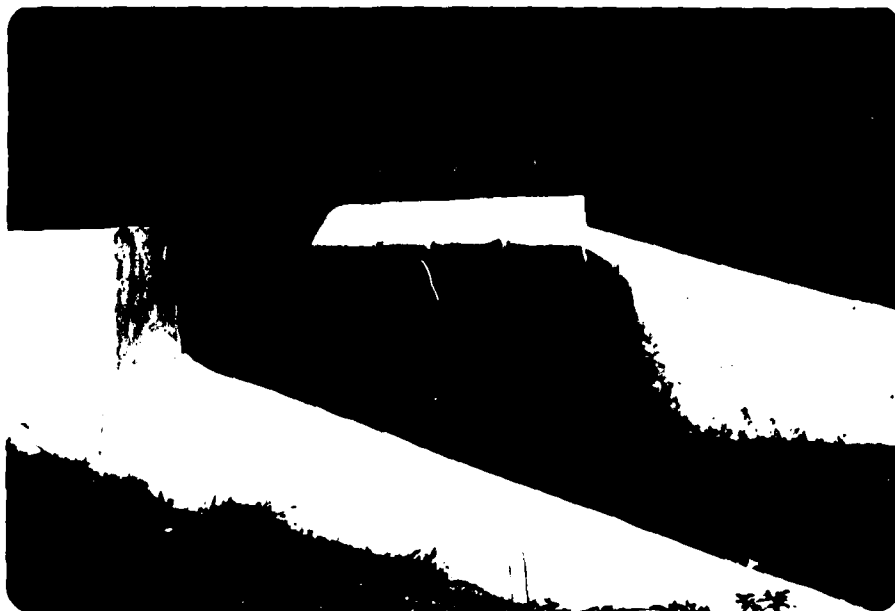
C. Spillway

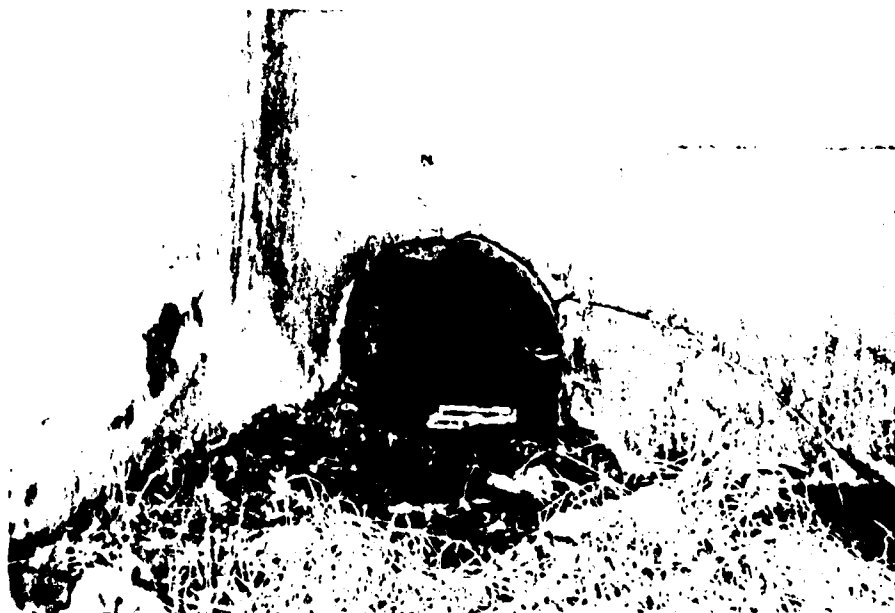
D. Low-level Outlet Pipe

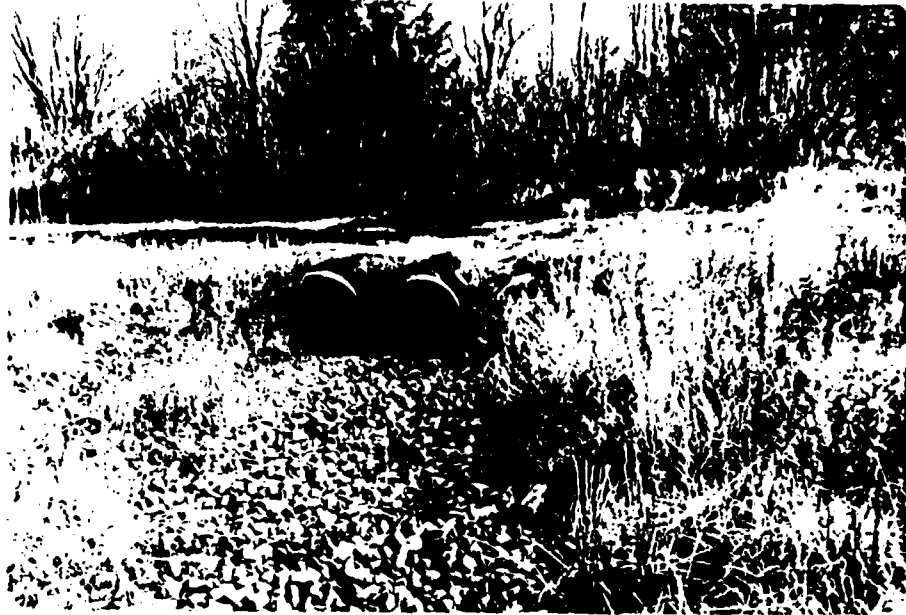
(3) Appurtenant Structures. The condition of the spillway concrete is of concern both structurally and hydraulically and has been discussed in Paragraph 5.1c(3). In addition, the absence of adequate erosion protection in the spillway discharge channel could lead to further undermining of the spillway and subsequent structural problems. The corroded steel outlet pipe is reportedly encased in concrete and is not considered to affect the structural integrity of the dam or spillway.

G. Spillway Discharge Channel

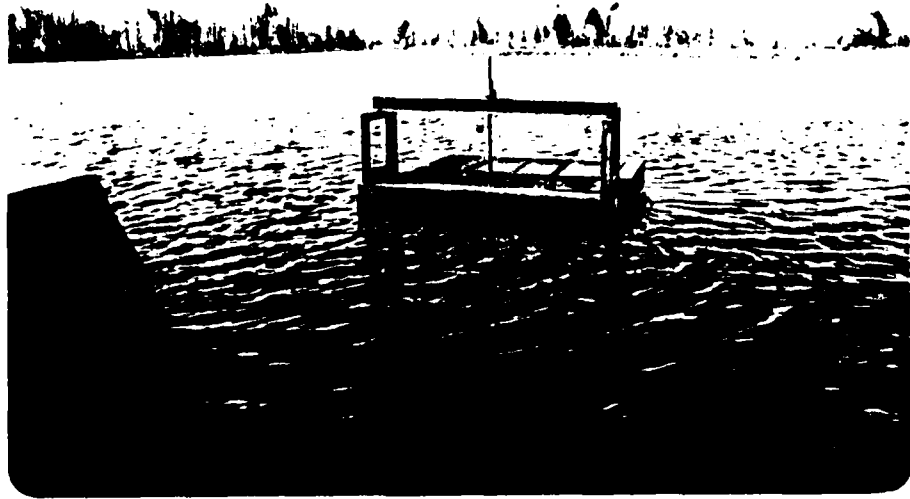
I. Outlet Works Intake Structure

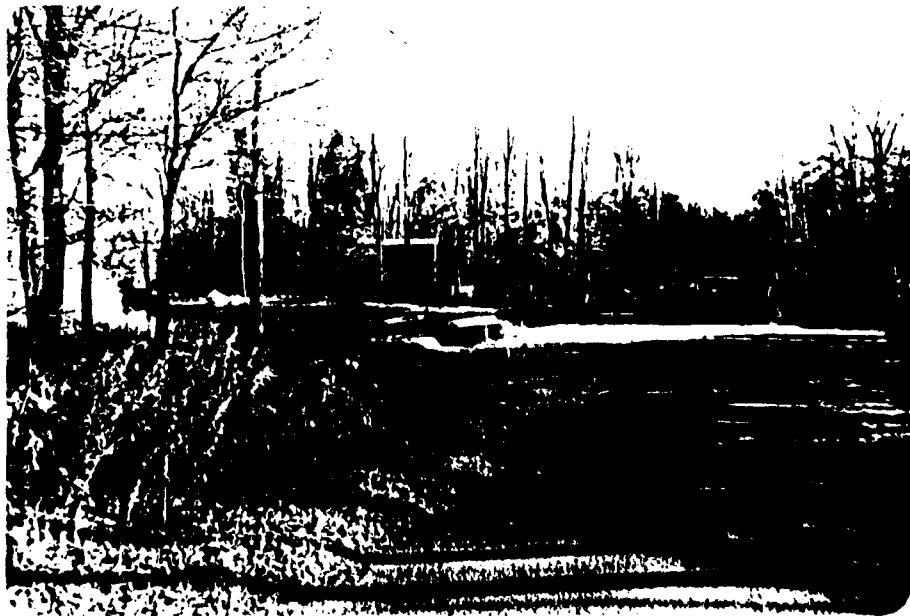
J. "Canoe Harbor" Area
