AD-A097 932 NAVAL RESEARCH LAB WASHINGTON DC  
MB20B BASE STOCK AS TARNISH PROMOTER OR PREVENTOR. (U)  
APR 81 E G SHAFRIN, R J COLTON  
UNCLASSIFIED NRL-MR-4497

| (9) REPORT DOCUMENTATION PAGE | | READ INSTRUCTIONS<br>BEFORE COMPLETING FORM |
|---|---|---|
| 4. TITLE (and Subtitle)<br>MB20B BASE STOCK AS TARNISH PROMOTER<br>OR PREVENTOR | 5. TYPE OF REPORT & PERIOD COVERED<br>Report on one phase of a<br>continuing NRL problem. | |

## MB20B BASE STOCK AS TARNISH PROMOTER OR PREVENTOR

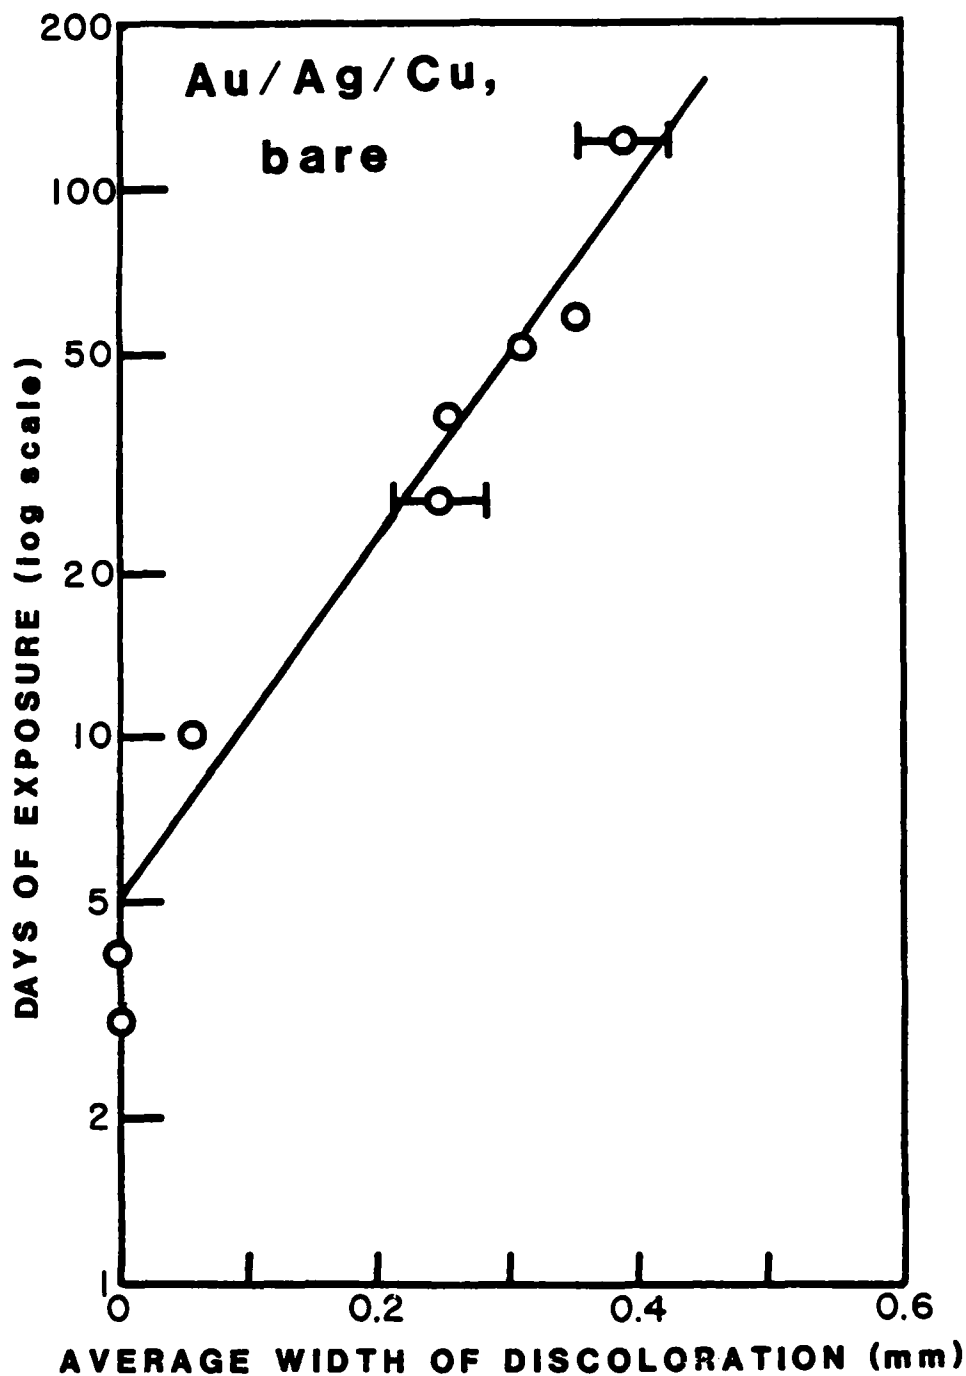
Fig. 1 — Semi-log plot of the rate of growth of the discoloration "halo" parallel to the long sides of a laboratory-induced scar through the gold coating of a bare Au/Ag/Cu reference coupon exposed to the ambient at room temperatures and humidities

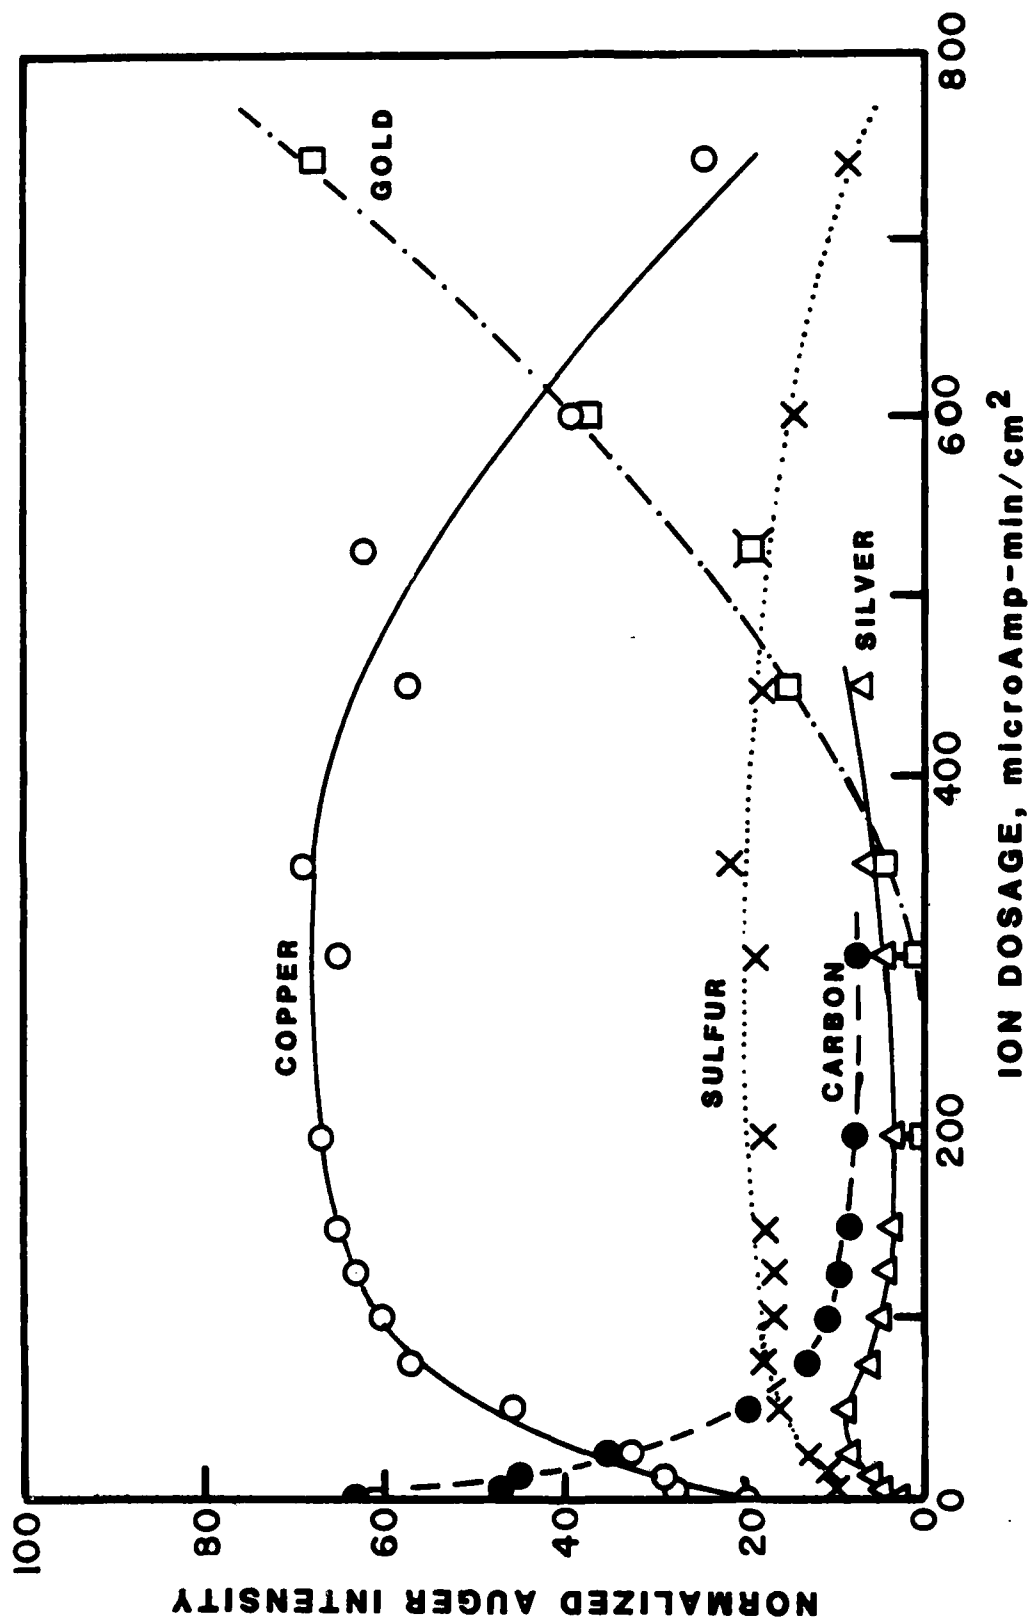
accelerated sulfiding conditions; Cu had been absent, however, when the bare reference coupon had been subjected to long-term, ambient exposure (Table III). In the presence of the formulated oil, sulfiding of the connector resulted in a pronounced enhancement of Cu with no obvious concomitant enhancement of any anionic species. No attempt was made (by ESCA-XPS) to distinguish metallic from ionic copper in the tarnish. Additional evidence for the dominance of the copper constituency in the accelerated-tarnish products on the lubricated connectors comes from depth-profile studies (Fig. 5). Once the carbon contamination has been essentially eliminated by a brief sputtering (~2 minutes at 25  $\mu\text{A}/\text{cm}^2$ ), the Cu concentration rose far more than did the Ag; also, the high Cu concentration persisted to considerable depth.

Fig. 5 - Auger/sputter depth profile of a new Au/Ag/Cu female connector after exposure to H<sub>2</sub>S with MIL-L-81846 present (#7 of Tables I and VI)
