**N.J. NO NAME**

**DAM NO. 50**

**(NJ 00814)**

**PHASE 1 INSPECTION REPORT.**  
**NATIONAL DAM SAFETY PROGRAM**

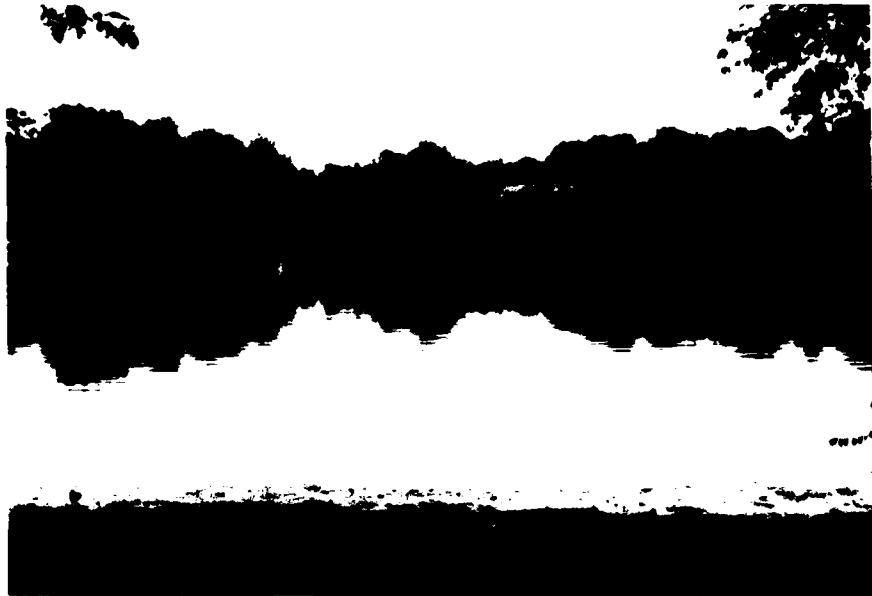
View of Lake from Dam Crest
