PASSAIC RIVER BASIN,  
VAN WINKLE BROOK, UNION COUNTY,  
NEW JERSEY.

# BRIANT PARK DAM

(NJ 00784)

## PHASE 1 INSPECTION REPORT. NATIONAL DAM SAFETY PROGRAM

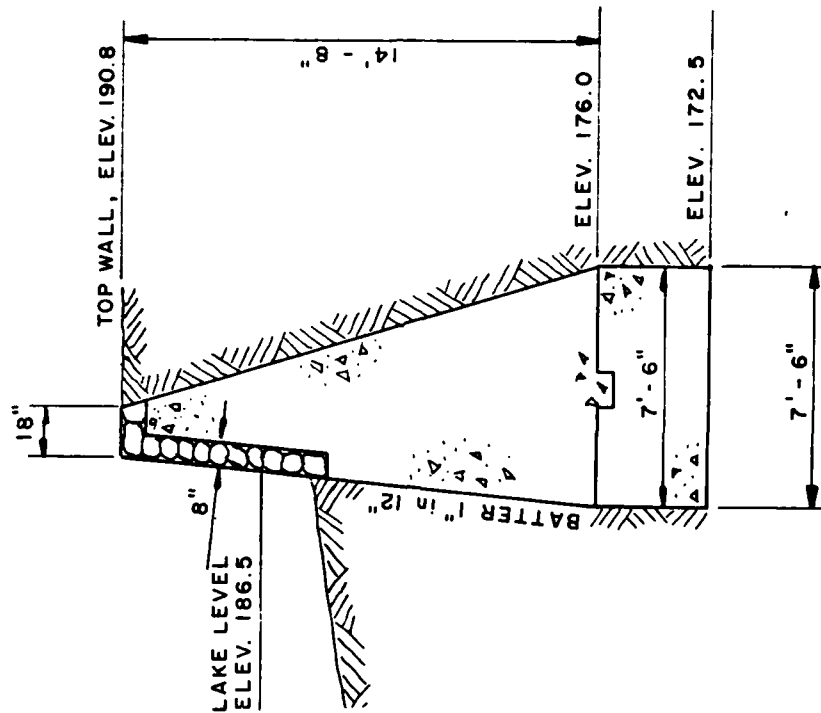
SECTION B - B

SECTION THRU RETAINING WALL  
NOT TO SCALE

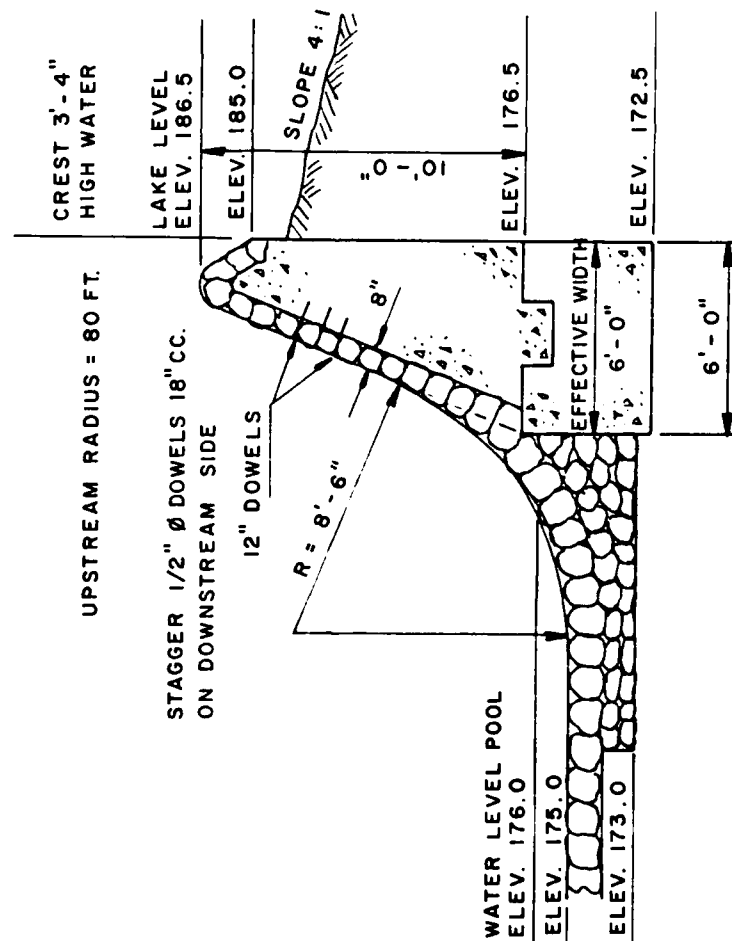
SECTION A - A

SECTION THRU CENTER OF DAM  
NOT TO SCALE
