ATLANTIC COAST BASIN  
WILLOW BROOK, MONMOUTH COUNTY  
NEW JERSEY

**N.J. NO NAME  
DAM NO. 52  
NJ 00806**

**PHASE 1 INSPECTION REPORT  
NATIONAL DAM SAFETY PROGRAM**

Name of Dam: N.J. No Name Dam No. 52 Fed ID # NJ 00806

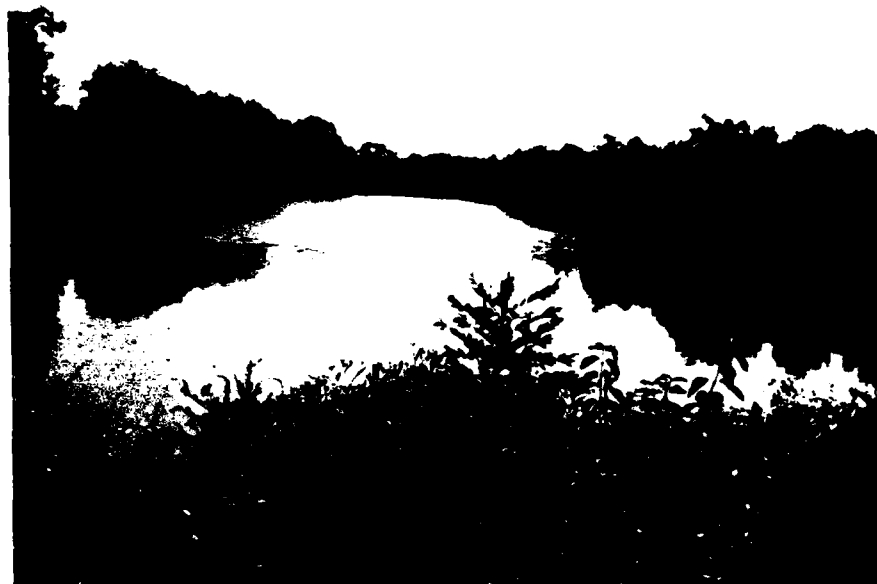
The reservoir of the No Name Dam No. 52 is relatively small in area (4.6 acres), and its contributing drainage area is only 0.13 square miles. The reservoir, however, is between 10 to 16 feet deep, its area having been formed by excavation of the existing marl. The reservoir banks are fairly steep, stable, and overgrown with brush and weeds.

View of Lake from Dam Crest August, 1980
