**CONCRETE AND ROCK TESTS  
MAJOR REHABILITATION OF DRESDEN ISLAND  
LOCK AND DAM, ILLINOIS WATERWAY  
CHICAGO DISTRICT, PHASE II COMPLIANCE  
SCOUR DETECTION**

R. L. Stowe, B. A. Pavlov

March 1981  
Final Report

Prepared for U. S. Army Engineer District, Chicago  
Chicago, Ill. 60604

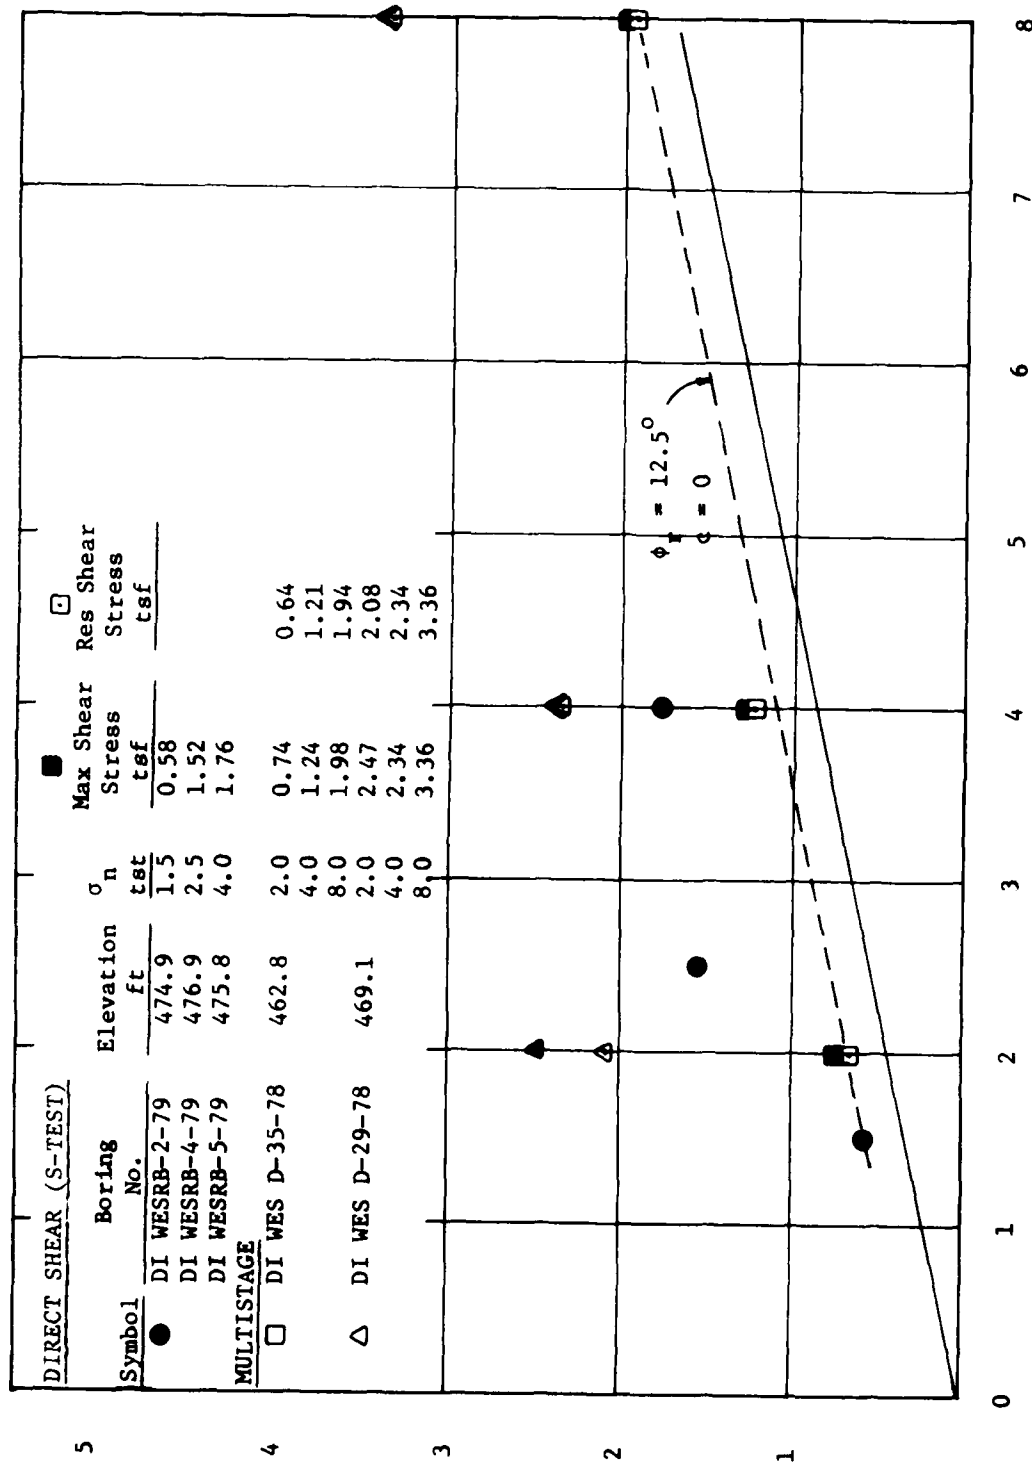
71. The failure envelopes for the critical zones within the foundation are presented in Figures 11 through 13. The critical zones in terms of sliding are the green clay layer at the base of the Ft. Atkinson and the clay and shale/clay filled partings in the Ft. Atkinson. The bedrock feature having the lowest residual strength is the green clay layer; residual strengths of  $c = 0$  and  $\phi_r = 12.5^\circ$  were obtained; see Figure 11. A conservative envelope was constructed by placing it through the lower data points and then shifting it to have a zero cohesion. The green clay layer exists beneath a section of the lower approach wall. It was not found beneath any other concrete at the site.

72. As mentioned earlier, multistage shear tests were conducted on filled parting specimens out of necessity. Direct shear tests were run for comparison. The direct shear testing shows that maximum strengths are higher than reported for the multistage tests. Maximum and residual strengths were obtained on the filled partings using the following test technique. Four specimens each were used for the two differently filled partings. Each of the four specimens had different normal loads applied; 1.5, 2.5, 4.0, and 8.0 tsf. A specimen was consolidated with a normal load, sheared, and a peak load determined. The shear and normal loads were removed, the specimen repositioned, the same normal load reapplied and sheared again. This sequence was continued with the same specimen until a residual strength was obtained. Another specimen was likewise tested at a greater normal load, and so forth. The peak and residual shear stress values from the four specimens were used to construct maximum and residual strength failure envelopes; thus, maximum and residual  $\phi$  angles were determined; see Figures 11 and 12.

Figure 11. Direct shear (S-Test) and multistage shear test results, green clay layer at contact of Ft. Atkinson & Maguoketa Formations

76. It is recommended that when the clay and shale/clay seams are considered for design the following shear strengths be used: clay, maximum and residual, respectively, be  $\phi = 43^{\circ}$ ,  $c = 2.3$  tsf, and  $\phi_r = 23.3^{\circ}$ ,  $c = 0$ ; shale/clay, maximum and residual, respectively, be  $\phi = 34.3^{\circ}$ ,  $c = 1.6$  tsf, and  $\phi_r = 21^{\circ}$ ,  $c = 0$ .

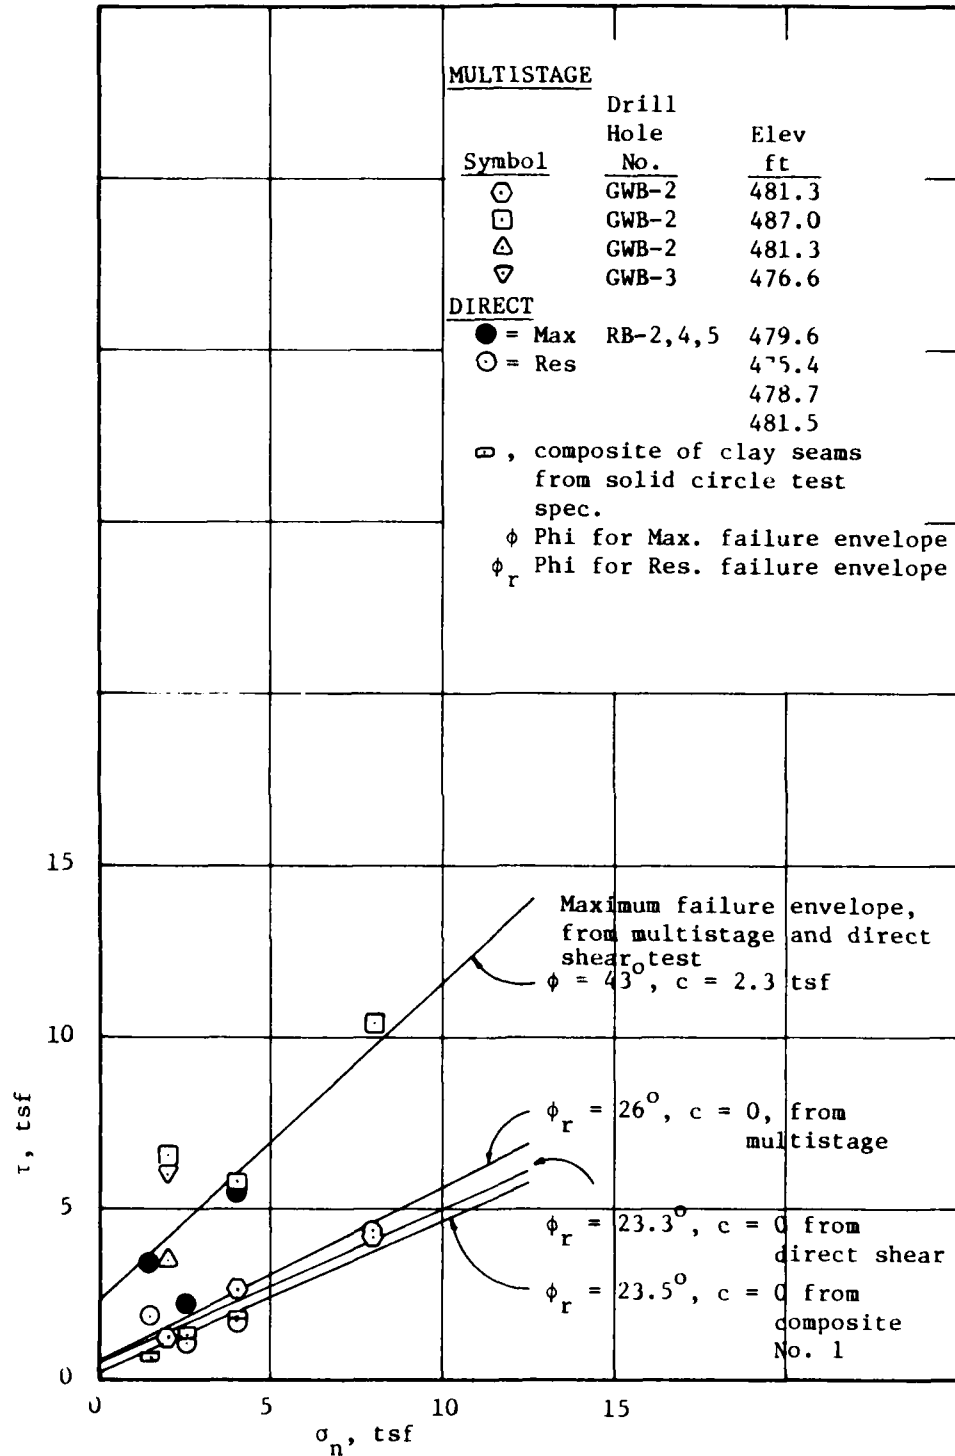
Figure 12. Direct shear results, clay seam in limestone.

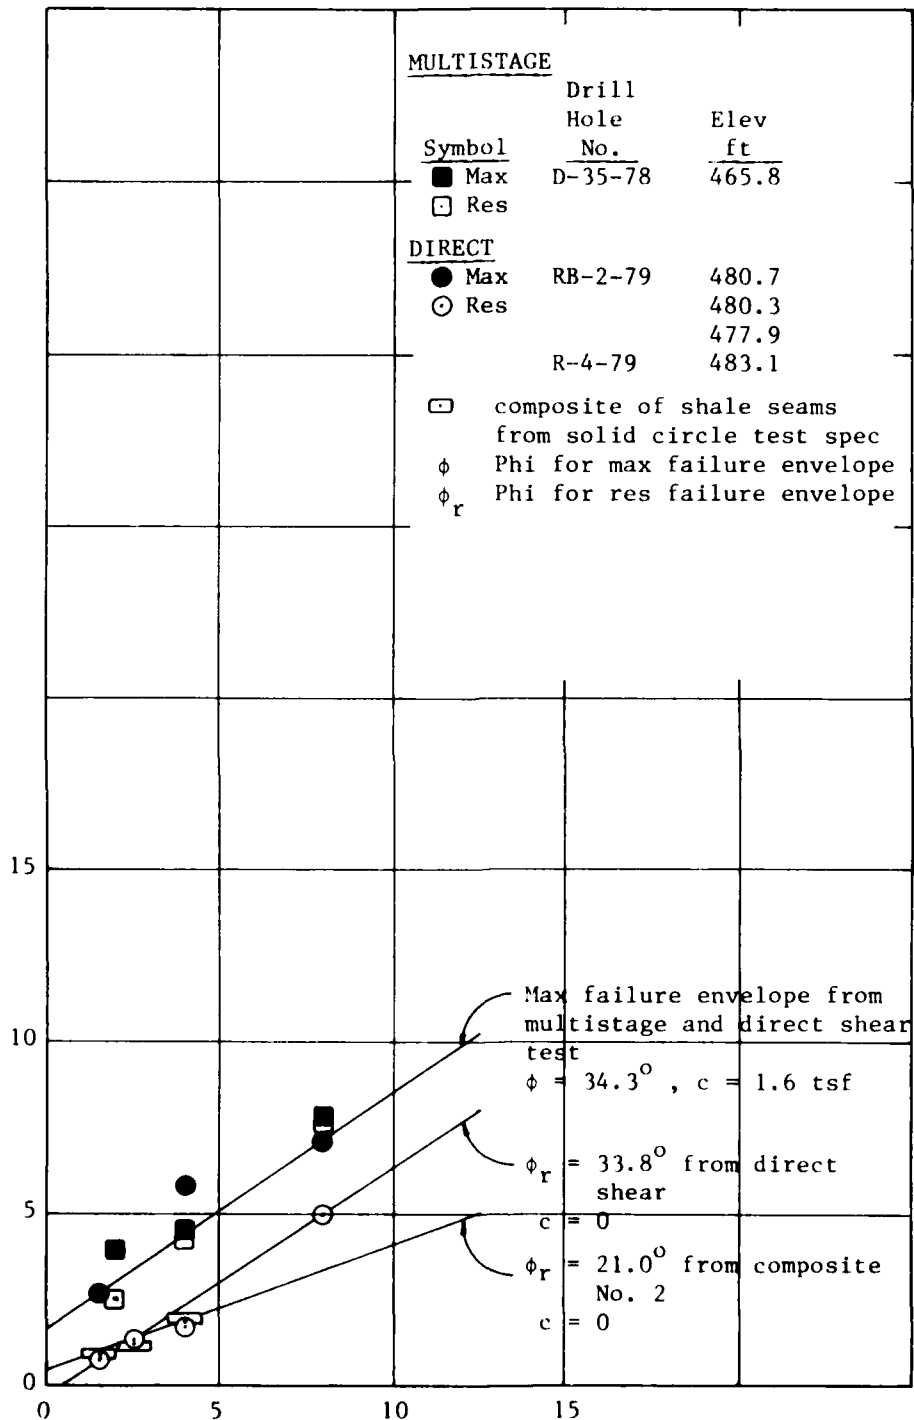
Figure 13. Direct and multistage shear results, shale/clay seam (1/8 to 1/4 in. thick) in limestone.
