LACKAWAXEN RIVER BASIN  
DYBERRY CREEK, PENNSYLVANIA

**JADWIN DAM**

DAM, OUTLET WORKS & SPILLWAY  
PERIODIC INSPECTION REPORT NO. 4

NOVEMBER 1980

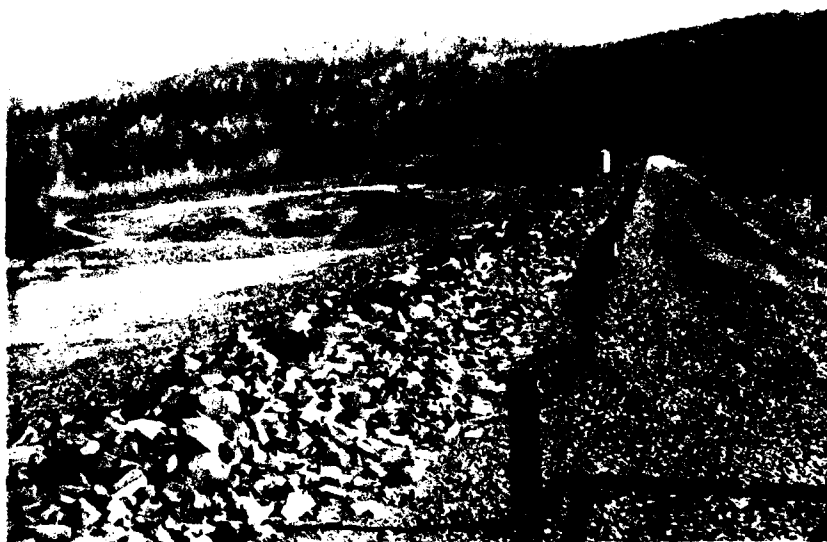
Photo No. 1. Looking across dam crest from right abutment.
