| REPORT DOCUMENTATION PAGE | | READ INSTRUCTIONS<br>BEFORE COMPLETING FORM |
|---|---|---|
| 1. REPORT NUMBER<br>NRL Memorandum Report 4501 | 2. GOVT ACCESSION NO.<br>AD-A098 894 | 3. RECIPIENT'S CATALOG NUMBER |
| 4. TITLE (and Subtitle)<br>SHOCK AND VIBRATION PERFORMANCE OF<br>WIND INDICATING EQUIPMENT, TYPE F | 5. TYPE OF REPORT & PERIOD COVERED<br>Final report on one phase of<br>an NRL problem. | 6. PERFORMING ORG. REPORT NUMBER |
| 9. PERFORMING ORGANIZATION NAME AND ADDRESS<br>Naval Research Laboratory<br>Washington, D.C. 20375 | 10. PROGRAM ELEMENT, PROJECT, TASK<br>AREA & WORK UNIT NUMBERS<br>63541N; 0291-0-1 | |

SHOCK AND VIBRATION PERFORMANCE OF WIND INDICATING EQUIPMENT,  
TYPE F.

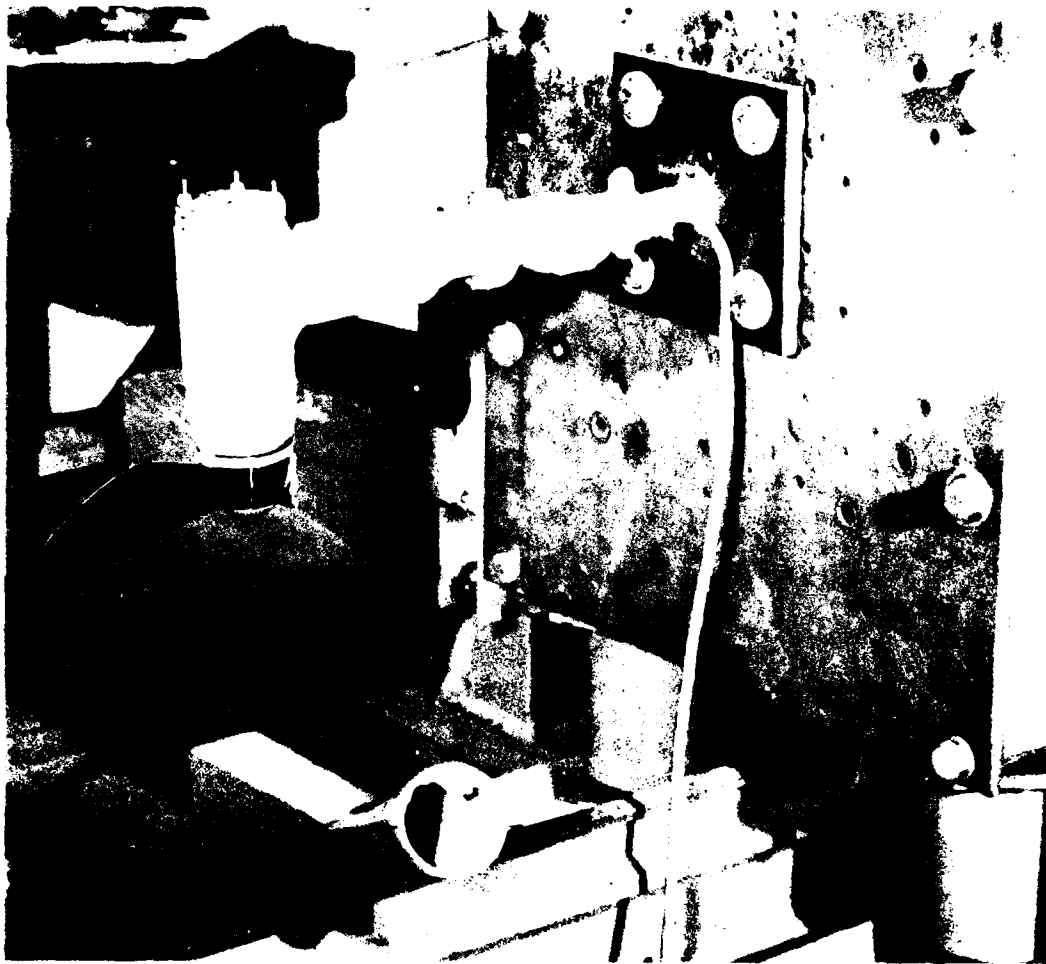
was 185°, and speed indication was 10 knots. No damage was noted after either the 1-ft or 3-ft blows. The 5-ft blow caused considerable damage to the vane, as shown in Figs. 3 and 4 and listed below.

- (1) One of the rotor blades snapped off.
- (2) The center assembly section was bent and deformed (Fig. 4).
- (3) The tail section snapped off due to failure of the epoxy bond to the metal insert at its forward end, which remained bolted to the center assembly section.
- (4) In addition to the damage to the vane, the pintle bolt was bent slightly.

Fig. 3 The detector after the 5-ft Back blow. Note broken rotor blade and tail assembly

- (1) Replacement of the rotor.
- (2) No action was taken.
- (3) Fastening the tail of the metal insert with four sheet-metal screws.
- (4) No action taken.

3.9. Assessment of Shock Performance - The vane assembly constitutes the most serious problem area. The rotor itself may fail, and to ensure reliability it may be necessary to construct it of metal. The bonding of the tail section is totally inadequate, and the material itself subject to cracking; perhaps this could be cured by one-piece construction. The center assembly section must be more robust in order to resist the deformation observed. The nuts and bolts holding the vane assembly together must be reconfigured to prevent loosening. Each potential fix would appear likely to exacerbate another existing problem -- a metal rotor and one-piece tail

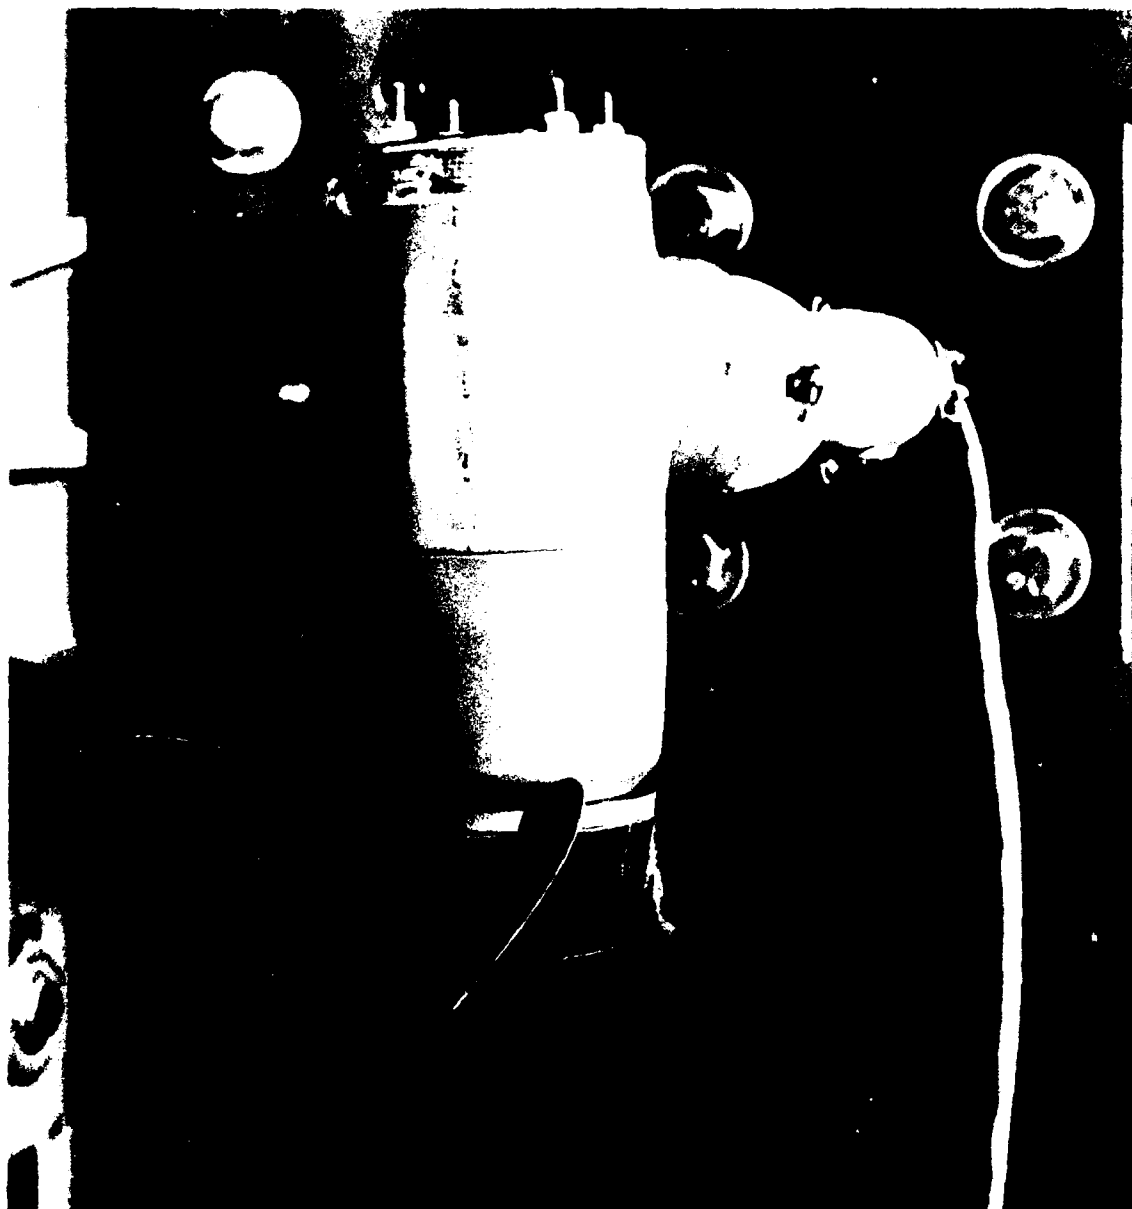
Fig. 4 — Damage to the detector from 5-ft Back blow. The metal insert of the tail assembly is still attached to the center assembly section, but the epoxy bond to the tail molding has failed. Note deformation of the center assembly section.

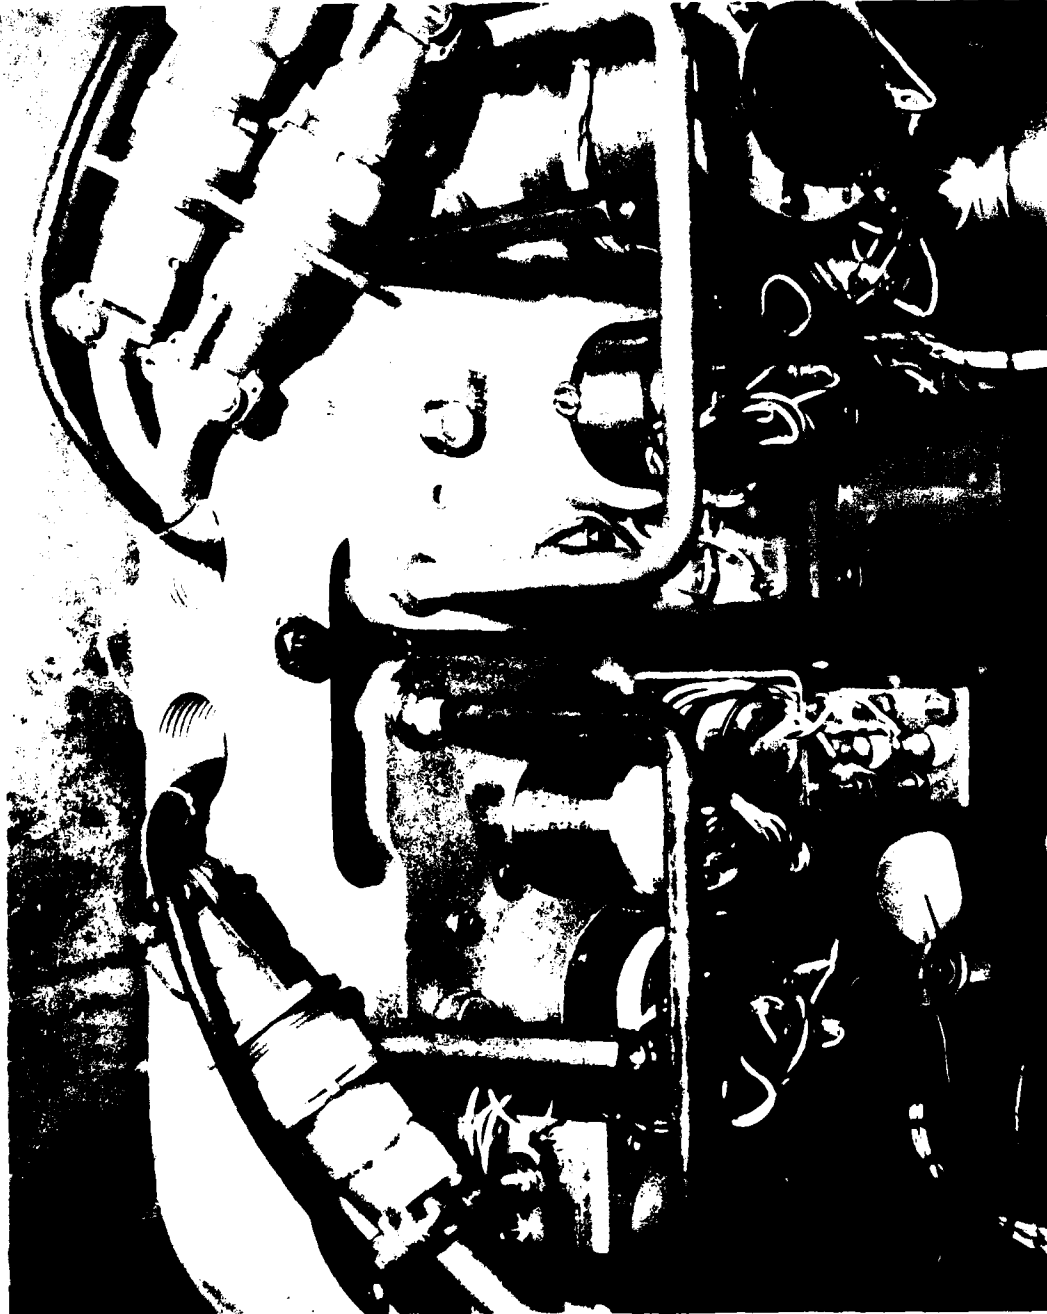
the base plate of the transmitter had fractured at the mounting bolt on the center line of the top side (Fig. 10). Such a fracture would be most likely to occur under Back blows: it may in fact have been sustained during the Back blows, probably the 5-ft, and passed unnoticed until the two Top blows had opened it a little further. Since the fracture did not appear to extend completely through the base plate, and the remaining blows of the test schedule were Top and Edge, which would be less likely to extend it than the Back blows, the test was continued. When the shaft retainers had been replaced, the system functioned properly. The 5-ft blow had no apparent effect on operation or the fracture.

4.7. Assessment of Shock Performance - The behavior of the shaft retainers is another example of the need for secure fasteners discussed above. The fracture of the base plate, which is an aluminum casting, would constitute a failure. Cast materials are generally discouraged or forbidden for shipboard installations because of their poor shock resistance. The low ductility typical of cast metals renders the extent to which a fracture will propagate unpredictable. In this case, the fracture remained minor; in the next, it could be catastrophic. Note also that even the minor fracture found here could, because of its location, have had considerable influence of the dynamics of the transmitter, and possibly on its performance under shock.

Fig. 10 — The fracture in the transmitter base plate found after the 3-ft Top blow. The fracture is located at the bolt at top-center, and progresses about half-way through the base plate. It may well have been initiated during the Back blows.

6.3. The structural problem with the transmitter base plate is one of material. Cast metals are essentially banned by shock requirements, and should be replaced by forged or machined assemblies wherever they occur. This applies also to those parts which did not misbehave during the tests described here. Cast materials simply cannot be relied upon in the shipboard shock environment.

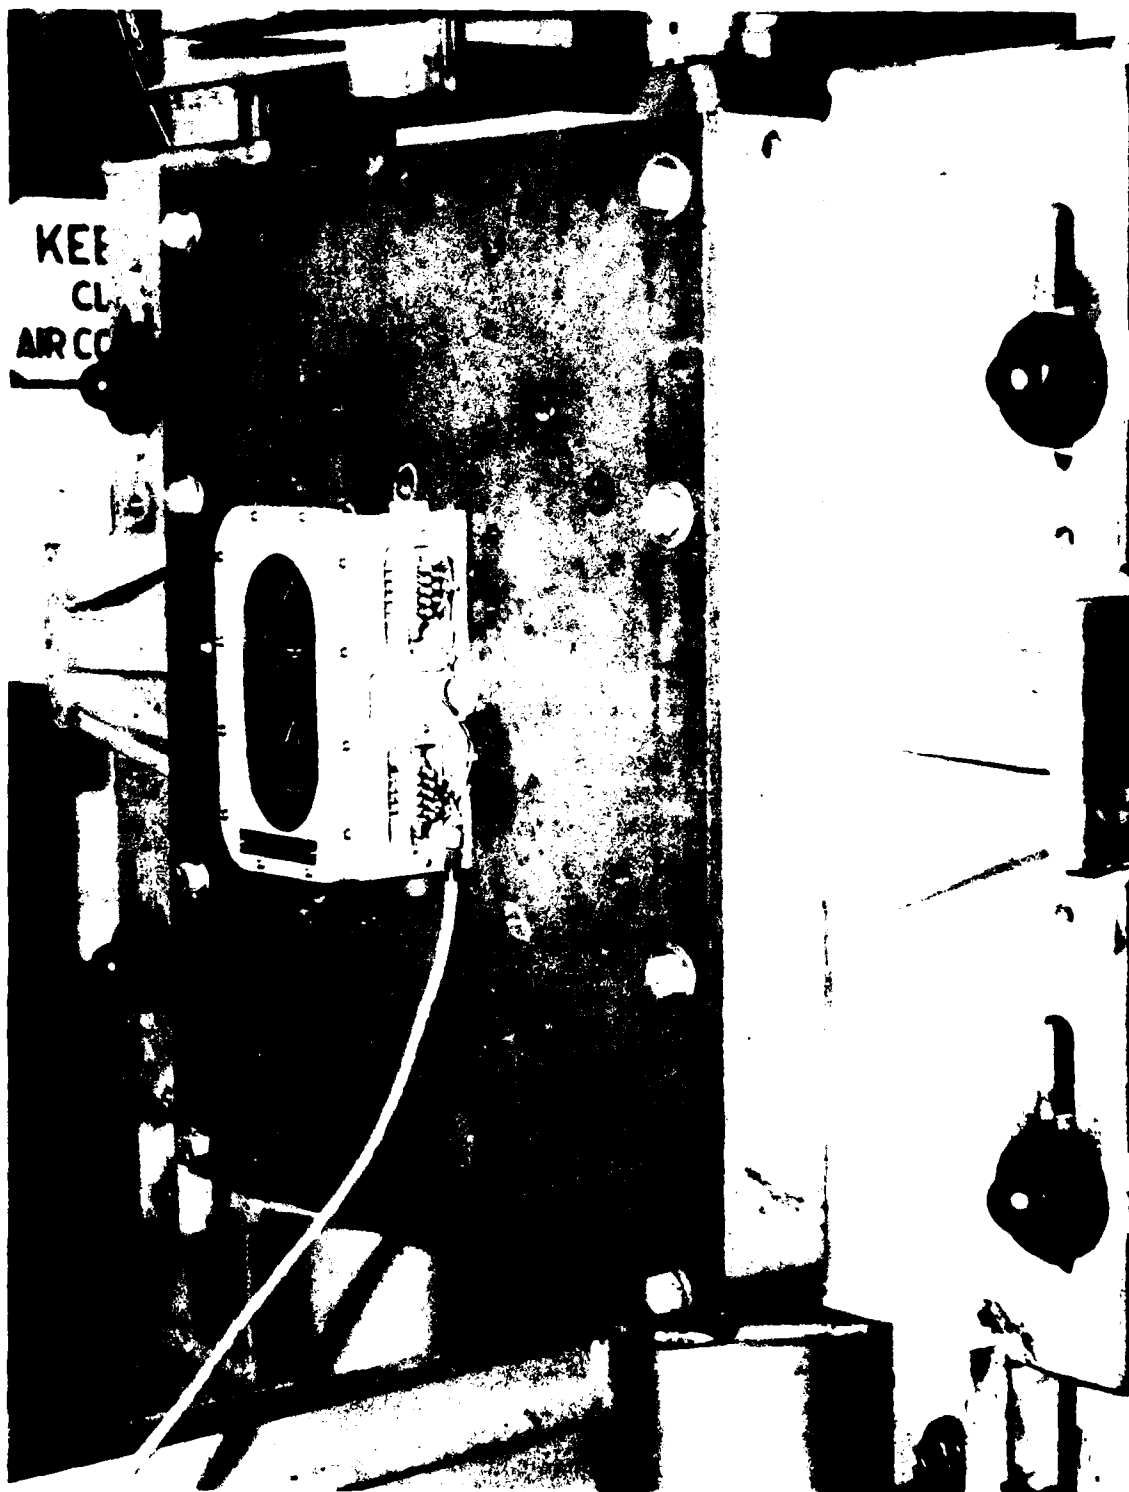
5.6.2. Back Blows - On the 1-ft blow, the direction indication once more changed from  $0^{\circ}$  to  $345^{\circ}$ , while the speed indication remained at 0 kt. The direction indication was reset to  $0^{\circ}$ . During the 3-ft blow, the indicator became completely inoperative. Examination disclosed that the fasteners for both synchros had bent, allowing them to drop out of position and rotate freely. In addition, the speed synchro was inoperative:

5.7. Assessment of Shock Performance - In contrast to its excellent vibration performance, the shock performance of the indicator was totally inadequate. Again, a major contributor was internal fasteners. The reason for the malfunction of the speed synchro is not at present known; tests at NAEC are expected to identify it. It too may be related to the failure of the fasteners to restrain the synchro properly.

6.2. The inadequacy of internal fasteners involves fasteners of all descriptions -- nuts and bolts, screws, shaft retainers, synchro clamps, etc. All must be reviewed with regard to dynamic loadings. Cures to be considered would include resizing, adding locking mechanisms, etc. Note that the clamping arrangement traditionally employed for installing synchros and servoes is inadequate for shock and vibration loadings, particularly with regard to screw size.
