BLUE MARSH DAM  
AND  
RESERVOIR

CONDITION REPORT.

DAM, OUTLET WORKS, SPILLWAY  
& BERNVILLE PROTECTIVE WORKS.  
PERIODIC INSPECTION REPORT

SEPTEMBER 1979.

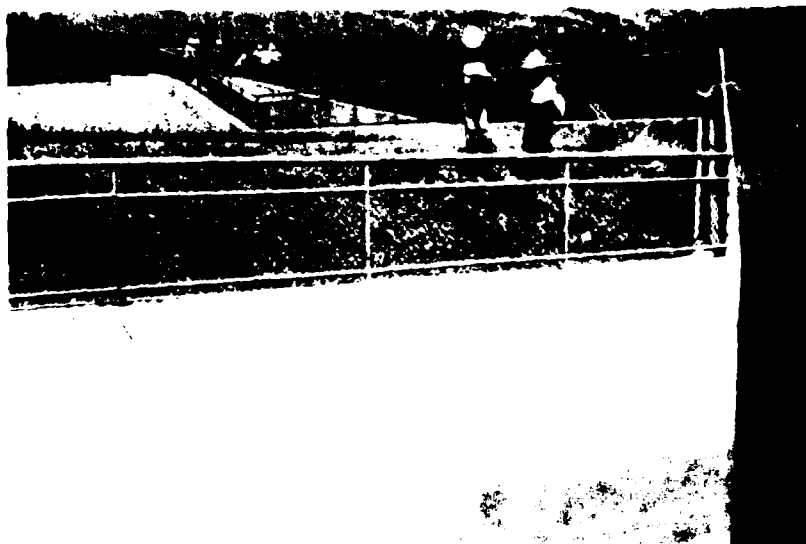
Photo No. 1. Cracks in wingwall-right side of stilling basin

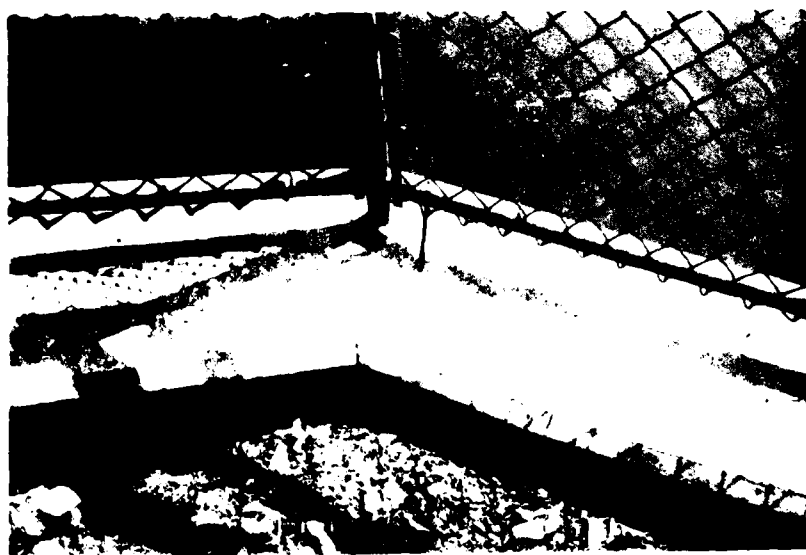
Photo No. 2. Crack at wingwall/stilling basin wall intersection -  
right side

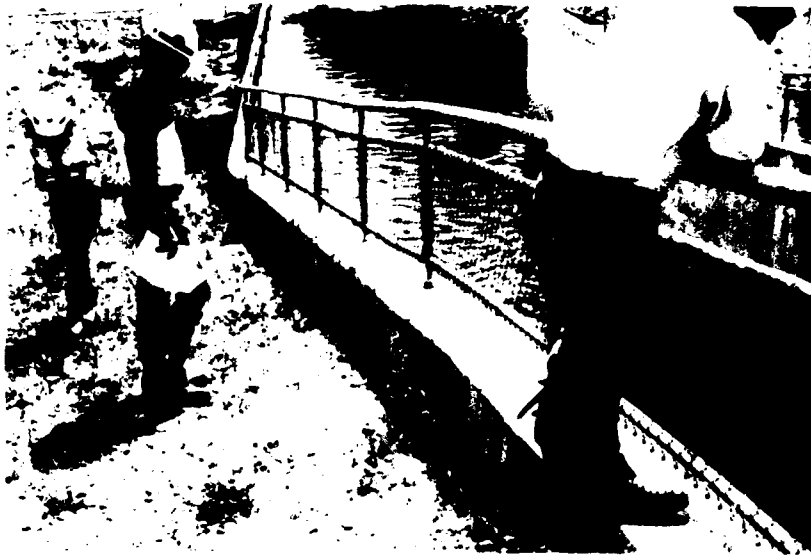
Photo No. 5. Displacement of stilling basin posts and handrails  
- left side.

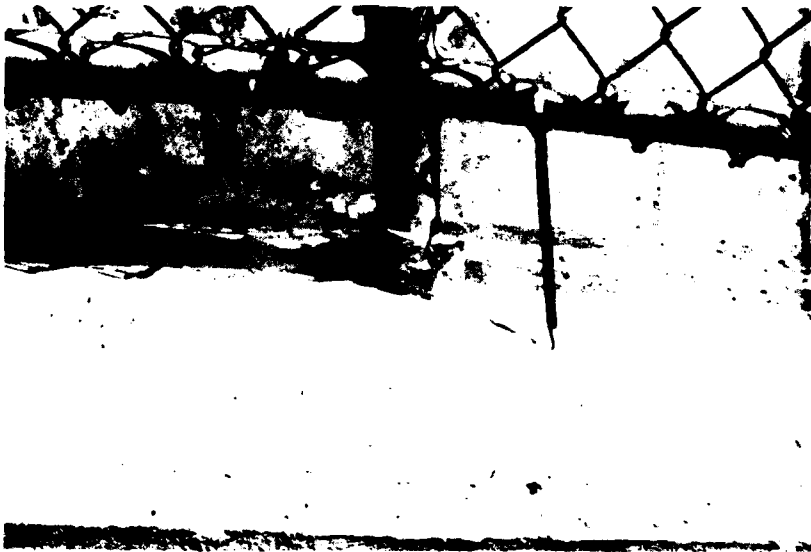
Photo No. 6. Close up at base of displaced post-right side

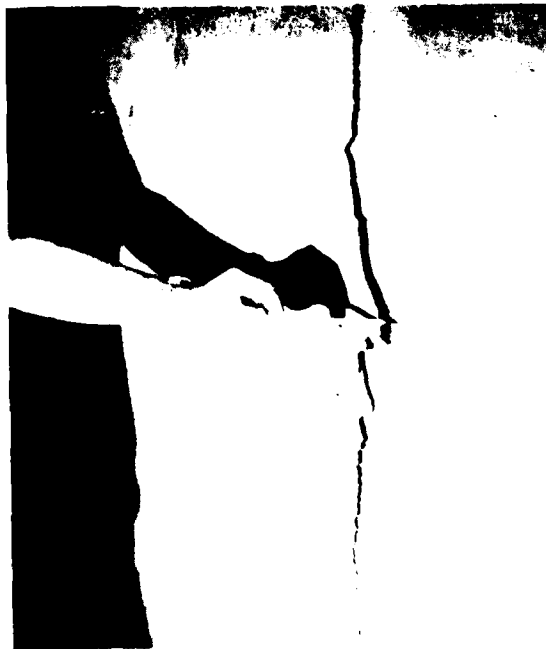
Photo No. 8. Patching material pulled loose from wall at offset joint.  
Bernville Protection Works- Pressure Conduit of  
Detention Dam No. 2
