DELAWARE RIVER BASIN,  
CHESTNUT BRANCH-MANTUA CREEK,  
GLOUCESTER COUNTY,  
NEW JERSEY.

National Dam Safety Program  
**ALCYON LAKE DAM**

**NJ 00427**

**PHASE 1 INSPECTION REPORT-  
NATIONAL DAM SAFETY PROGRAM**

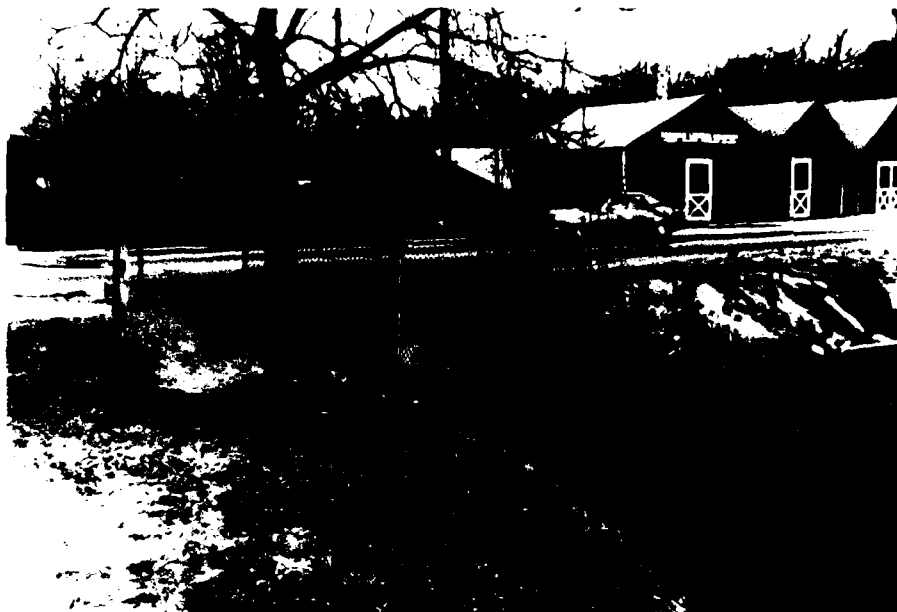
The auxiliary spillway is a 5'-0" diameter steel pipe with an irregular concrete inlet which is blocked up by stoplogs to El. + 84. The pipe appears to be partially blocked up and the stoplogs appear to be immovable. The penstock discharges into the foundations of an old millhouse and hence into a concrete lined millrace which extends about 150 feet downstream.

View of auxiliary spillway inlet
