DELAWARE RIVER BASIN,  
TAR HILL BROOK TRIBUTARY OF  
PEQUEST RIVER, SUSSEX COUNTY,  
NEW JERSEY.

# LAKE LENAPE DAM

(NJ 00019)

## PHASE 1 INSPECTION REPORT. NATIONAL DAM SAFETY PROGRAM.

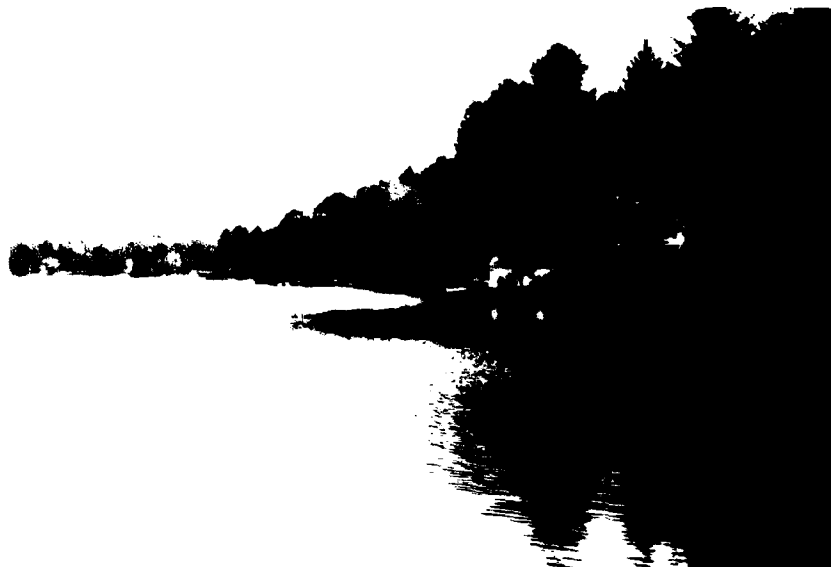
View of east reservoir shoreline  
taken from spillway.

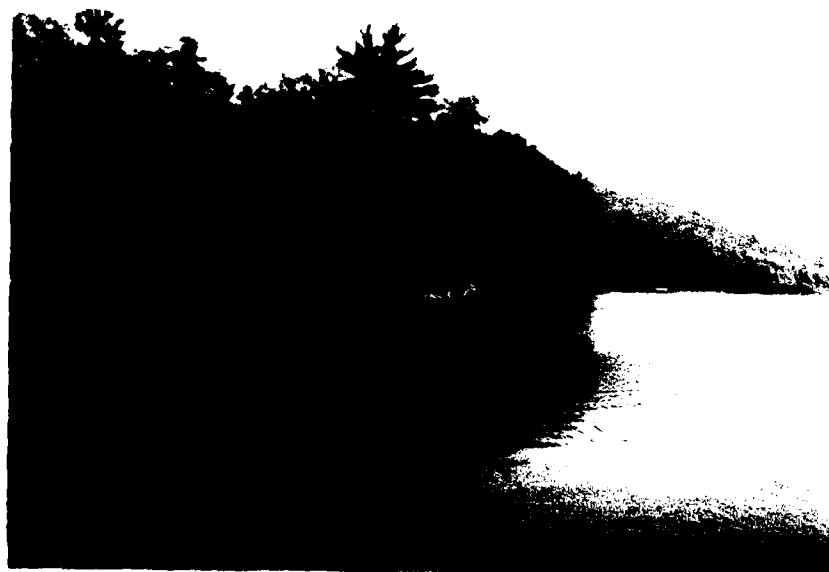
View of west reservoir shoreline  
taken from spillway

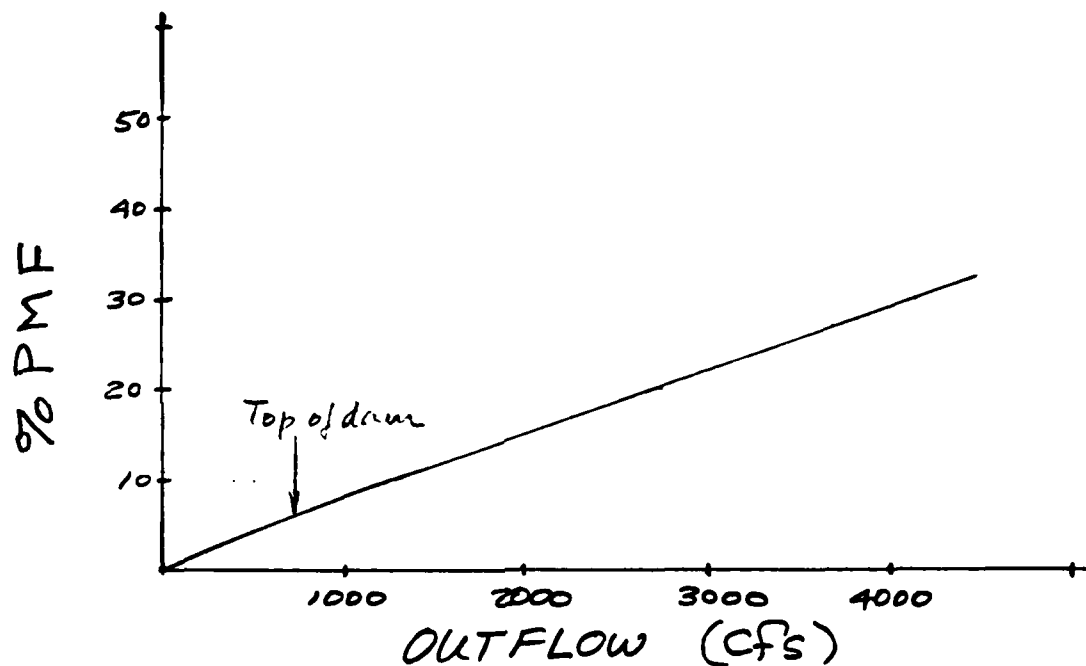
# OVERTOPPING POTENTIAL

- 1) VARIOUS % OF PMF HAVE BEEN ROUTED USING HEC-1
- 2) PLOT PEAK OUTFLOW VS % PMF

- 3) DAM OVERTOPS AT ELEVATION 109.1 WITH  $Q = 739$  cfs.  $\therefore$  DAM CAN PASS APPROXIMATELY 6% OF THE PMF.
