⑥ National Dam Safety Program Lake  
Windsor Dam (NJ-00034)

HUDSON RIVER BASIN,  
TRIBUTARY PAPAKATING CREEK,  
SUSSEX COUNTY,  
NEW JERSEY.

PHASE 1 INSPECTION REPORT  
NATIONAL DAM SAFETY PROGRAM

LAKE WINDSOR DAM (NJ00034)

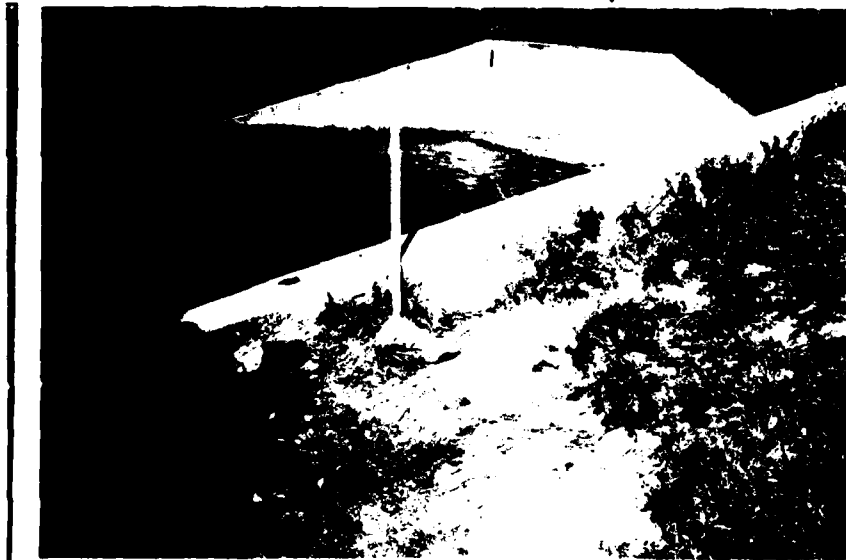
| VISUAL EXAMINATION OF | OBSERVATIONS | REMARKS OR RECOMMENDATIONS |
|---|---|---|
| SLOUGHING OR EROSION OF EMBANKMENT AND ADJUTENT SLOPES | MODERATE EROSION ON UPSTREAM SOUTH EMBANKMENT NEXT TO SPILLWAY RETAINING WALL.<br>MANY FOOT PATHS WITH MINOR EROSION ON BOTH EMBANKMENTS. | REPAIR EROSION. |
| RIPRAP FAILURES | UPSTREAM - DETERIORATION & MINOR DISLODGE-<br>MENT OF RIPRAP.<br><br>DOWNSTREAM - SPILLWAY RIPRAP HAS ACCUMULATED<br>SEDIMENTATION AND THERE IS SOME<br>DISLODGE-<br>MENT OF STONE. | REPAIR DISLODGED RIPRAP. |

Erosion and deterioration of riprap      26 September 1980  
at south upstream embankment and  
spillway wing wall.

(5) Repair deteriorated or dislodged riprap on the upstream face of the embankment and at the downstream toe of the spillway.

(6) Repair eroded areas on the embankment of the dam.

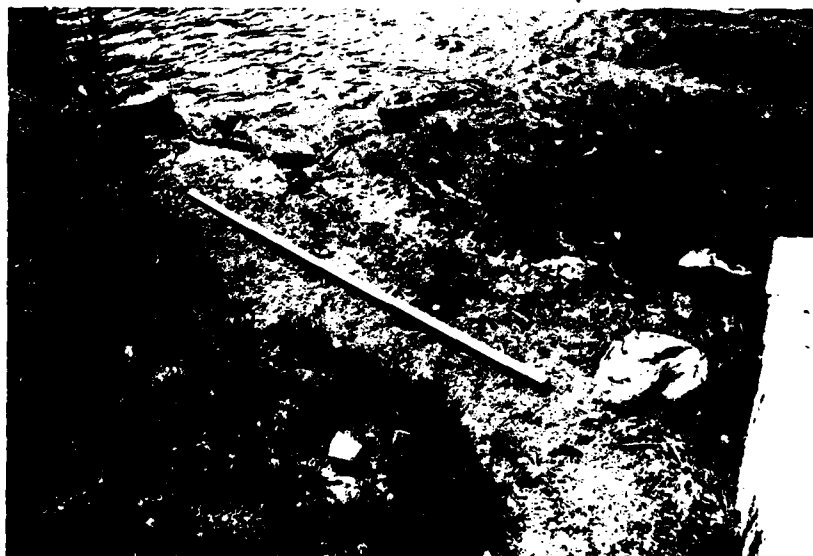
Erosion and deterioration of riprap      26 September 1980  
at south upstream embankment and  
spillway wing wall
