Report No. FAA-RD-80-111

## CONDITION SURVEY OF POROUS FRICTION SURFACE COURSE

APRIL 1981  
FINAL REPORT

U. S. DEPARTMENT OF TRANSPORTATION  
FEDERAL AVIATION ADMINISTRATION  
Systems Research & Development Service  
Washington, D. C. 20591

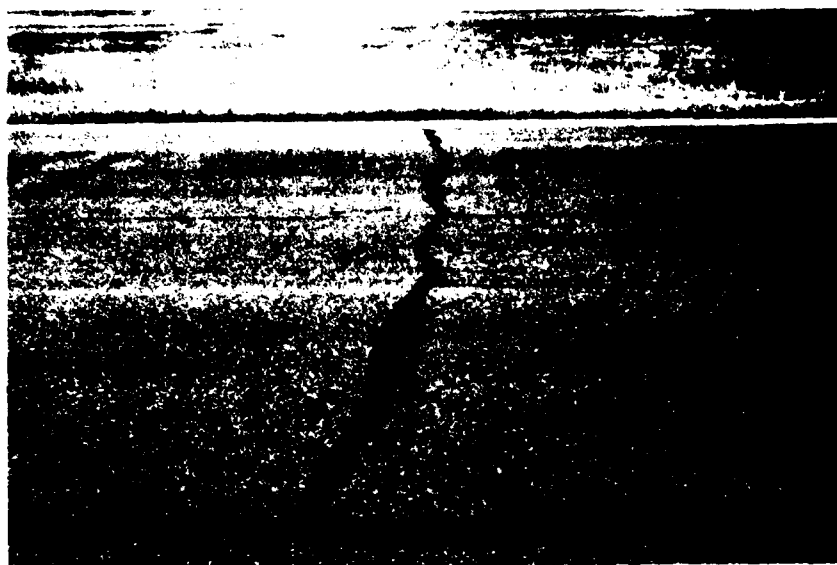
Figure 1. Sealed reflective cracks  
(runway 16-34, Great Falls)

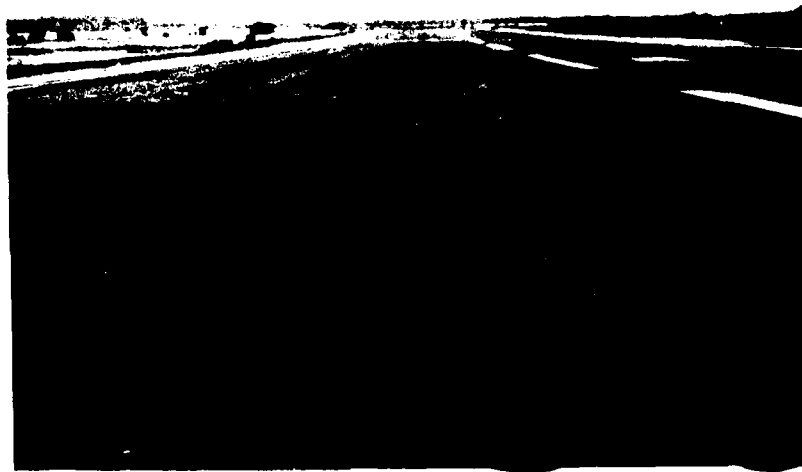
Figure 9. View of new PFC extension, old PFC in background (runway 17-35, Dallas)

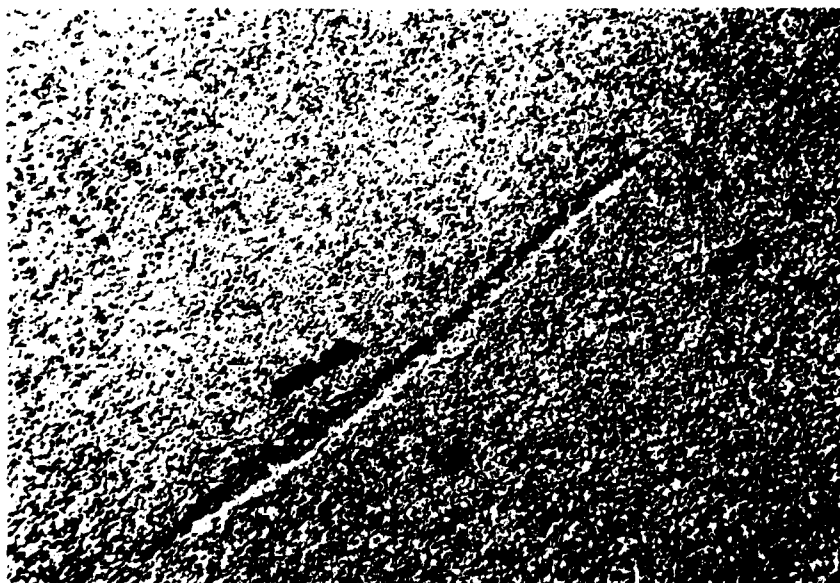
At the time of survey, the pavement was in good condition with only minor damage from snow removal equipment (Figure 11). The PFC had

Figure 11. Surface texture and equipment damage (Portland)

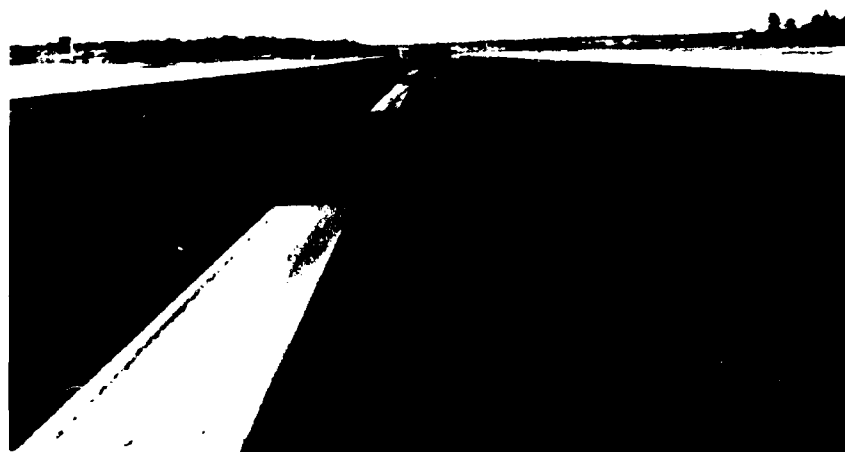
not been damaged by turns at the taxiways. Longitudinal paving joints were in good condition. A few popouts and also several reflective cracks with adjacent minor raveling were noted. The minor rubber buildup posed no problem (Figure 12).

Figure 12. Overall view of PFC runway (Portland)

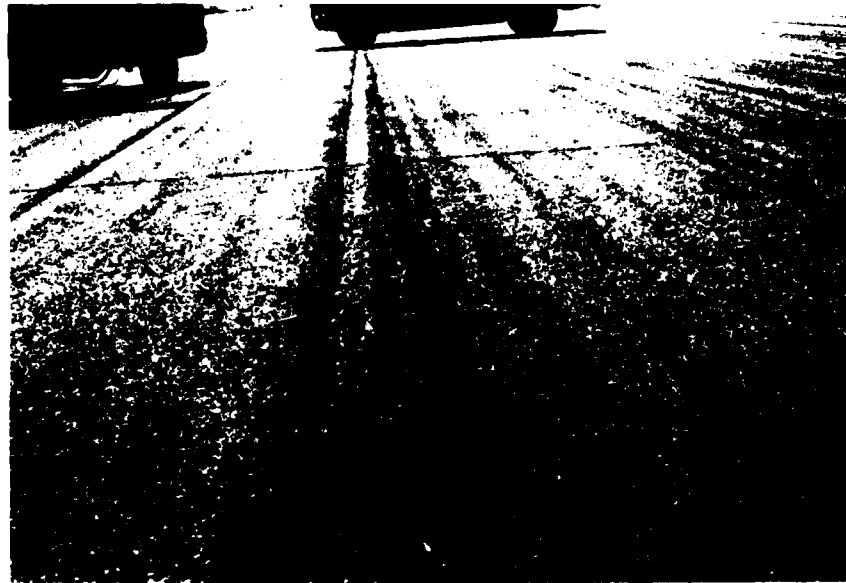
Figure 18. Surface raveling and reflective cracks  
(runway 13-31, Sioux City)

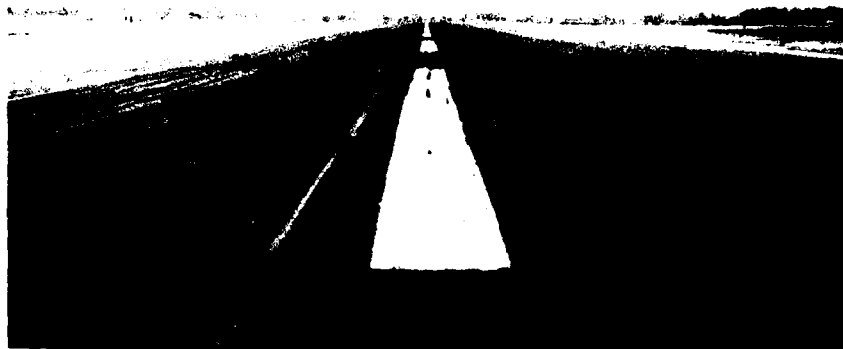
A quartzite aggregate was used with a specific gravity<sup>5</sup> of 2.68 and a Los Angeles abrasion test<sup>6</sup> value of 21 percent. The PFC was mixed in a batch plant, placed with a conventional paver, and rolled with a steel-wheel roller. Large reflective cracks running both longitudinally and transversely along the runway showed severe raveling (Figure 19). According to airport personnel, the rubber buildup, which was heavy in spots, had not caused any problems (Figure 20).

Figure 20. Overall view of PFC runway  
(runway 13-31, Sioux City)

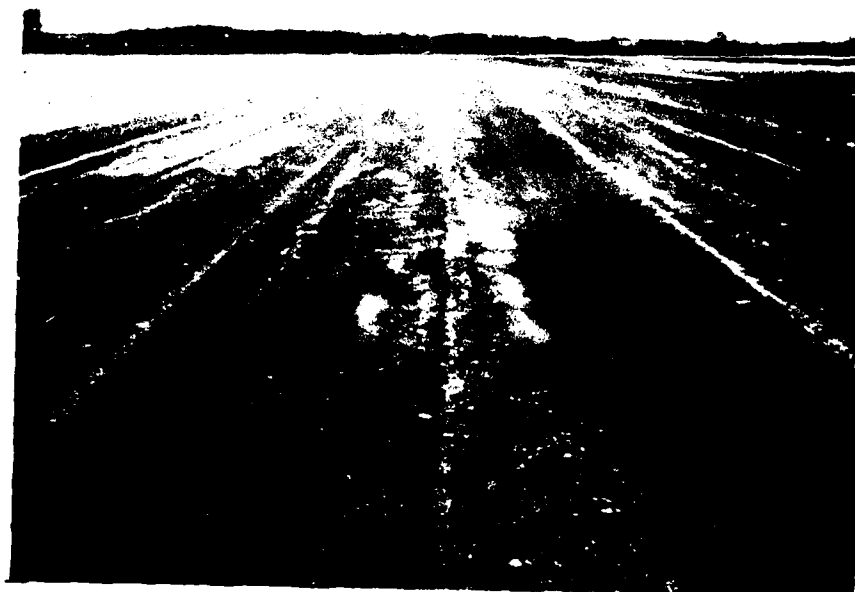
Figure 22. Joints, rich spots, and broken aggregate (runway 15-33, Sioux Falls)
