DELAWARE RIVER BASIN,  
TROUT BROOK, SUSSEX COUNTY,  
NEW JERSEY.

LAKE PLYMOUTH DAM

(NJ 00818)

PHASE I INSPECTION REPORT.  
NATIONAL DAM SAFETY PROGRAM

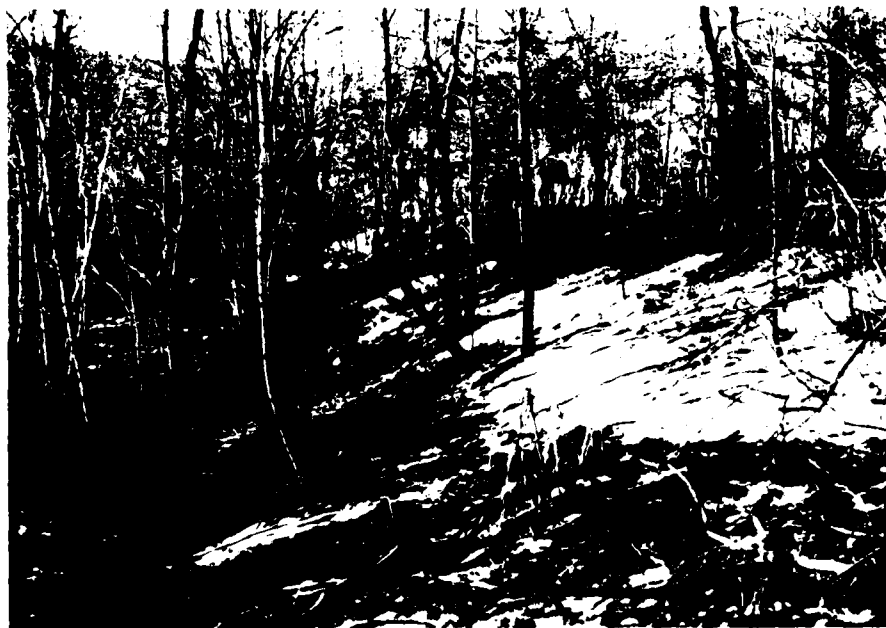
PHOTO 6  
DOWNSTREAM FACE OF DAM
