ATLANTIC COASTAL BASIN,  
NORTH BRANCH OF FORKED RIVER,  
OCEAN COUNTY,  
NEW JERSEY.

DEER HEAD LAKE DAM

(NJ 00789)

PHASE I INSPECTION REPORT.  
NATIONAL DAM SAFETY PROGRAM

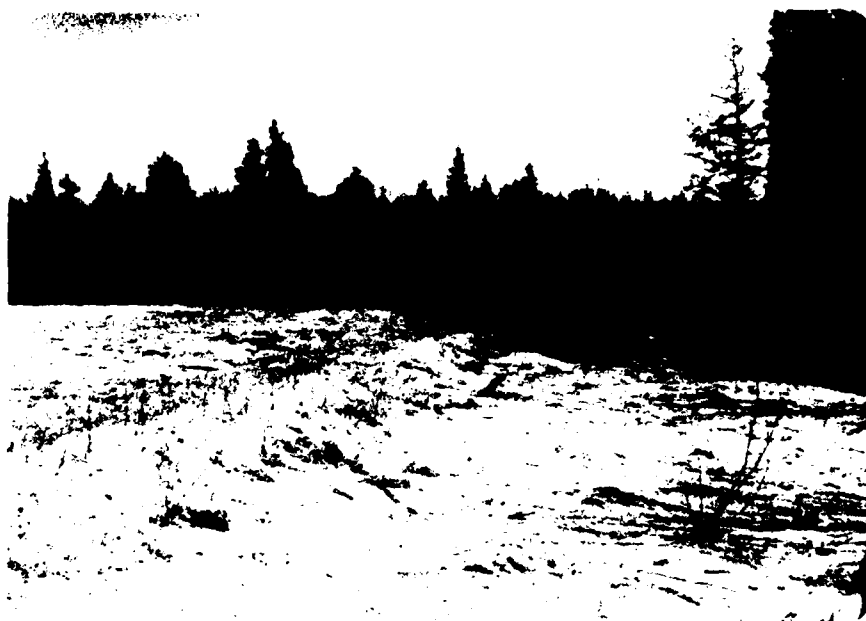
The earth embankment appears to be sound. No surface cracking on the embankment was noted. Some erosion due to rainfall runoff was observed in the parking area and on the left bank of the downstream channel between the old and new bridges. The vertical alignment of the crest is good. The horizontal alignment is very irregular due to the filling in on both sides of the original crest. The paved roadway is in good condition. There are telephone poles along the upstream crest between the road and the beach. No evidence of seepage or of burrowing by animals was observed.

Photo 4 - View of downstream slope looking towards the left end of the dam. (Photo taken February 15, 1981).

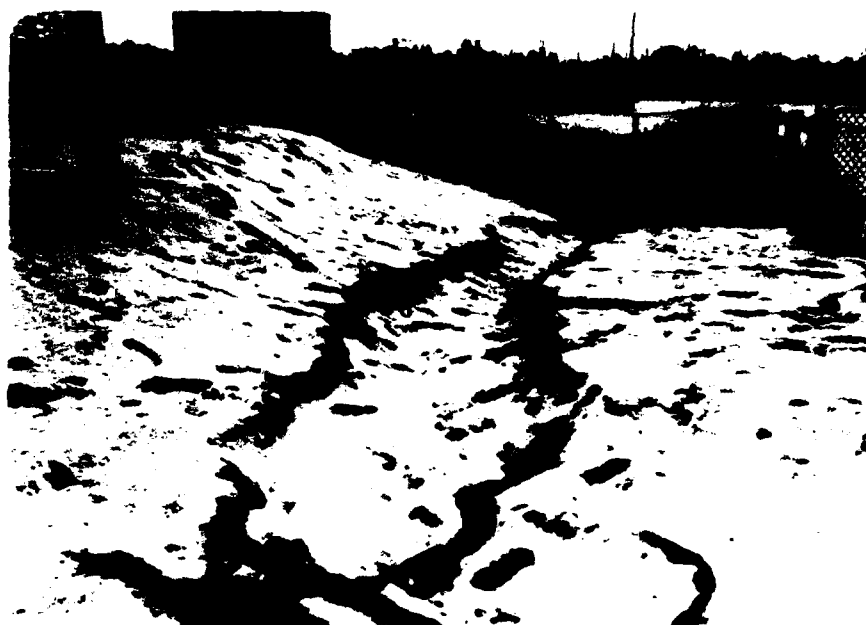
Photo 5 - View of erosion on left bank of channel between the old and new bridges at the concrete weir spillway. (Photo taken January 14, 1981).

(5) Fill in eroded areas of the embankment with appropriate material.

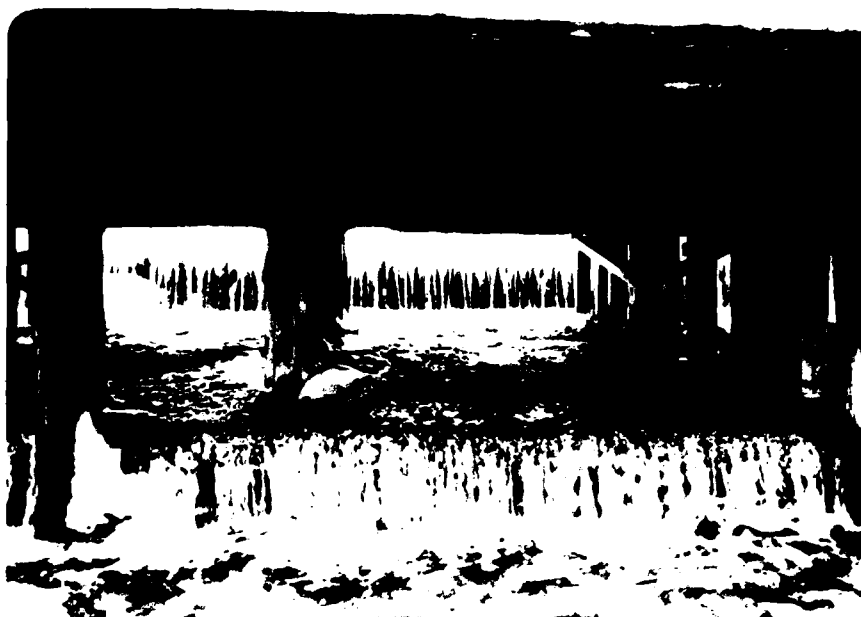
| VISUAL EXAMINATION OF | OBSERVATIONS | REMARKS AND RECOMMENDATIONS |
|---|---|---|
| | <p>Stilling basin for concrete weir left spillway has sections that have cracked and settled, surface is heavily spalled.</p> <p>N/A to drop inlet spillway at the right end of dam.</p> | <p>Repair stilling basin with epoxy cement.</p> |

Photo 10 - View of concrete discharge apron showing the cracked and settled sections of the apron. (Photo taken January 14, 1981).

- (1) Repair the stilling basin of the left spillway with epoxy cement.

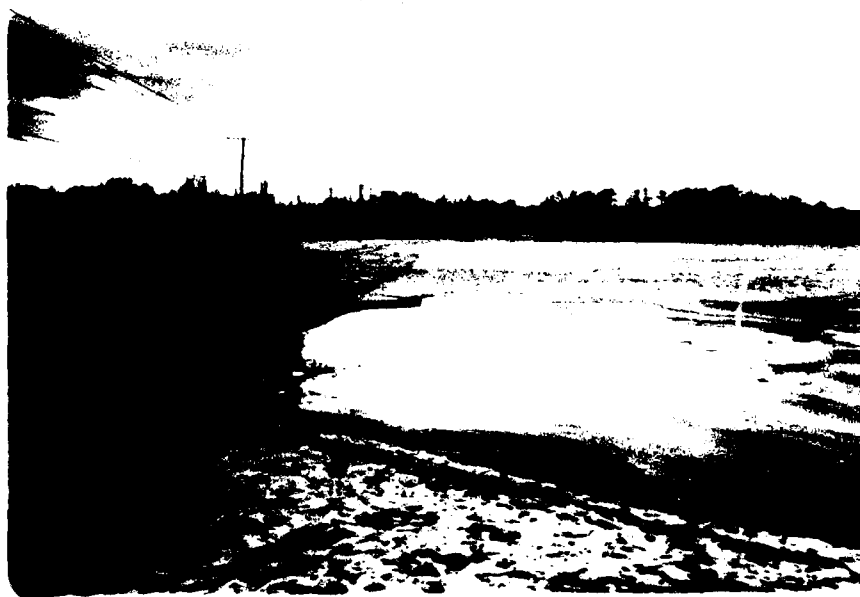
Photo 11 - Upstream view of concrete weir spillway taken from the left shoreline. (Photo taken January 14, 1981).
