CUMBERLAND POND DAM

NJ00824

PHASE I INSPECTION REPORT E

NATIONAL DAM SAFETY PROGRAM

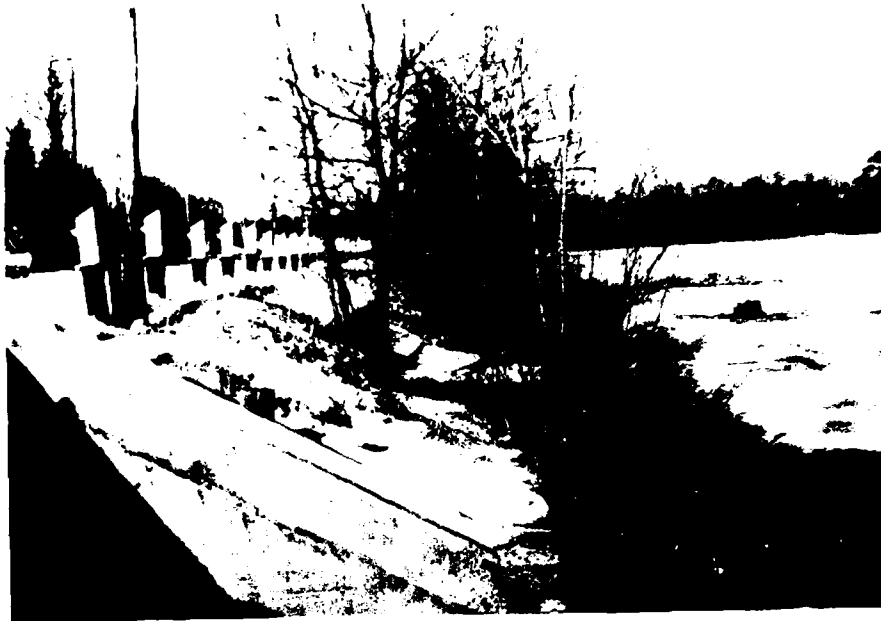
PHOTO 3

UPSTREAM FACE OF DAM NEAR SPILLWAY
